**A RESOLUTION OF THE COUNCIL OF THE CITY OF RICHMOND, CALIFORNIA,  
ACCEPTING THE KELLER BEACH SANITARY SEWER CCTV REVIEW AND  
ASSESSMENT REPORT FOR THE CITY OF RICHMOND PREPARED BY  
NCE-COASTLAND, DATED JANUARY 3, 2022**

## EXHIBIT A

**Date:** January 3, 2022  
**To:** Andre Jadcowski, P.E., NCE  
**From:** Jenny Melman, P.E.,  
NASSCO PACP Cert. U-0819-70306761  
**Subject:** City of Richmond  
Keller Beach Sanitary Sewer CCTV Review  
and Assessment Report

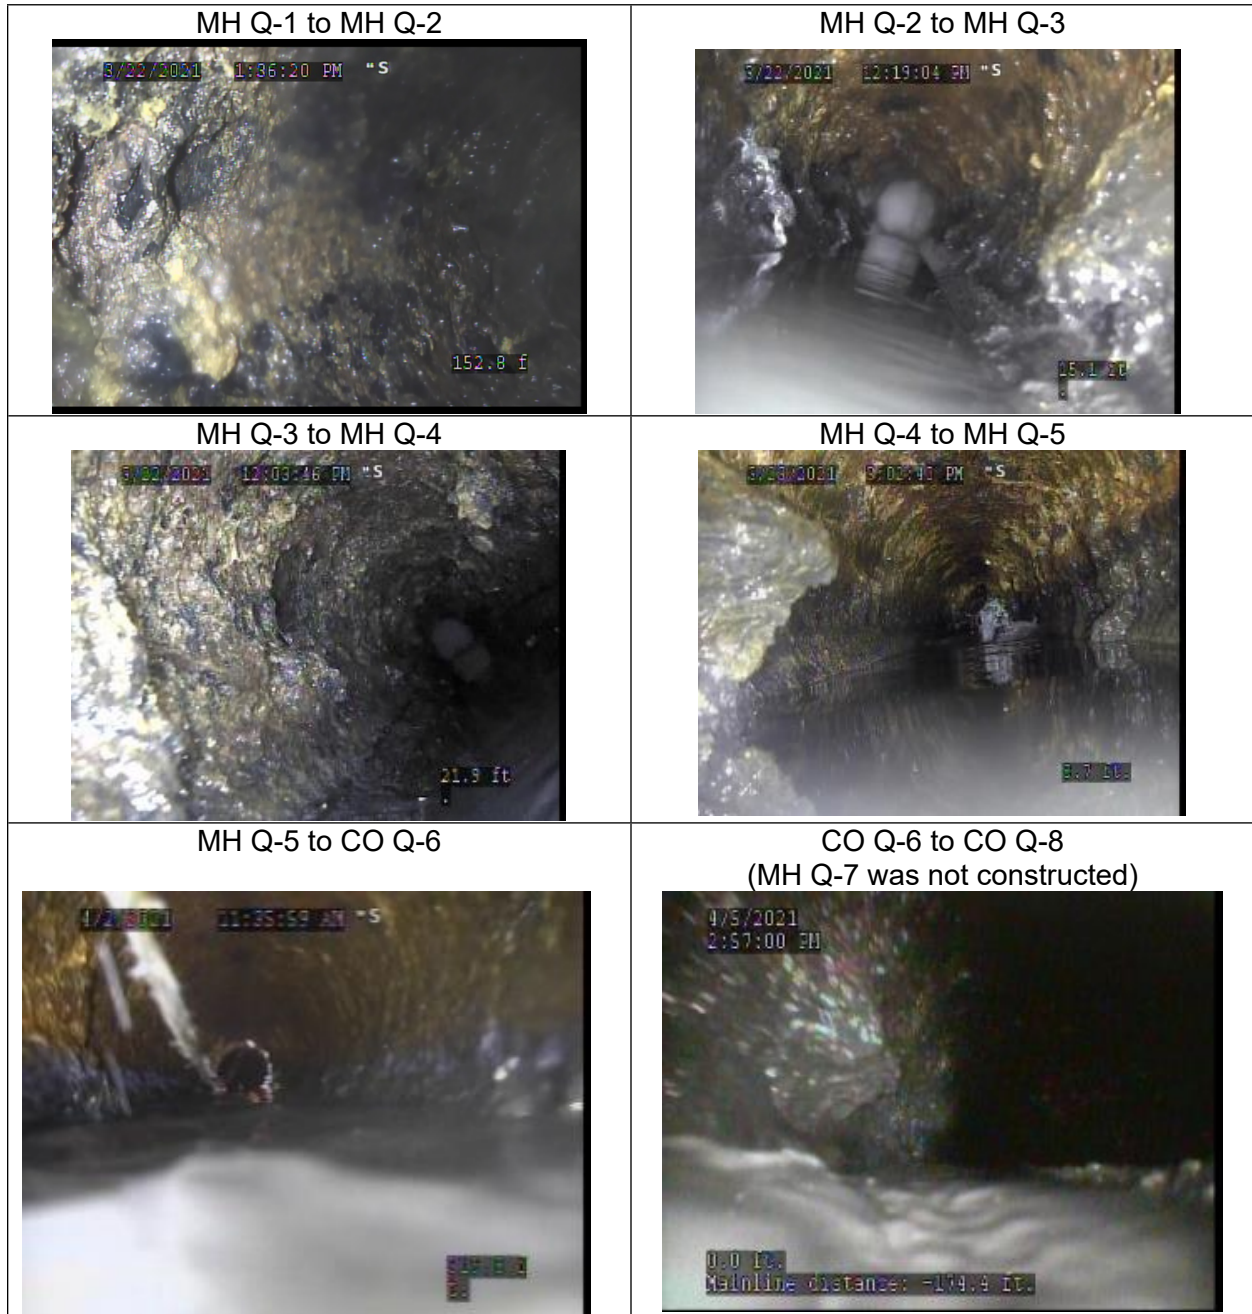
CO Q-8 to MH Q-9

According to Express Sewer, the entire reach of Keller Beach sanitary sewer was extremely corroded prior to cleaning. As shown in the post-cleaning images below, the upstream reach of pipe (MH Q-17 to MH Q-25) was generally descaled, while further downstream (MH Q-1 to MHQ-17) extensive turberculation and wall roughness remains.

No holes or cracks were observed in any segment (that was visible) of the Keller Beach sanitary sewer main, though the pipe walls show extensive evidence of pipe corrosion. Corrosion of the pipe walls (with a decrease of the pipe's structural integrity) has resulted over time due to the presence of corrosive hydrogen sulfide gas, a natural sewer gas, in the unlined pipe. The presence of extensive sags and pipe obstructions further exacerbate the problem by causing organic solids to settle and increases localized hydrogen sulfide gas production in the pipe. Corrosion will continue to deteriorate the pipe's structural integrity as long as the pipe remains exposed to sewage gases.

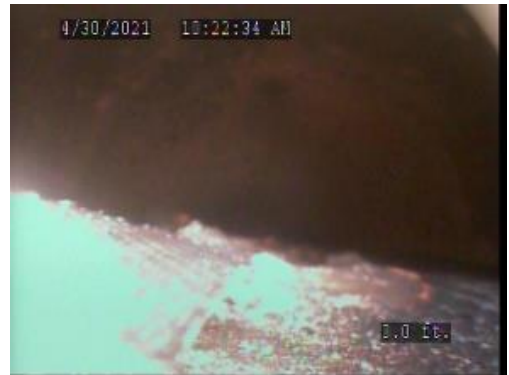
CO Q-18 to MH Q-19

CO Q-18	MH Q-19	US (reverse)	185	185	100%	10	CI	Pipe walls are fully descaled after cleaning. Rough wall surface.	Pipe holds water, may be due to sags. Water level 10-20% in reverse footage	Start at MH Q-19; Push cam to CO Q-18; Pull back with hydronozzle; 2 laterals observed; Ended at MH Q-19	Pipe inspected in reverse. MH Q-19 appears to be possible source of I/I and should be inspected.
MH Q-19	CO Q-20	DS	201	201	100%	8	CI	Pipe walls are fully descaled after cleaning. Rough wall surface.	Water level 5-100% Severe sags (camera underwater)	Start at CO Q-20; Push cam to MH Q-19; Pull back with hydronozzle; 1 lateral observed at 5'; Ended at CO Q-20	Push cam operated in reverse. Poor visual: rapid/shaky footage; no stills to inspect wall condition
CO Q-20	CO Q-22	US (reverse)	273	273	100%	8	CI	Rough wall surface. Pipe walls are fully descaled after cleaning. Poor visual (blurry and rapid return footage)	Low water level in most of reverse footage due to hydronozzle. Severe sags; Camera underwater 206'-226'	Start at CO Q-22; Ended at CO Q-20; Pull back with hydronozzle; Ended at CO Q-22	Push cam operated in reverse. Poor visual: rapid/shaky footage; no stills to inspect wall condition

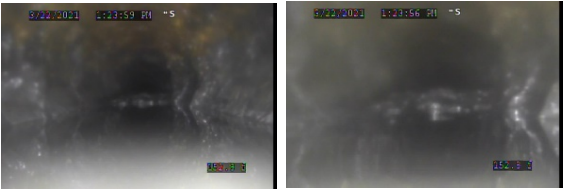
131.2	MGO		cam stationary, difficulty moving	
152.8	OBZ	03-09	no forward progress from here (51:30 to end of video)

152.8	MSA		Survey abandoned
