City of Richmond

Sole Source Justification

Keller Beach Sanitary Sewer

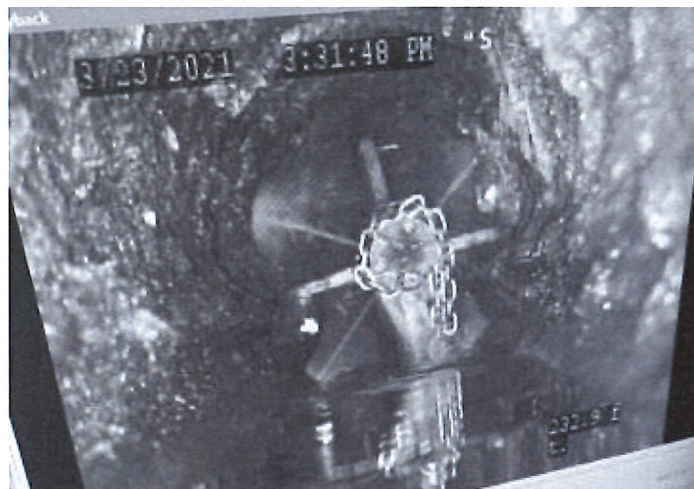
Figure 1. View of Keller Beach sewer pipe prior to cleaning. Hydro nozzle is in use. Chain flail is in view.

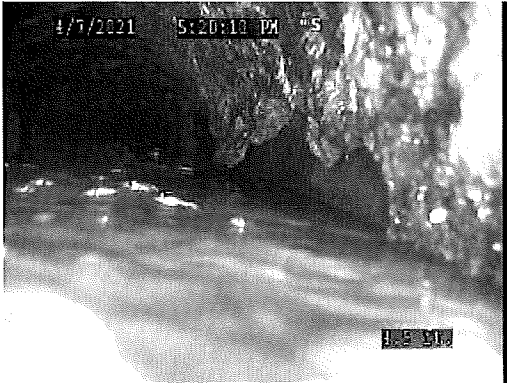
<p>CO Q-8 to MH Q-9</p>

According to Express Sewer, the entire reach of Keller Beach sanitary sewer was extremely corroded prior to cleaning. As shown in the post-cleaning images below, the upstream reach of pipe (MH Q-17 to MH Q-25) was generally descaled, while further downstream (MH Q-1 to MHQ-17) extensive turberculation and wall roughness remains.

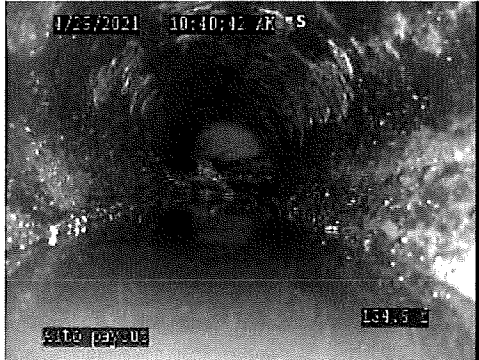
<p>CO Q-18 to MH Q-19</p>

CO Q-18	MH Q-19	US (reverse)	185	185	100%	10	Cl	Pipe walls are fully descaled after cleaning. Rough wall surface.	Pipe holds water, may be due to sags. Water level 10-20% in reverse footage	Start at MH Q-19; Push cam to CO Q-18; Pull back with hydronozzle; 2 laterals observed; Ended at MH Q-19	Pipe inspected in reverse. MH Q-19 appears to be possible source of I/I and should be inspected.
MH Q-19	CO Q-20	DS	201	201	100%	8	Cl	Pipe walls are fully descaled after cleaning. Rough wall surface.	Water level 5-100% Severe sags (camera underwater)	Start at CO Q-20; Push cam to MH Q-19; Pull back with hydronozzle; 1 lateral observed at 5'; Ended at CO Q-20	Push cam operated in reverse. Poor visual: rapid/shaky footage; no stills to inspect wall condition
CO Q-20	CO Q-22	US (reverse)	273	273	100%	8	Cl	Rough wall surface. Pipe walls are fully descaled after cleaning. Poor visual (blurry and rapid return footage)	Low water level in most of reverse footage due to hydronozzle. Severe sags; Camera underwater 206'-226'	Start at CO Q-22; Ended at CO Q-20; Pull back with hydronozzle; Ended at CO Q-22	Push cam operated in reverse. Poor visual: rapid/shaky footage; no stills to inspect wall condition

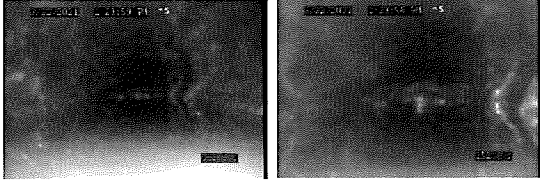
131.2	MGO		cam stationary, difficulty moving	
152.8	OBZ	03-09	no forward progress from here (51:30 to end of video)

152.8	MSA		Survey abandoned
