Port of Richmond Point Potrero Marine Terminal Assessment

Tuesday, May 6, 2025

moffatt & nichol

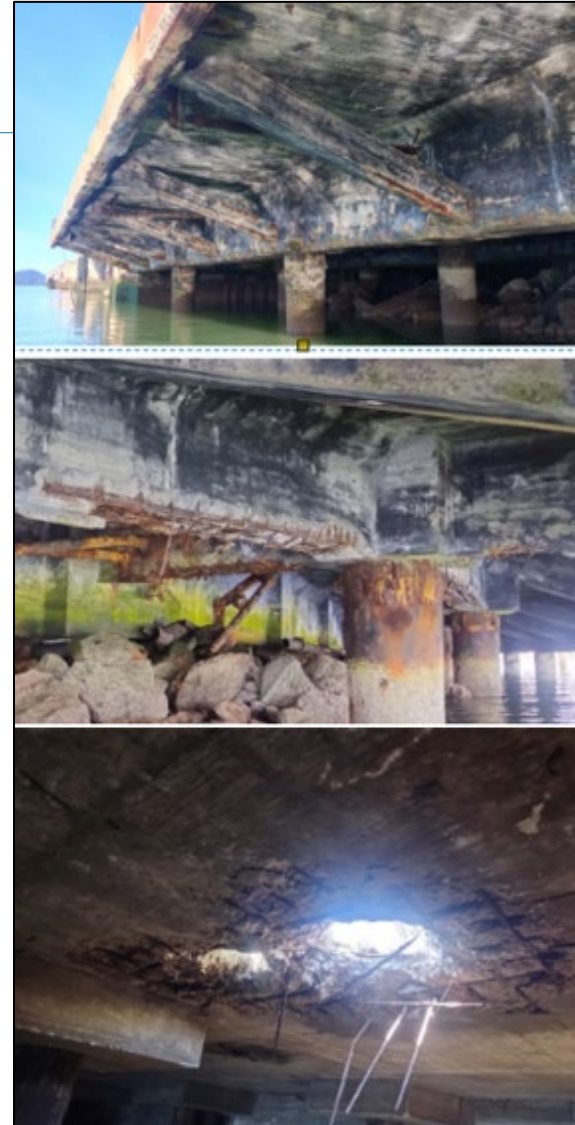
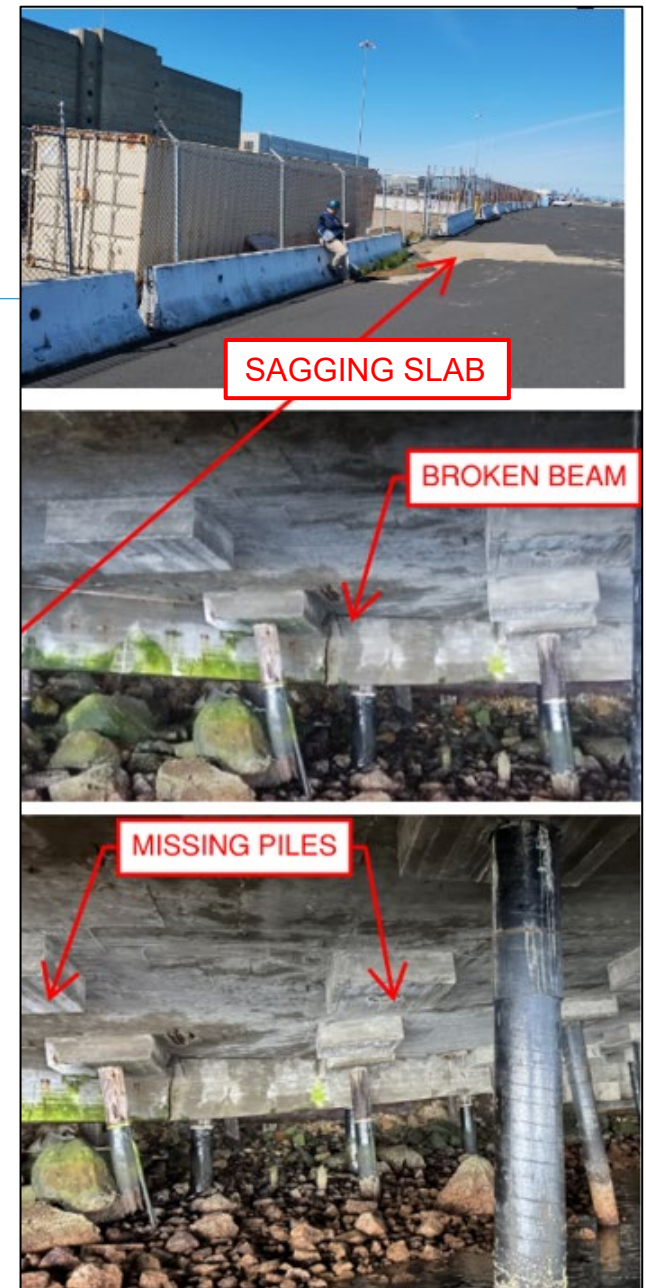
- › Slab sagging caused by beam failure below
- › Many damaged and missing timber piles
- › Pavement failure caused by soil erosion
- › Exposed reinforcing and corrosion damage below deck

Damage at Berths 5-6

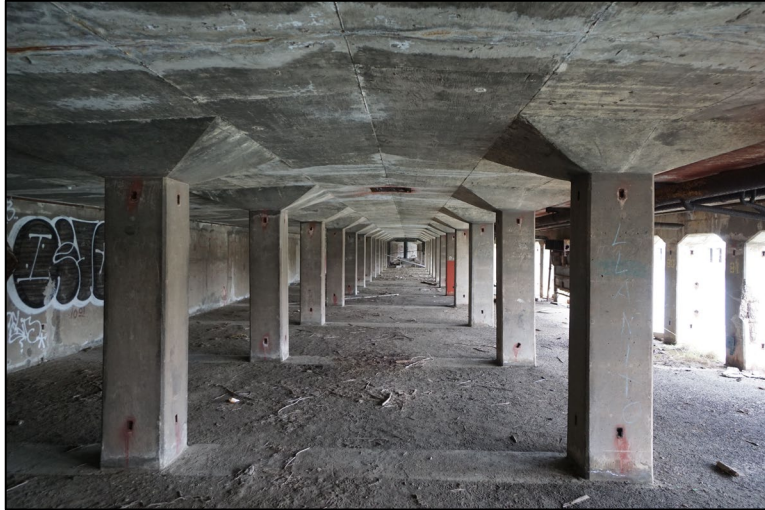
Interior columns

- › Interior columns generally in good condition
- › Exterior columns typically exhibit moderate to major damage
- › Cracks, exposed reinforcing steel, delaminations on outside face of basins

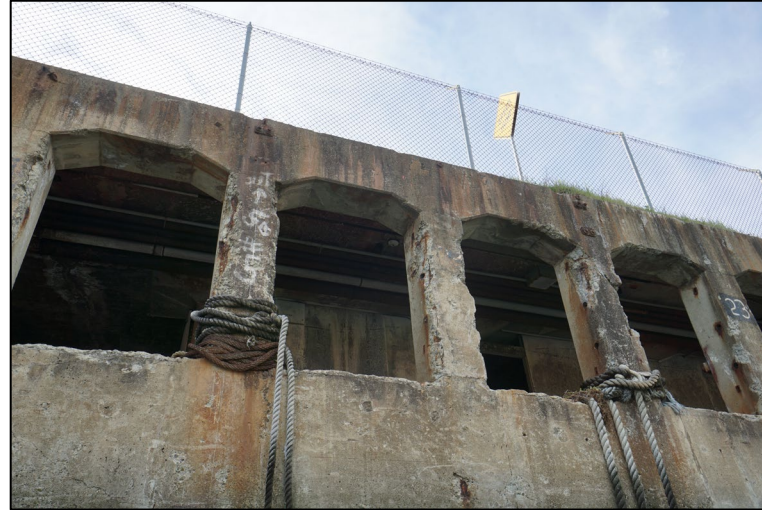
Exterior columns

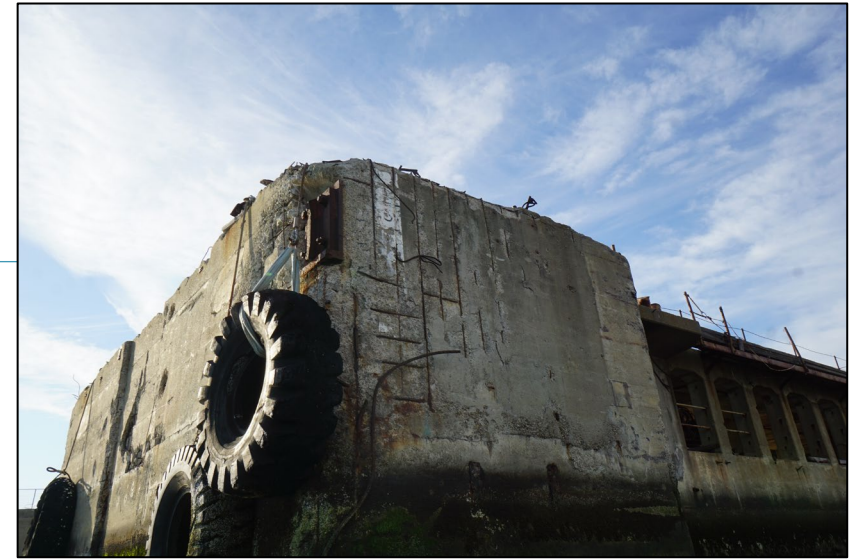
Outside face of basins

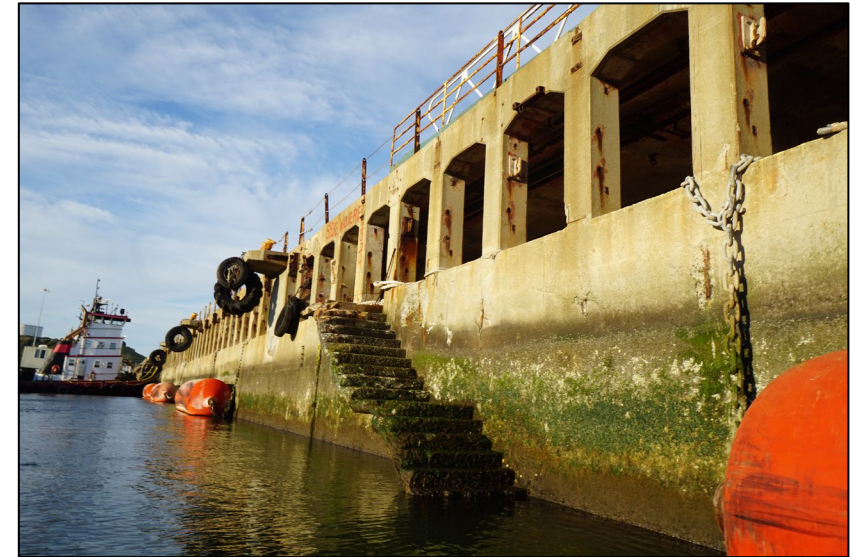
Exterior columns used in fender systems

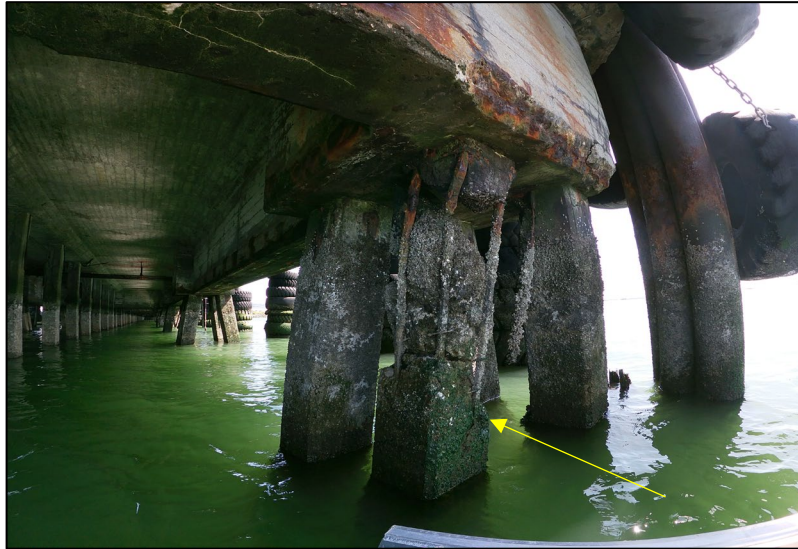
Severe pile

- › Pile clusters typically in minor to moderate condition
 - › Major or severe damage at (2) piles likely due to impact
- › Internal row of piles typically in moderate to major condition
- › Deep beams are typically delaminated and spalled with exposed reinforcing
- › Deck soffit has no / very little damage

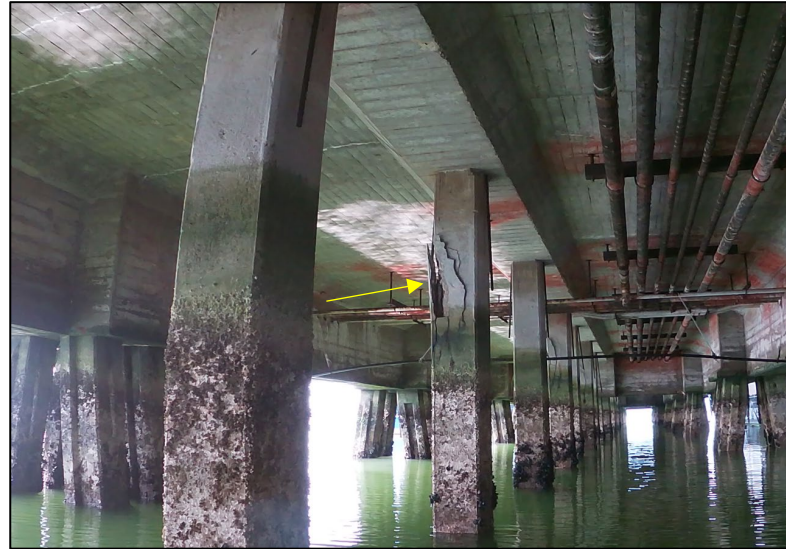
Typical pile damage at internal row

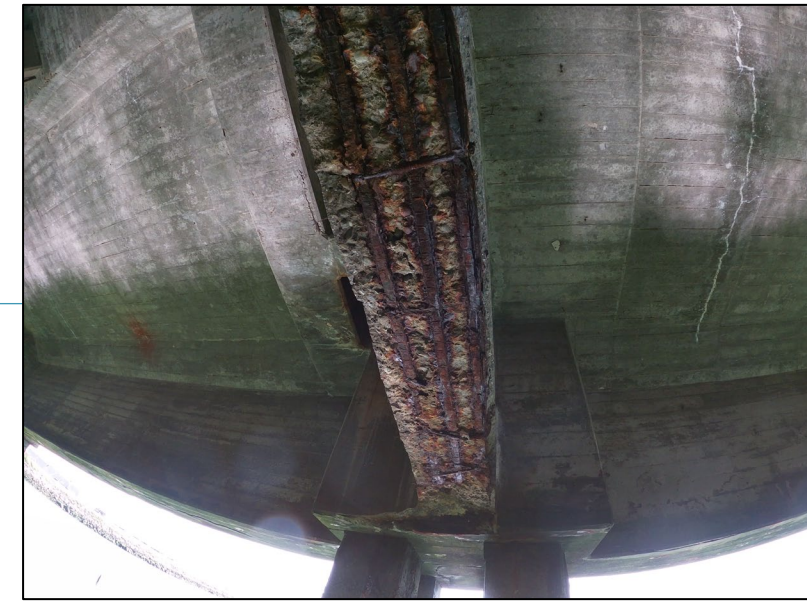
Exposed reinforcing at deep beam

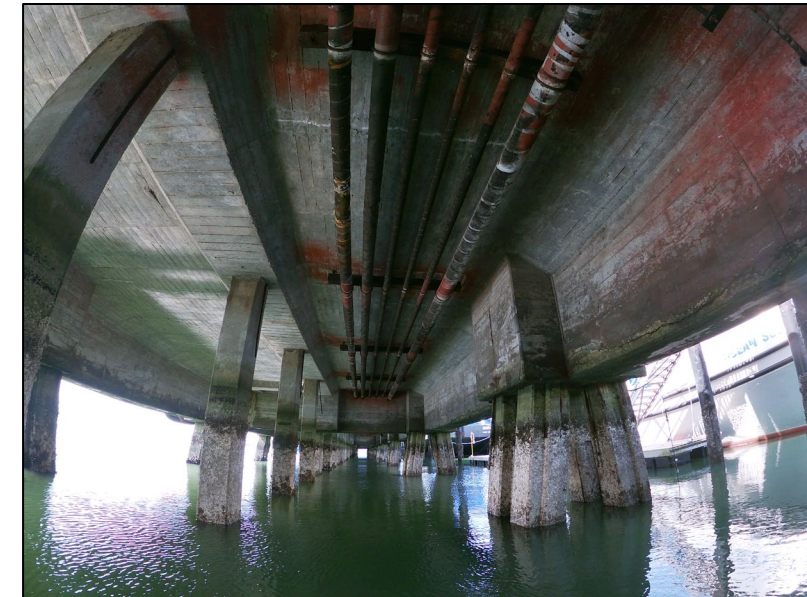
Deck soffit

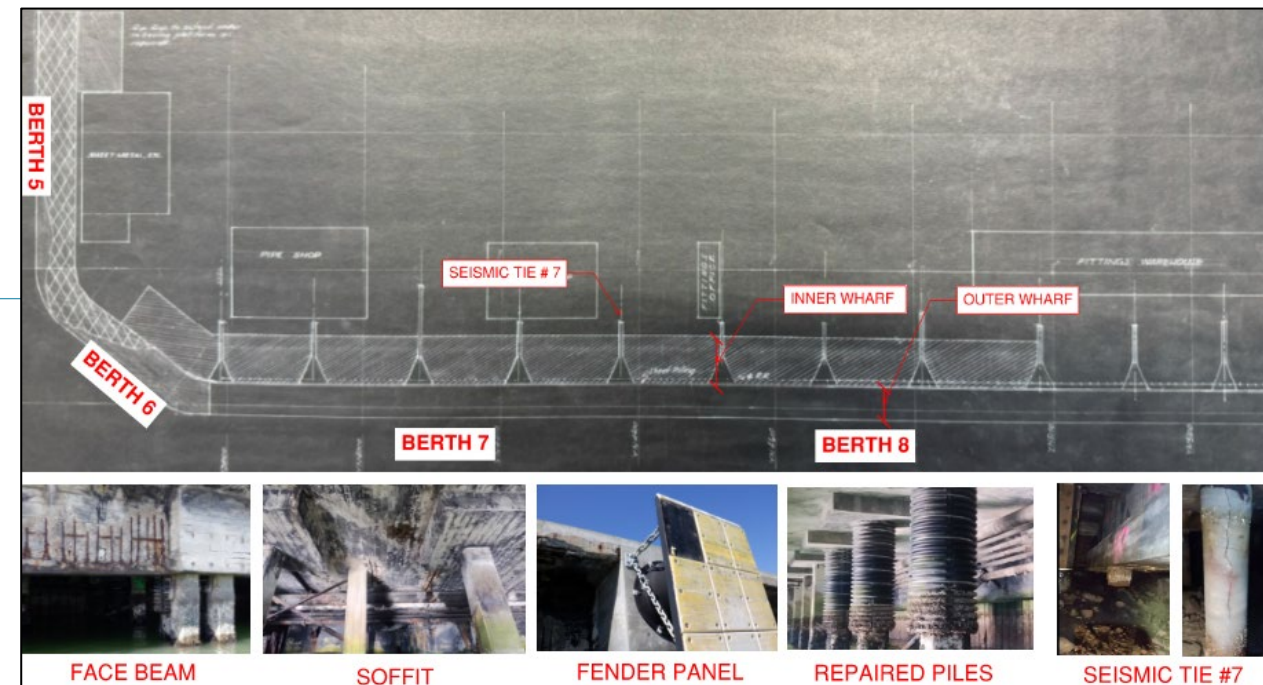
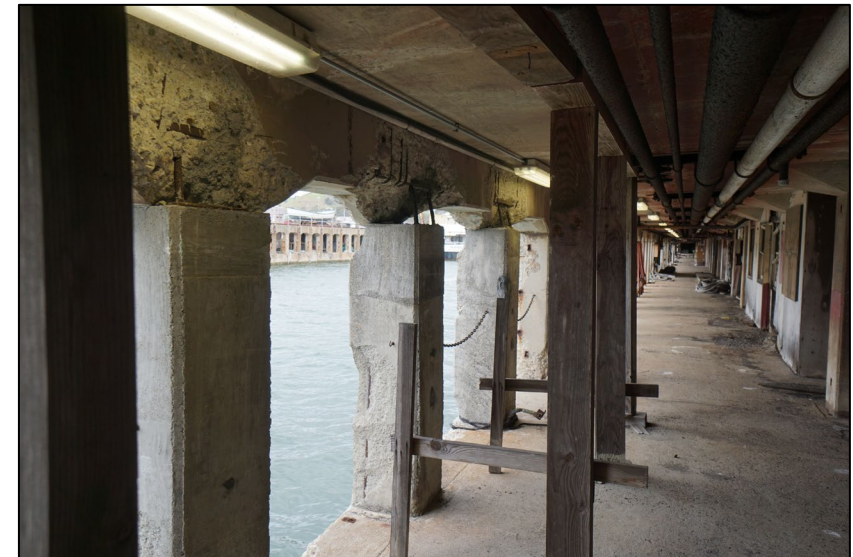
Damage at Berths 7-8 (above)
Columns in Serious condition at Graving Basin (below)

- › Berths 5-8
 - › Condition: Poor to Critical
 - › Action Needed: Critical repairs— restore beam under Berth 6 to original position and strength, tie beam repair, pavement failure repair
- › Graving Basins
 - › Condition: Fair
 - › Action Needed: Address potential environmental and safety hazards, develop mooring/fender system to reduce damage to structure, restrict loading at areas where columns are in serious condition
- › Finger Piers
 - › Condition: Fair to Poor
 - › Action Needed: Develop pier load ratings, consider upgrading of fender systems depending on projected use, restore edge beams to prevent further structural deterioration and decrease in capacity
