Building Enclosure Condition Assessment Report

Craneway Pavilion

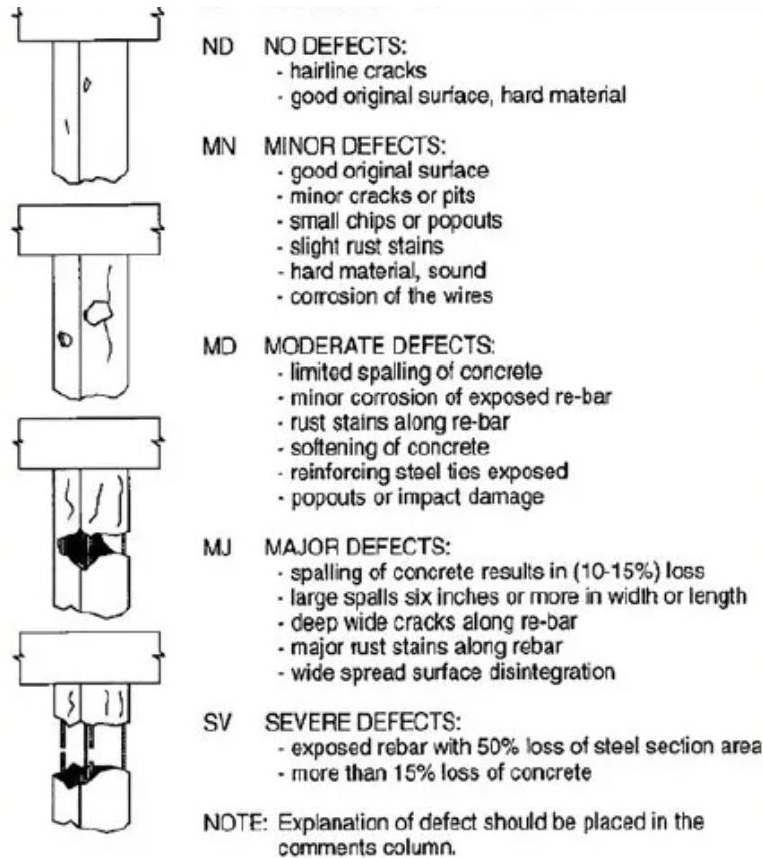
/ Photo 1– Concrete Pile Condition Rating Scale adapted from the U.S. Navy's Naval Facilities Engineering Systems Command - NAVFAC
 Approximately 90% of the piers were reviewed at low tide over two days at locations accessible by boat, via visual inspection from a maximum of one column bay away. Following the visual assessment, we performed physical inspections on a subset of piers with the assistance of a diver. These inspections included close-range underwater visual review and hammer sounding, with emphasis on the first three rows of piers from the exterior (Figure 69).

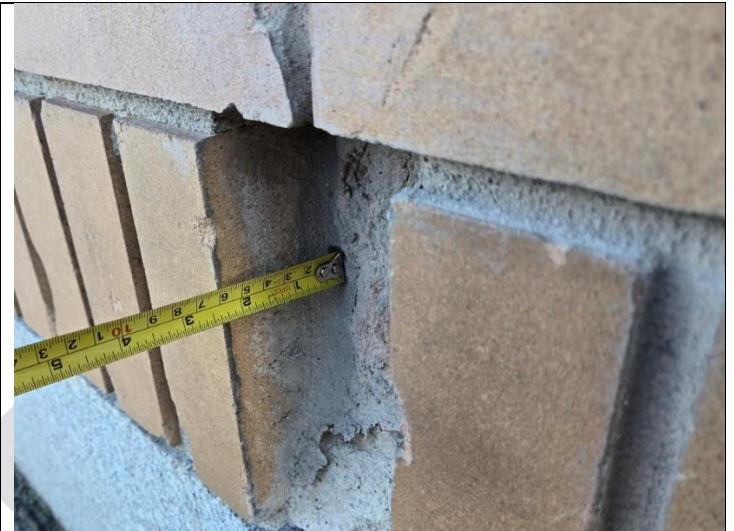
Figure 2. Missing brick

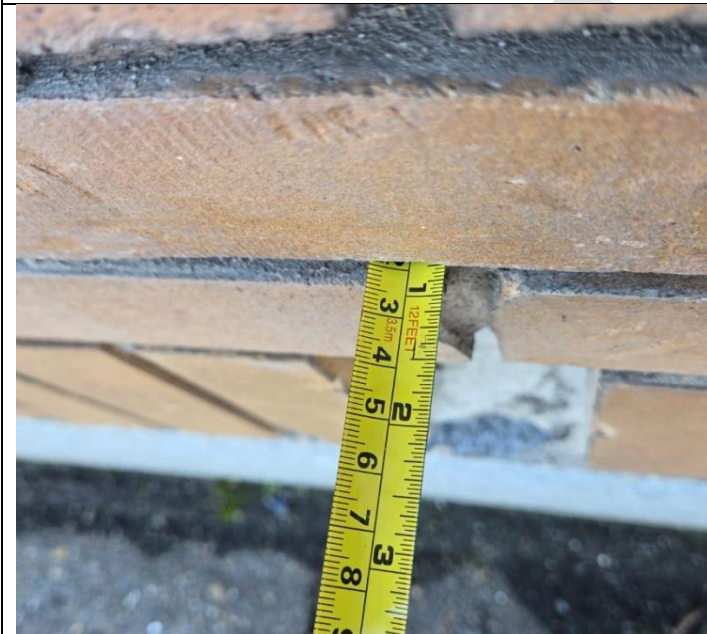
Figure 3. Recessed mortar joint

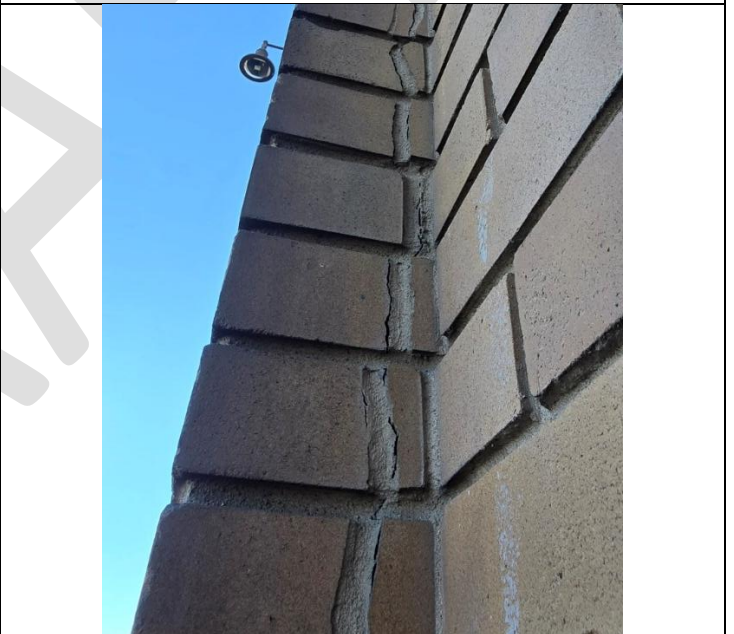
Figure 4. Vertical cracking near corner, previously filled with mortar

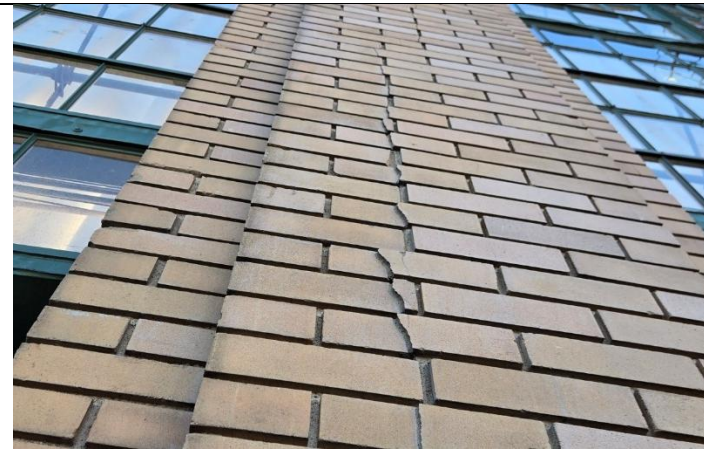
Figure 5. Vertical cracking and out-of-plane displacement at column on west elevation

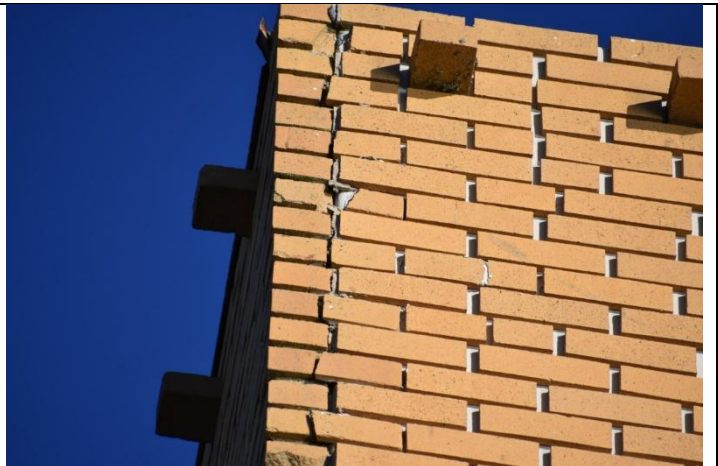
Figure 6. Vertical cracking at interface between brick masonry wall and FRP/fiberglass brick-veneer clad parapet at corner

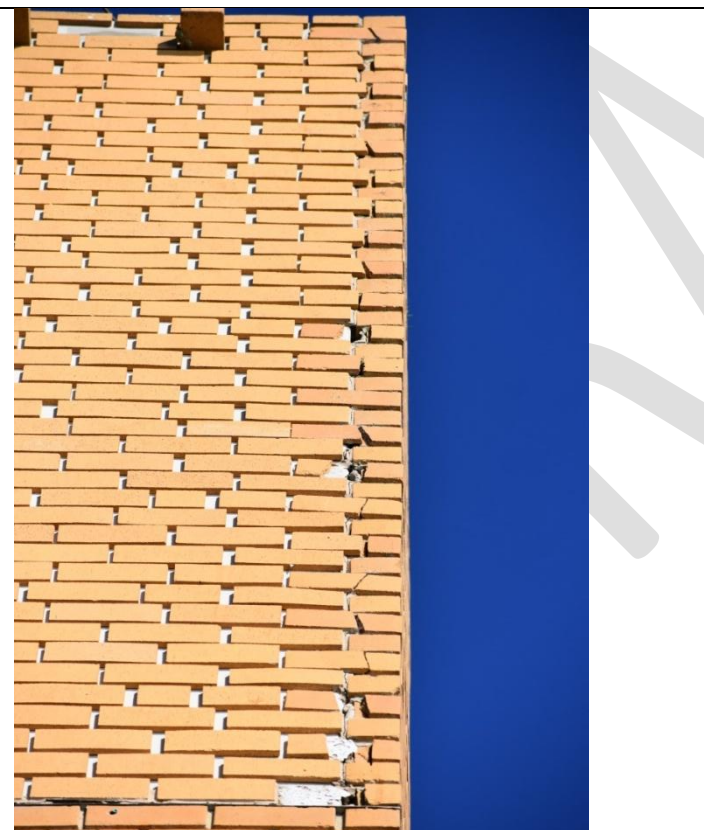
Figure 7. Vertical cracking at interface between brick masonry wall and FRP/fiberglass brick-veneer clad parapet at corner

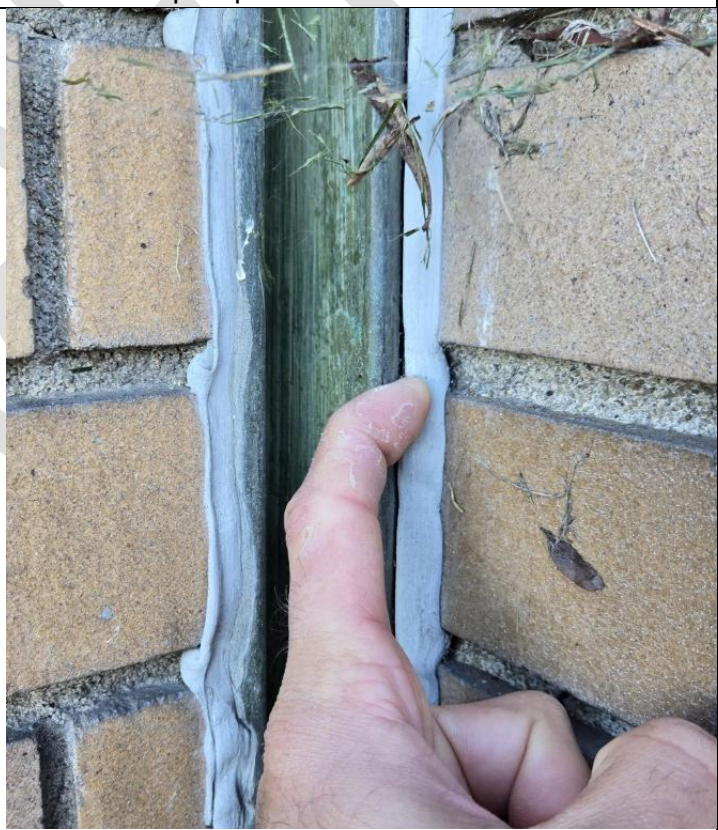
Figure 8. Sealant deterioration at vertical expansion joint on west elevation

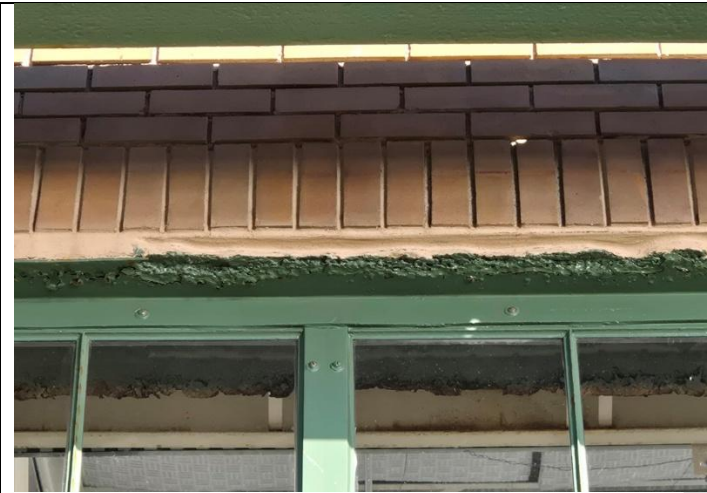
Figure 9. Corrosion and sectional loss of lintel, previously painted over

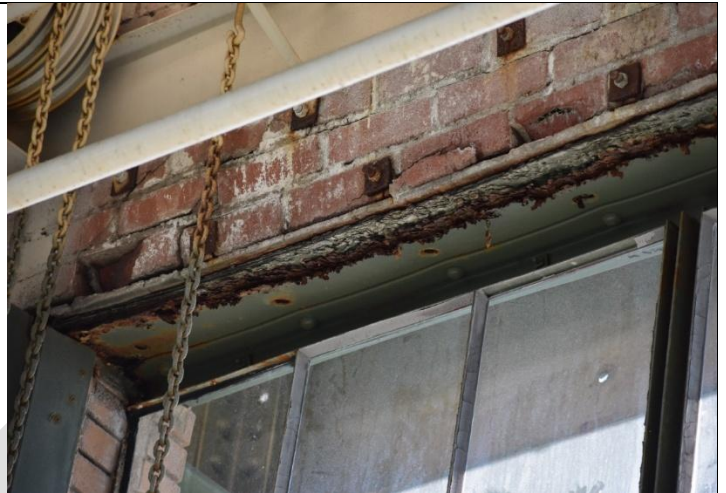
Figure 10. Significant corrosion and sectional loss of lintel as viewed from interior

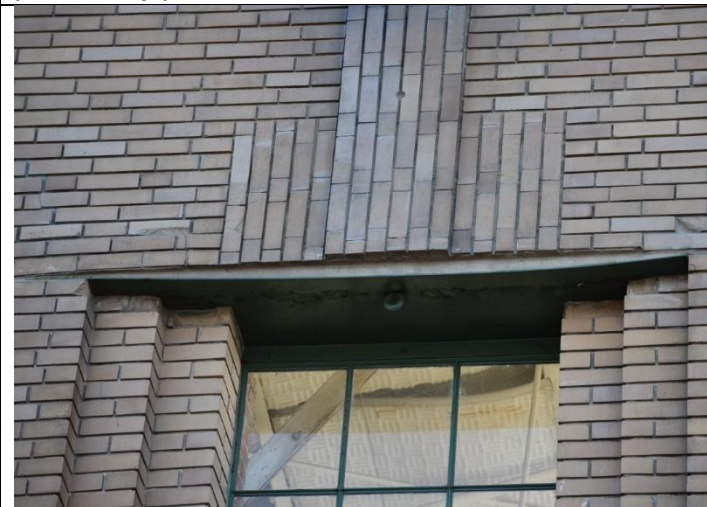
Figure 11. Deflection/sagging of brick lintel

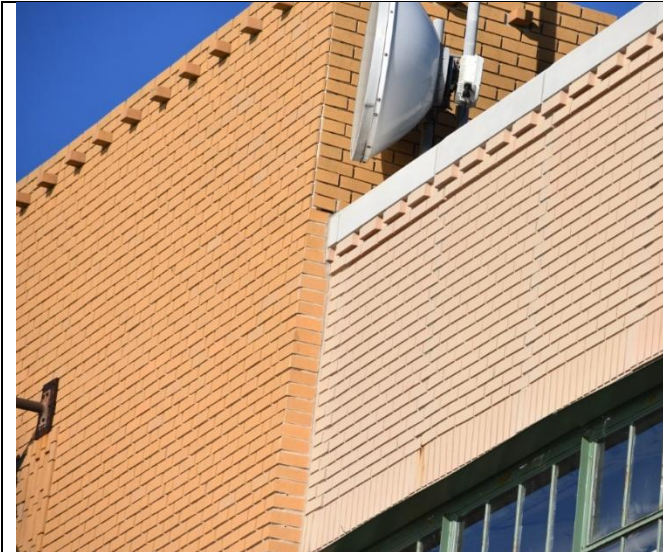
Figure 13. FRP/fiberglass panelized parapet assembly with adhered brick veneer; replacement for collapsed parapet in Loma Prieta earthquake

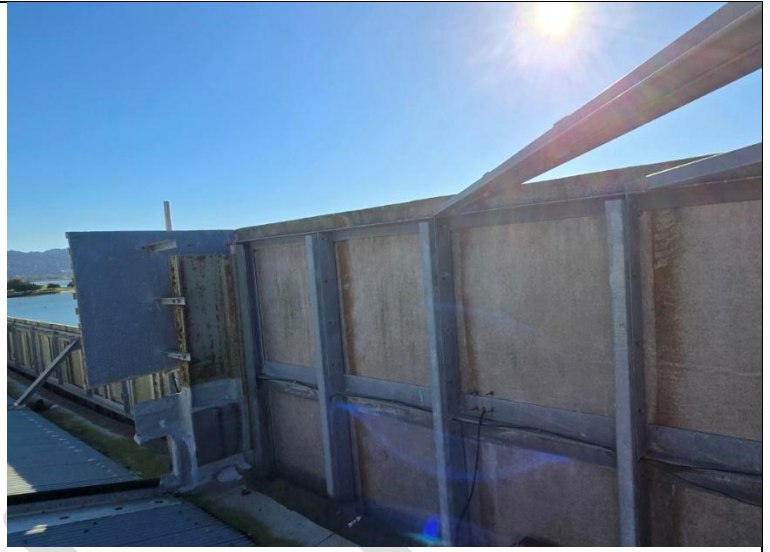
Figure 14. FRP/fiberglass panelized parapet assembly with adhered brick veneer; replacement for collapsed parapet in Loma Prieta earthquake

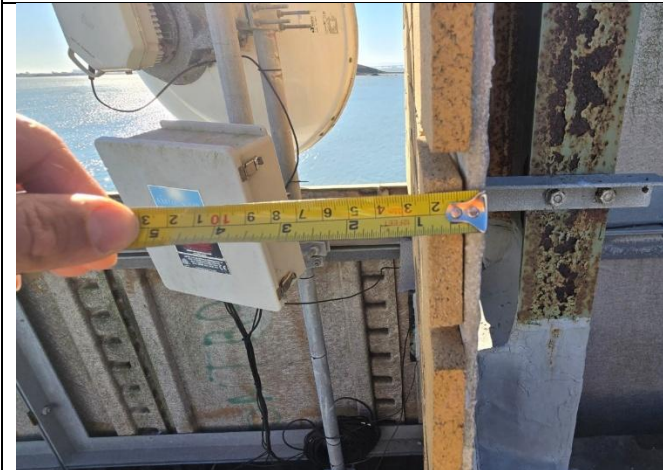
Figure 15. Thin brick veneer adhered to backing board

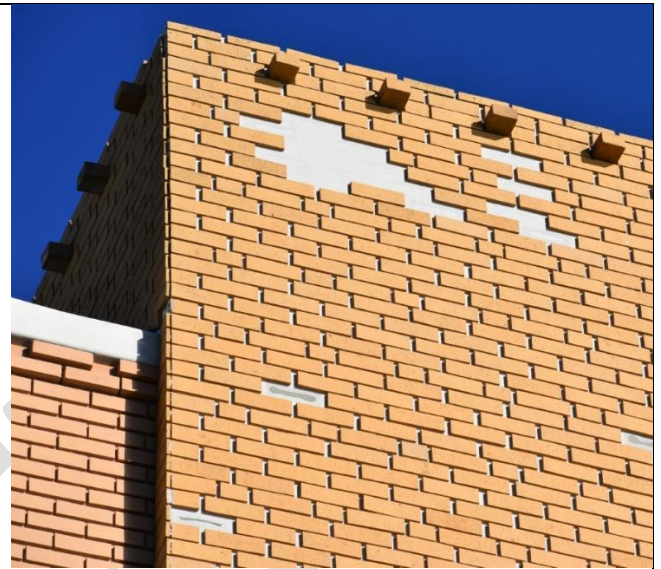
Figure 18. Missing brick veneer units

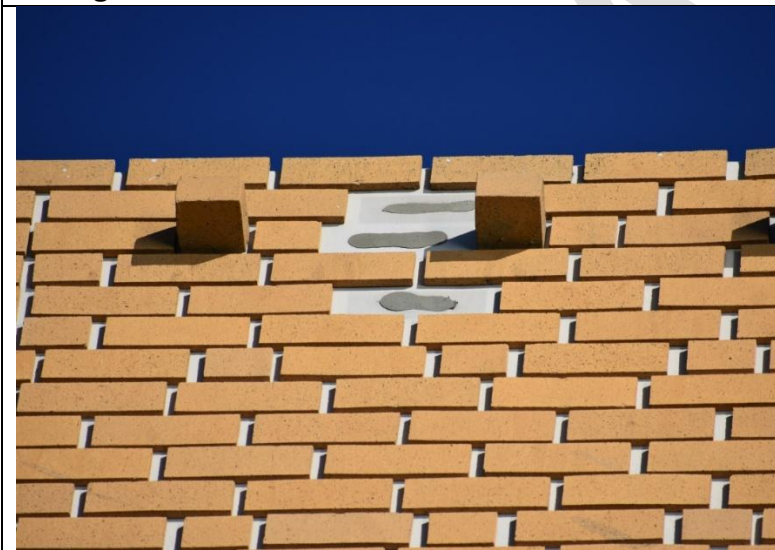
Figure 19. Adhesive residue where veneer units have fallen from façade at panelized parapet system

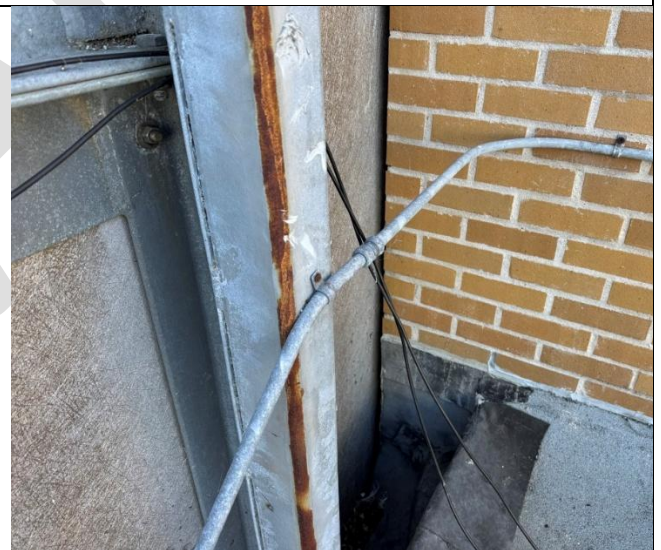
Figure 20. Minor surface corrosion of tube steel frame of FRP/fiberglass panelized parapet system

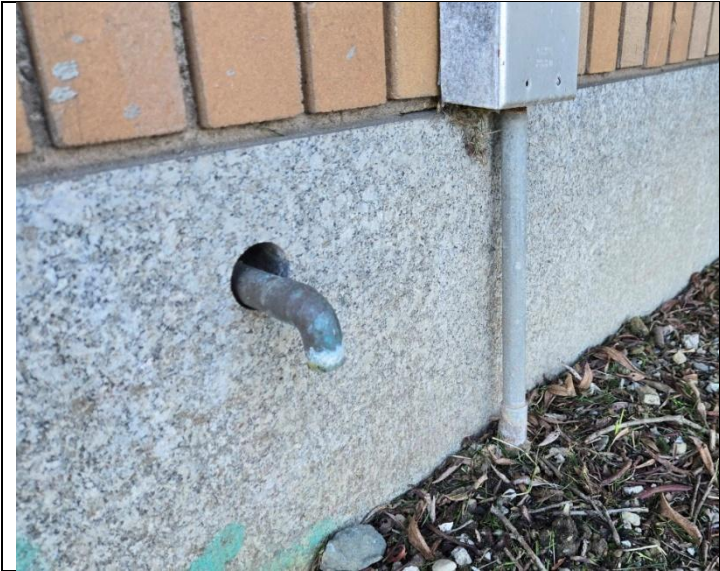
Figure 21. Granite at base of wall

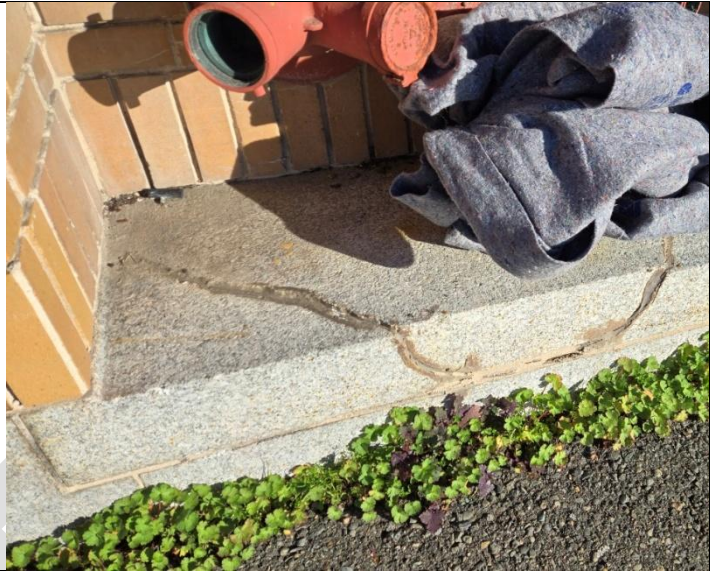
Figure 22. Cracking through granite at base of wall, previously sealed/epoxied

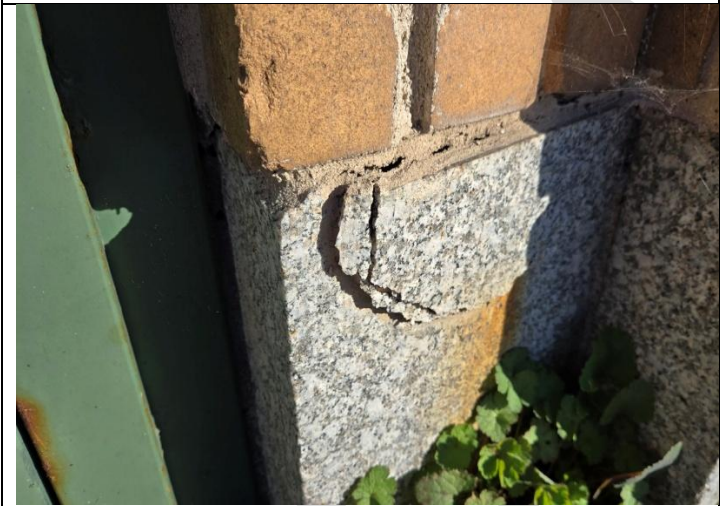
Figure 23. Spalling and corrosion staining at granite stone base

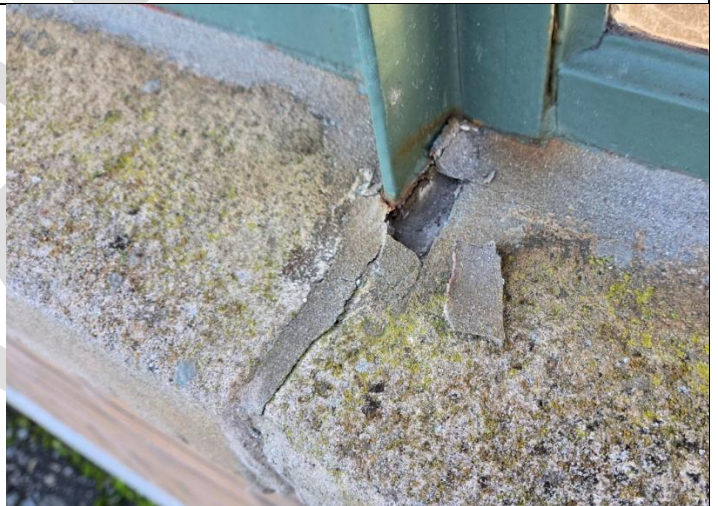
Figure 24. Failing mortar at window interface with stone sill

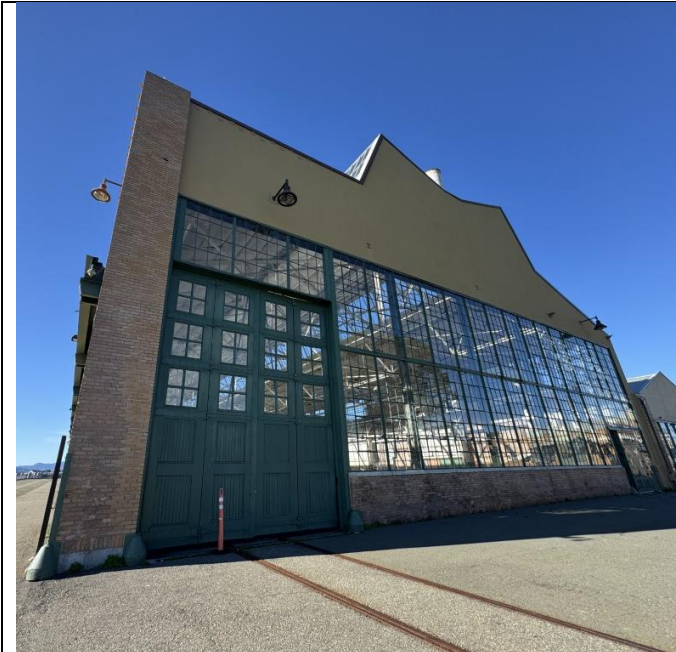
Figure 25. East elevation of Craneway Pavilion, gunite wall above window bay

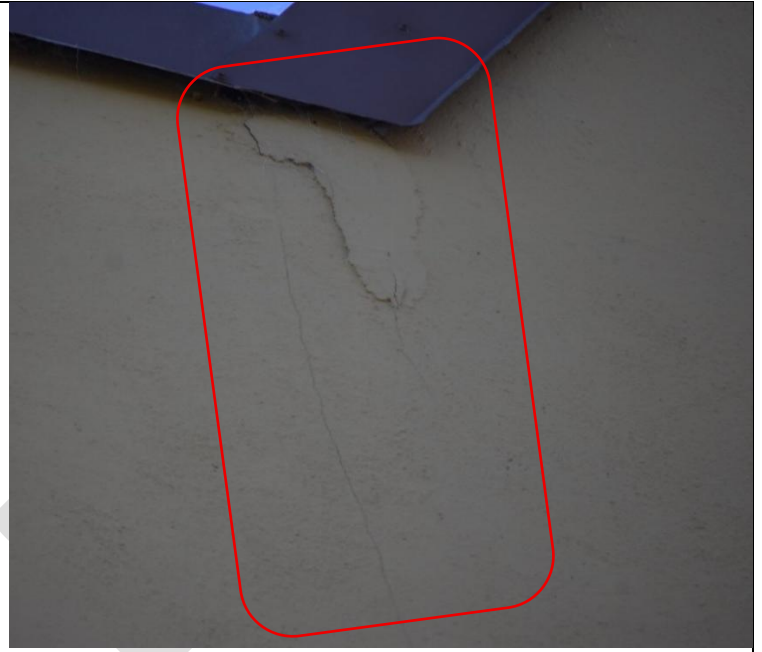
Figure 26. Vertical cracking through gunite wall

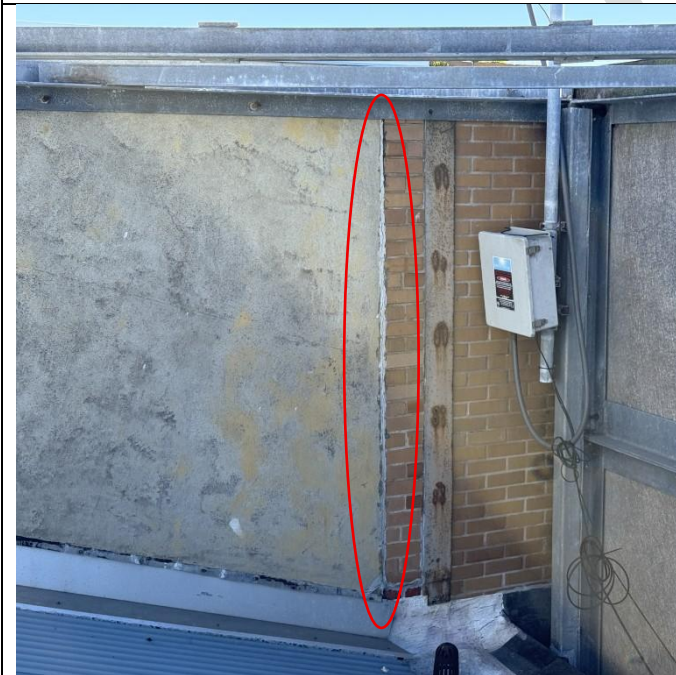
Figure 27. Failing sealant joint at interface with brick return wall near southeast corner

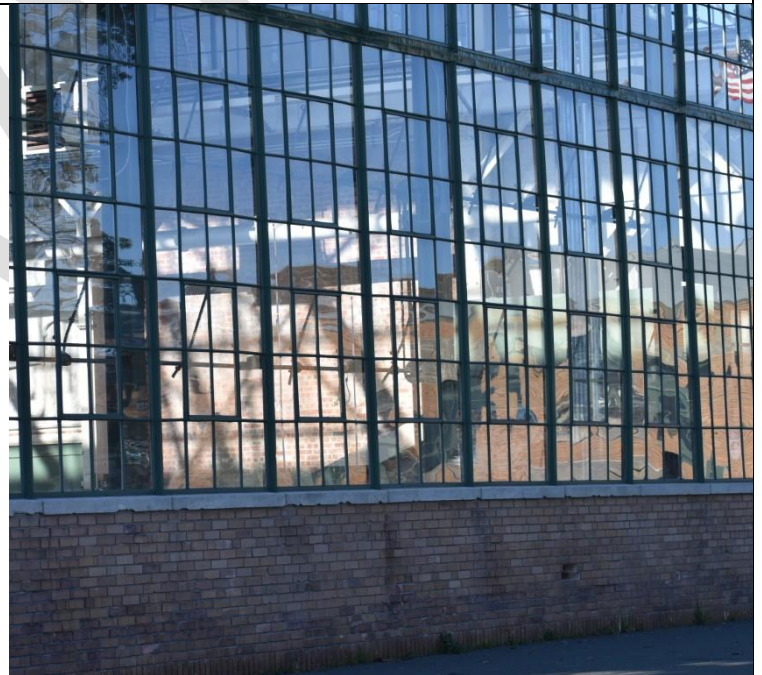
Figure 28. Existing steel-framed single-pane window system

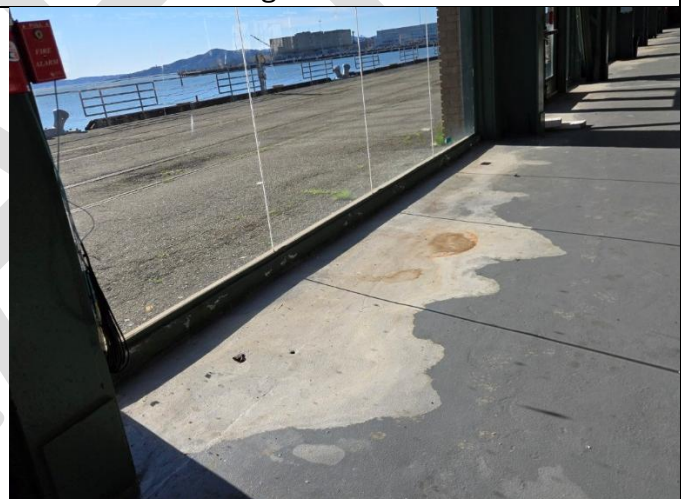
Figure 32. Signs of staining evident below new butt-glazed window system and concrete curb on south elevation

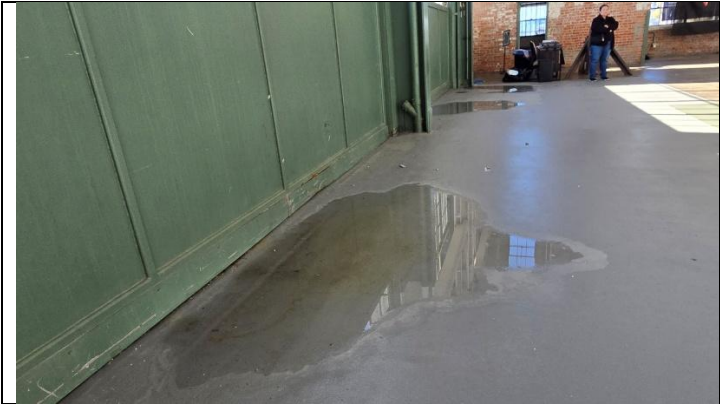
Figure 33. Ponding at base of painted overhead door on south elevation

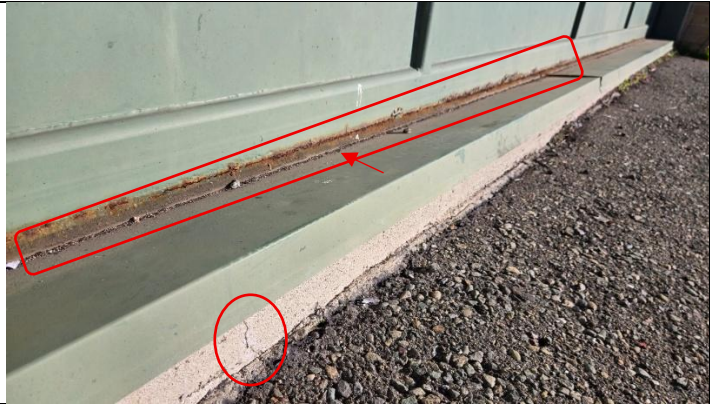
Figure 34. Back-sloped sill flashing, corrosion and sealant failure present. Hairline cracking through concrete curb

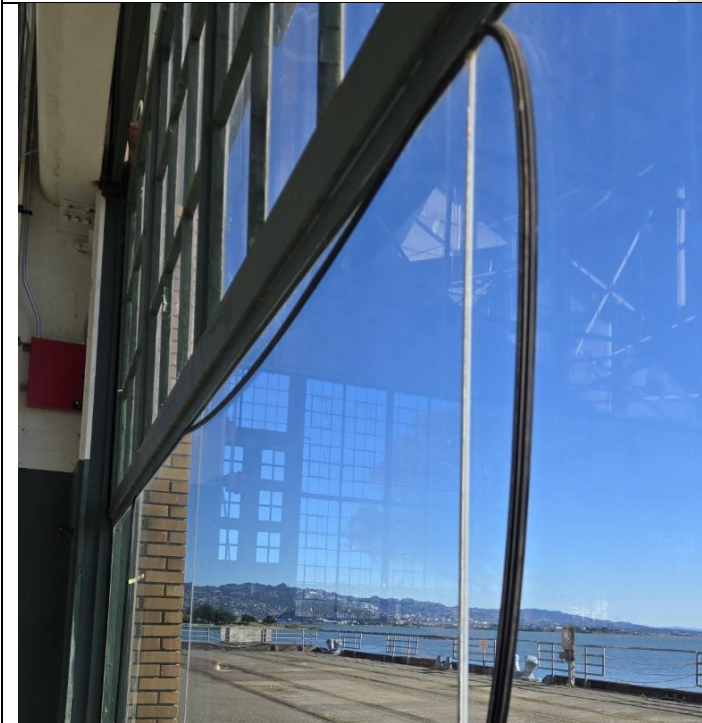
Figure 35. Disengaged gaskets at new butt-glazed window system on south elevation

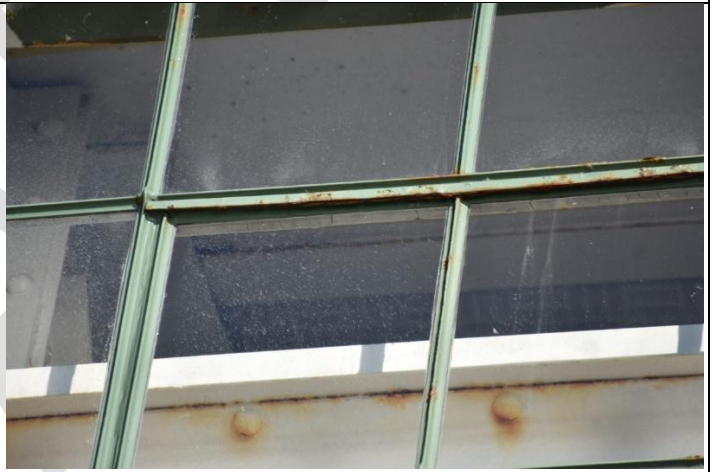
Figure 36. Corrosion and paint failure on original steel window frames

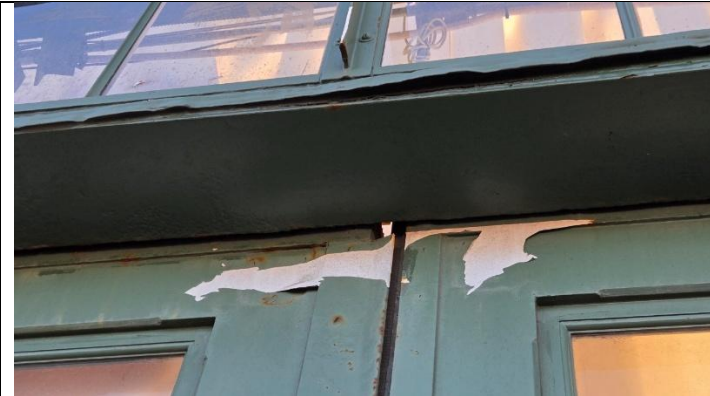
Figure 37. Corrosion and paint failure on original steel door frames

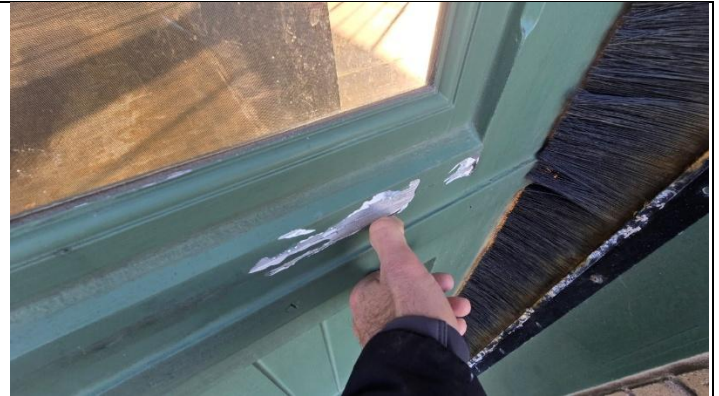
Figure 38. Paint failure on wood door frame

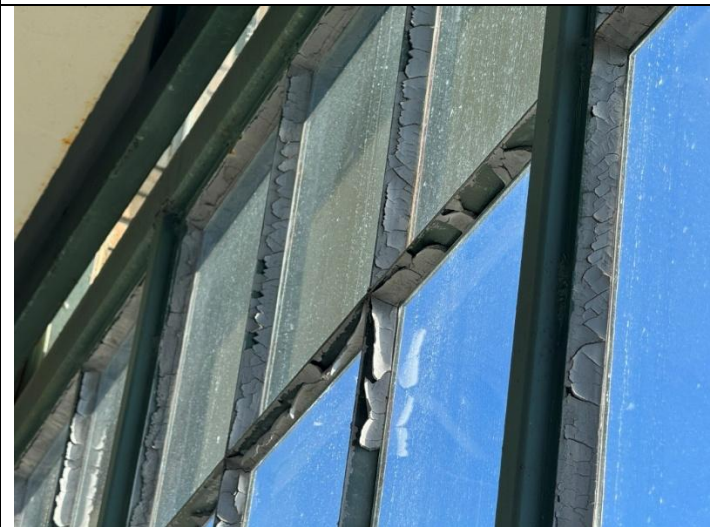
Figure 39. Failed glazing putty, relatively widespread

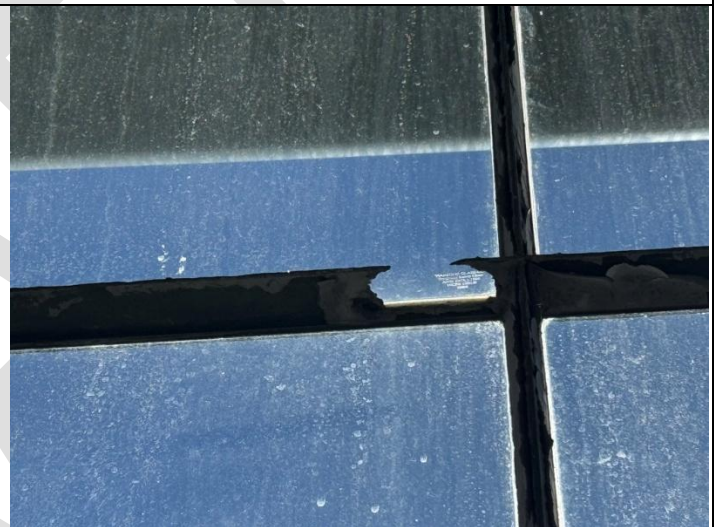
Figure 40. Sectional loss through frame muntin on interior

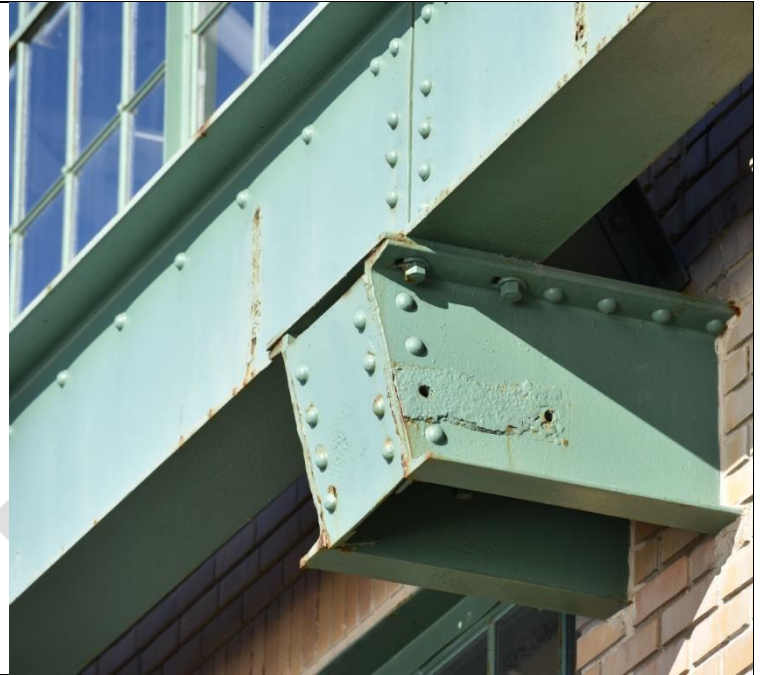
Figure 42. Surface corrosion and paint loss on steel gantry crane elements

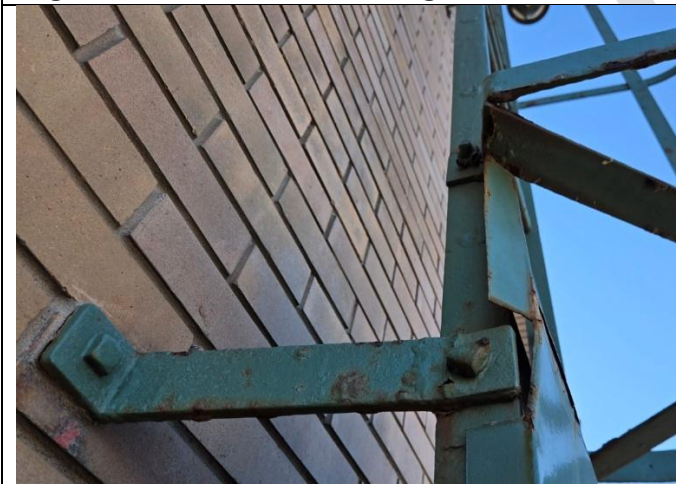
Figure 43. Surface corrosion and paint loss on ladder element

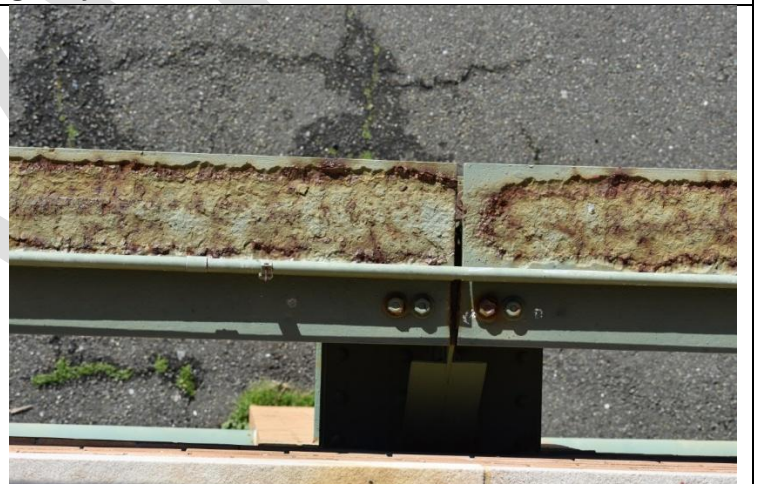
Figure 44. Surface corrosion and paint loss on steel gantry crane elements

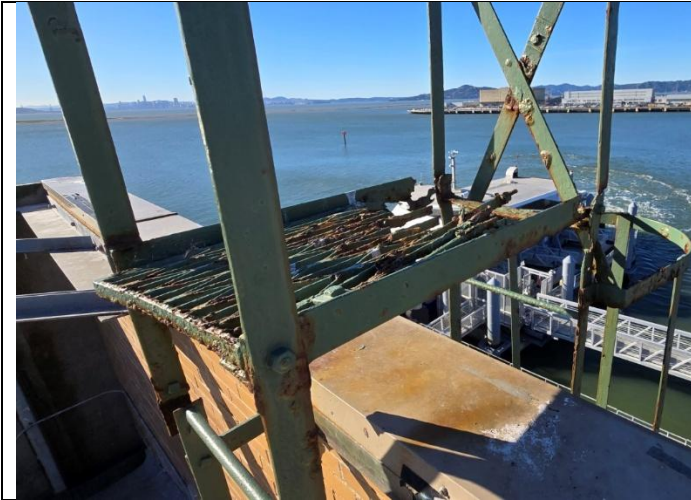
Figure 45. Significantly corroded ladder with sectional loss

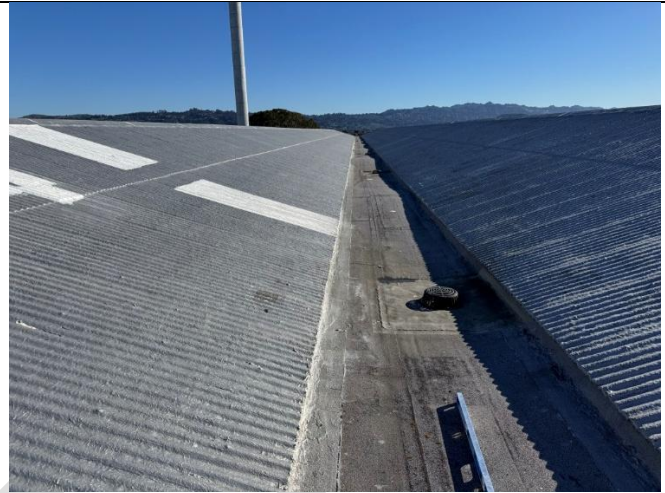
Figure 46. Overview of steep-sloped coated transite roof panels at upper sawtooth roof

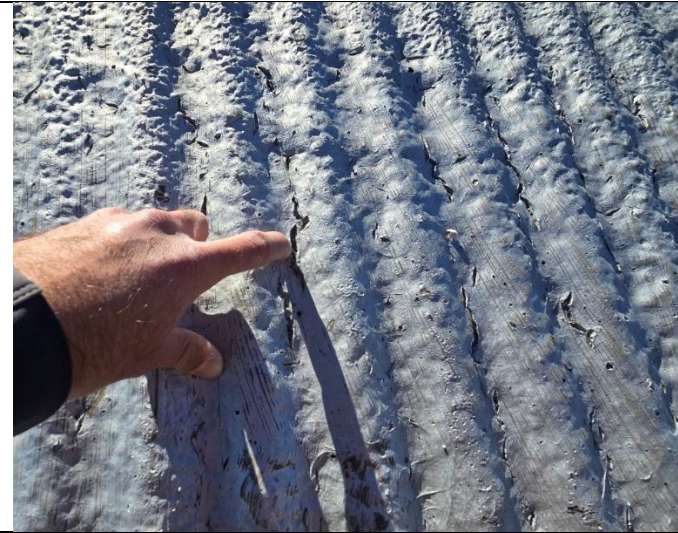
Figure 49. Failing coating over transite panels

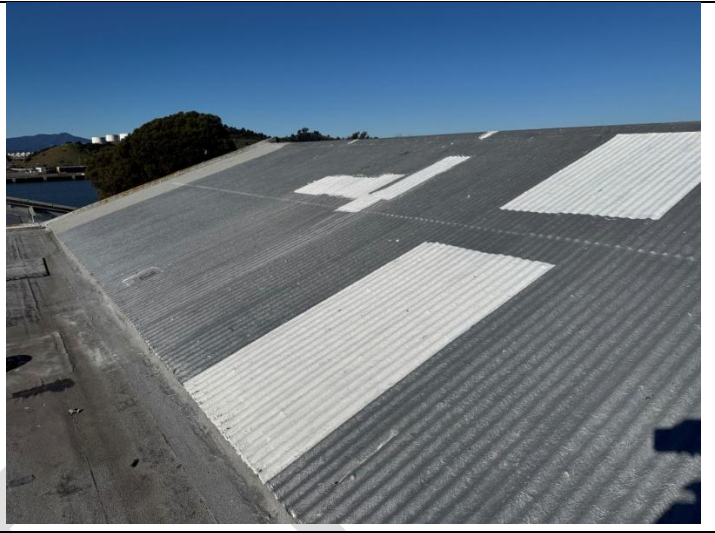
Figure 50. Targeted coating patches at transite roof panels

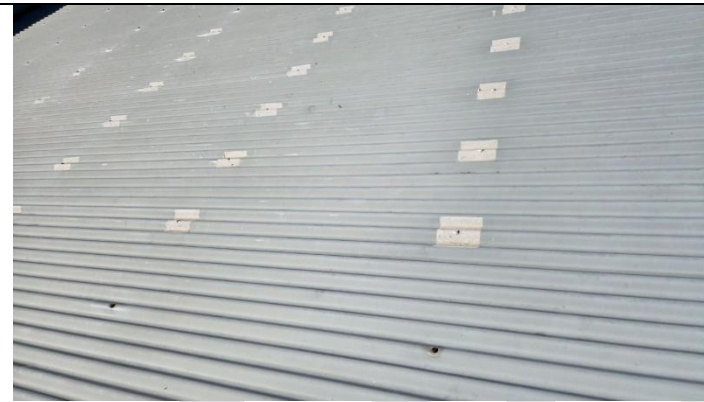
Figure 51. Localized liquid flashing/sealant over fastener penetrations; some corroded fasteners present

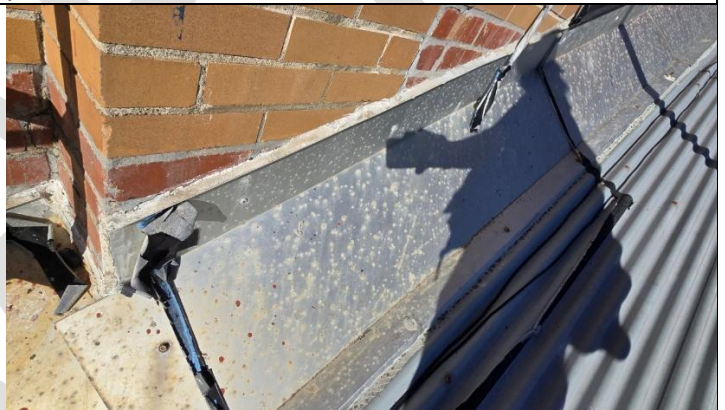
Figure 52. Surface mounted counter flashing between brick parapet and metal roof

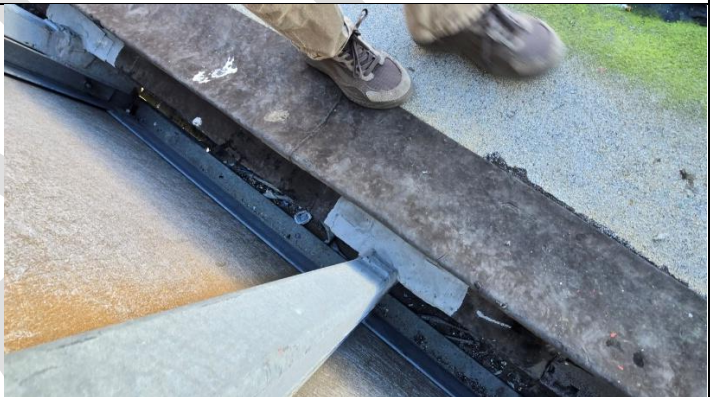
Figure 56. Transition from bituminuous membrane to EPDM membrane at roof edge condition adjacent to FRP/fiberglass parapet system

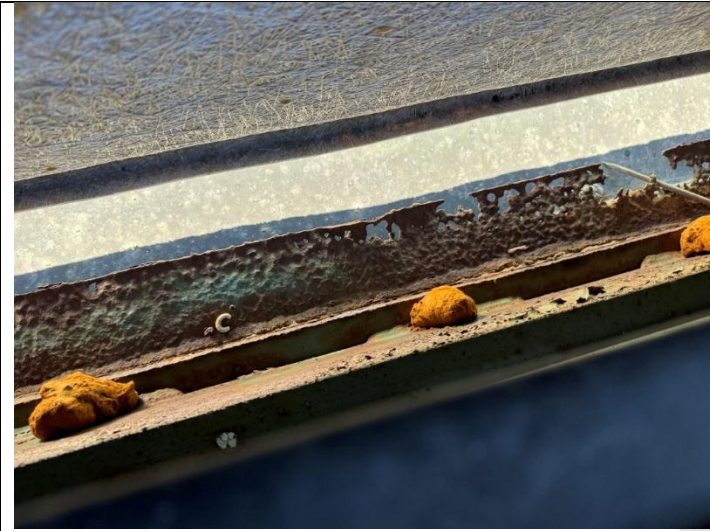
Figure 57. Significantly corroded steel angle behind base of newer parapet panelized cladding; likely abandoned

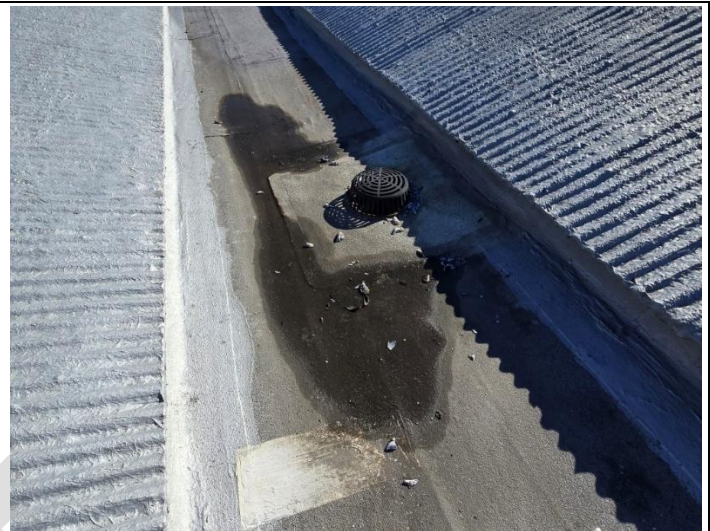
Figure 58. Ponding water near area drains

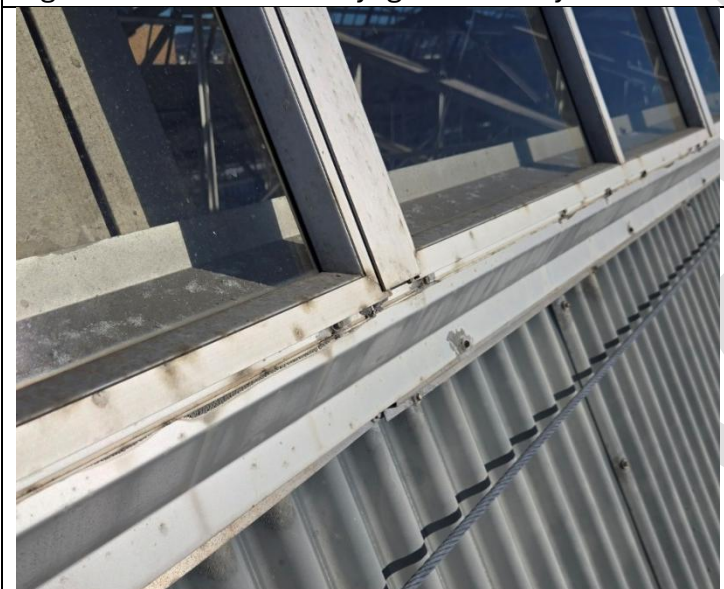
Figure 63. Condensation gutter at inside of skylight frame. Minor aluminum surface corrosion present on exterior surface

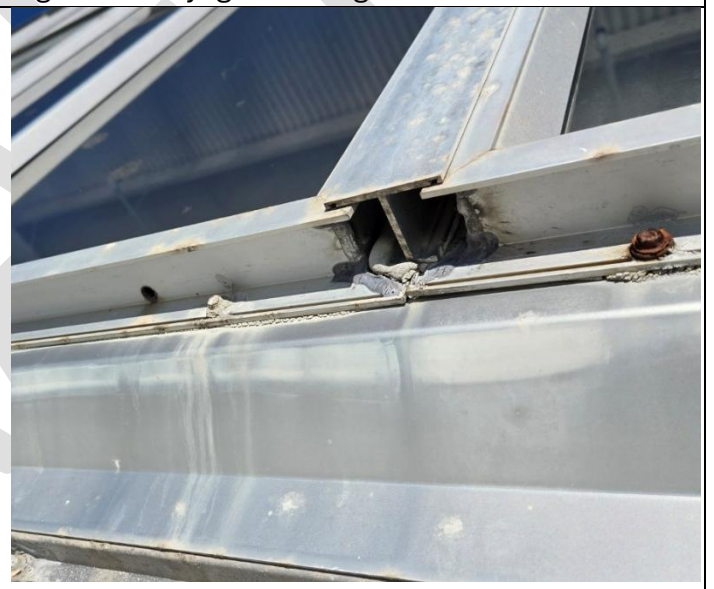
Figure 64. Drainage of vertical mullion. Corroded fasteners present at some locations

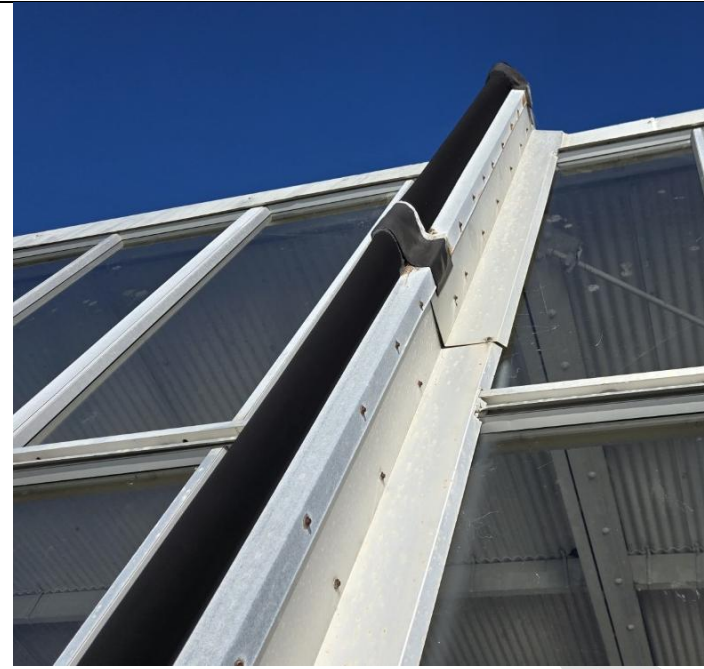
Figure 65. Expansion joint bellows transitioning across skylight assembly

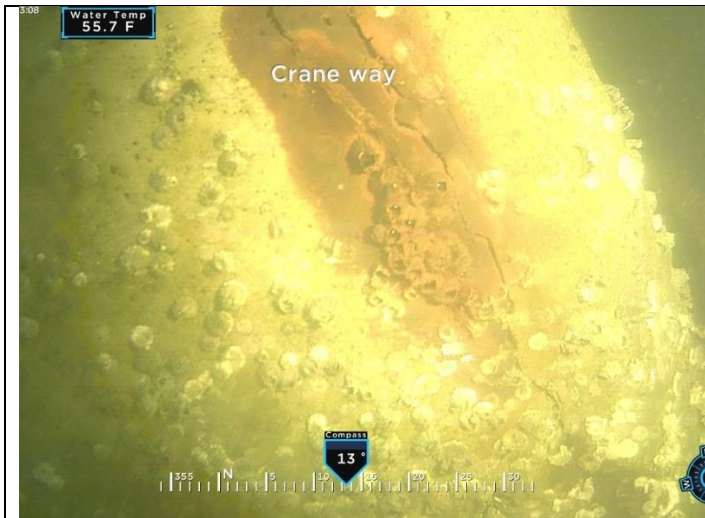
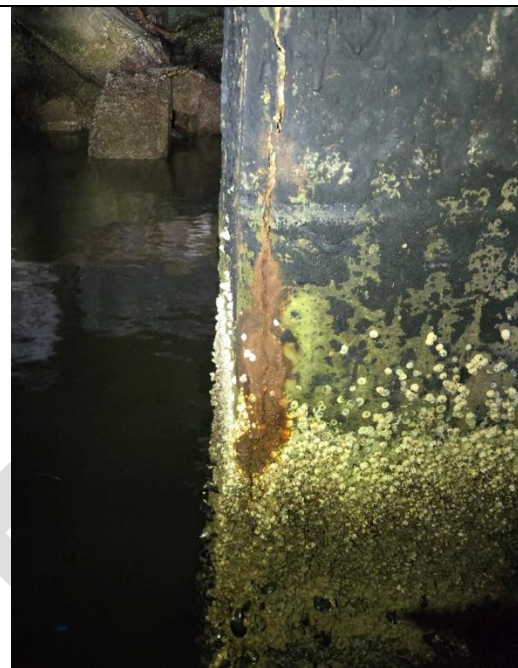
Figure 69. View of cracking and rust staining extending several feet below waterline during low tide, as viewed by diver (*Photo provided by Power Engineering*)

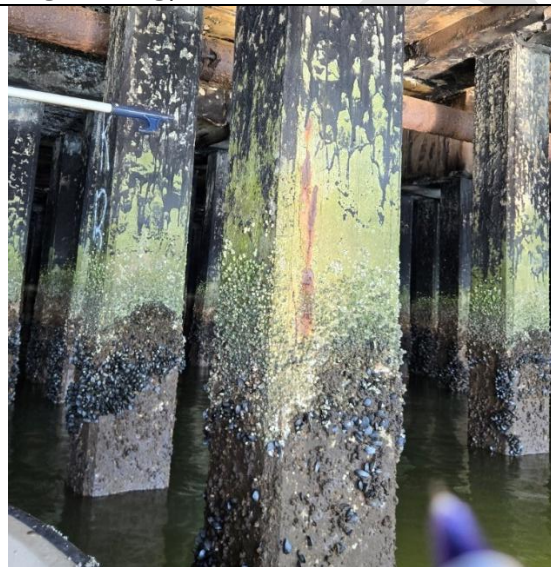
Figure 71. Corrosion staining and minor cracking of pier – Minor Defect Category

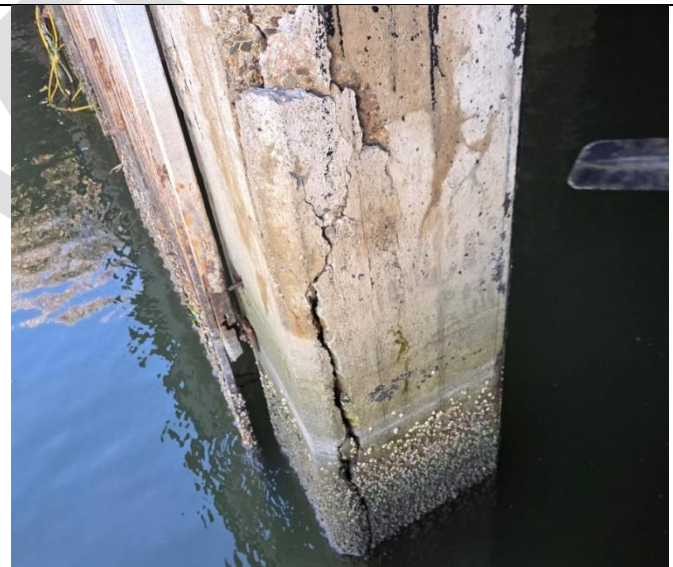
Figure 72. Significant spalling and sectional loss present – Severe Defect Category

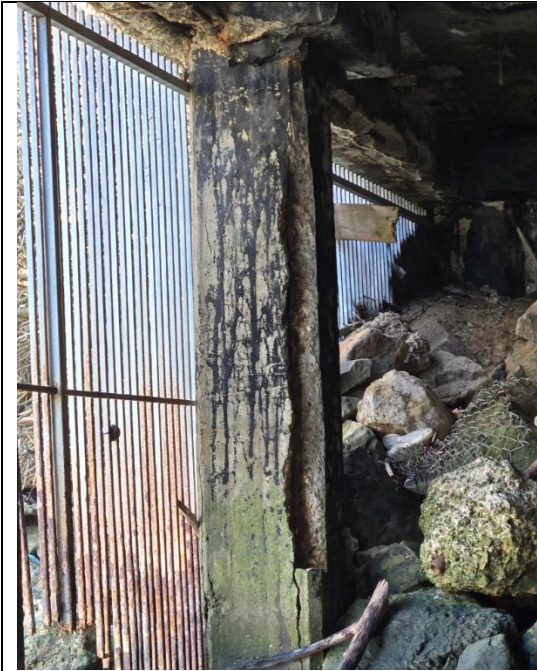
Figure 73. Significant spalling and sectional loss present, corroded reinforcing visible – Severe Defect Category

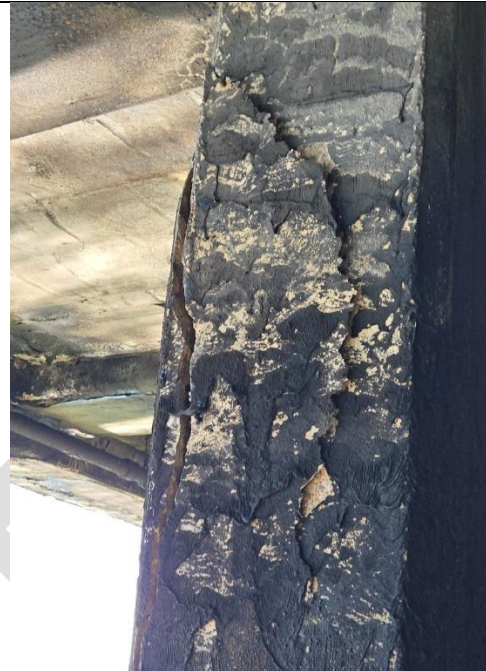
Figure 74. Significant spalling and sectional loss present – Severe Defect Category

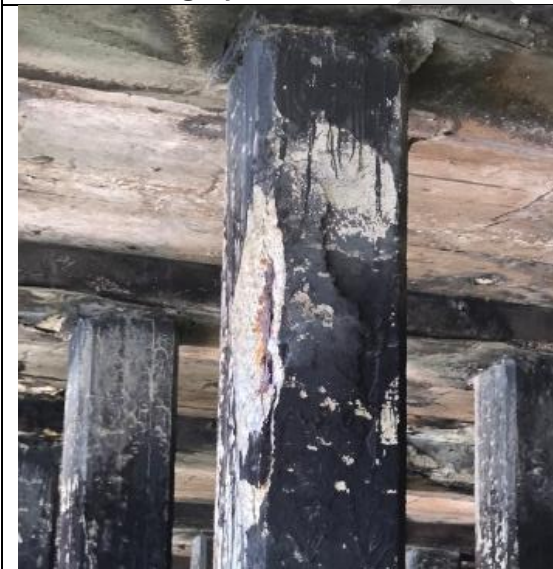
Figure 75. Significant spalling and sectional loss present, corroded reinforcing visible – Severe Defect Category
