Building Enclosure Condition Assessment Report

Craneway Pavilion

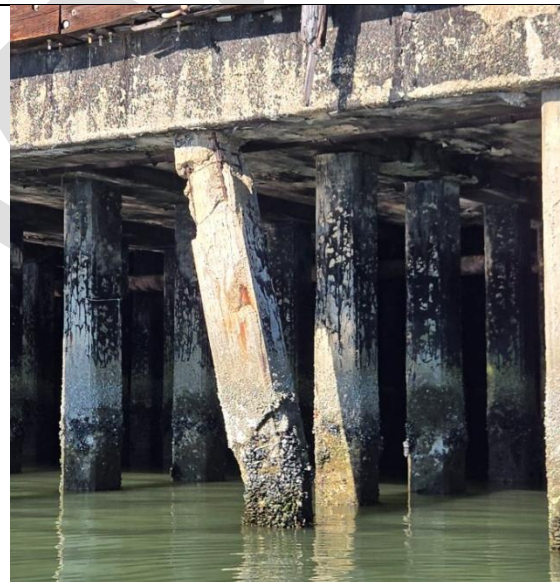
Figure 76. Significant spalling and sectional loss present, corroded reinforcing visible – Severe Defect Category

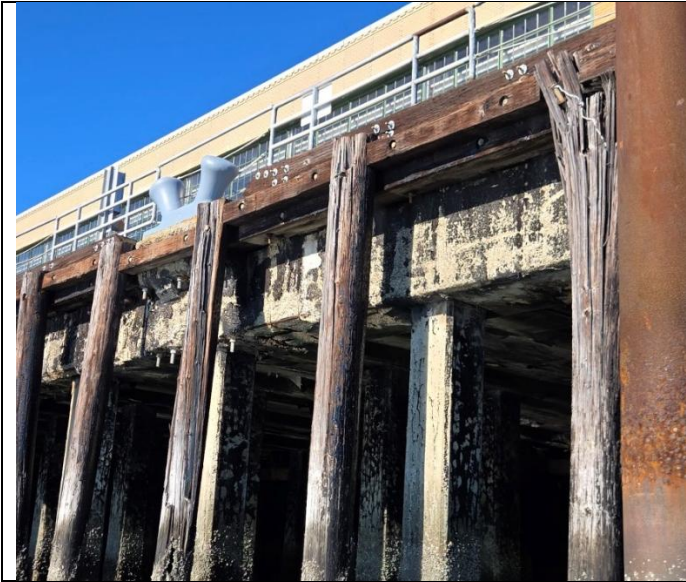
Figure 77. Deteriorated wooden pilings and corroded steel pilings

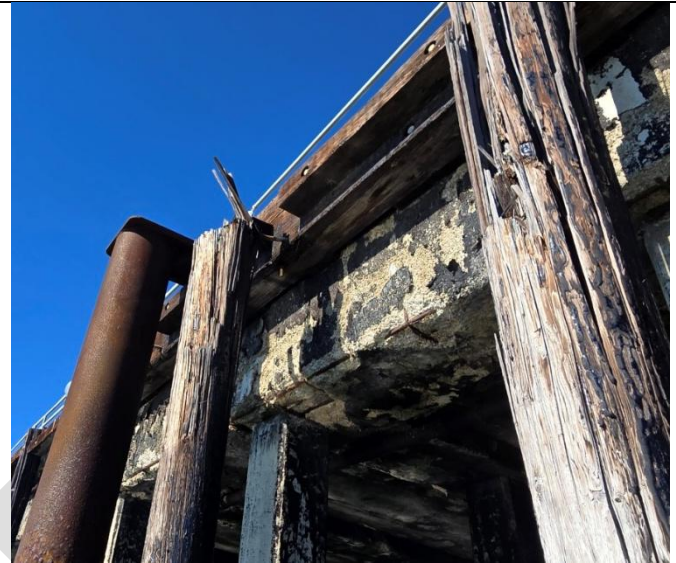
Figure 78. Deteriorated wooden pilings and corroded steel pilings

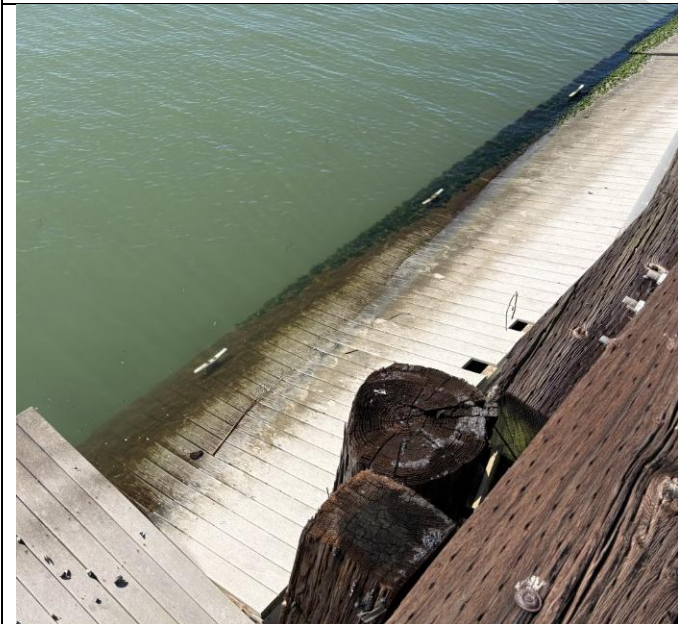
Figure 79. Partially submerged dock along southern elevation

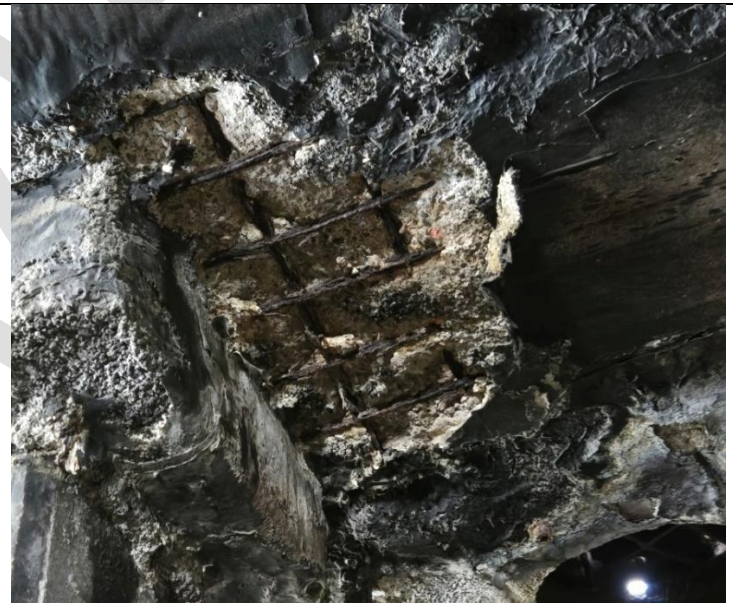
Figure 80. Sectional loss at underside of slab and corrosion of reinforcing steel

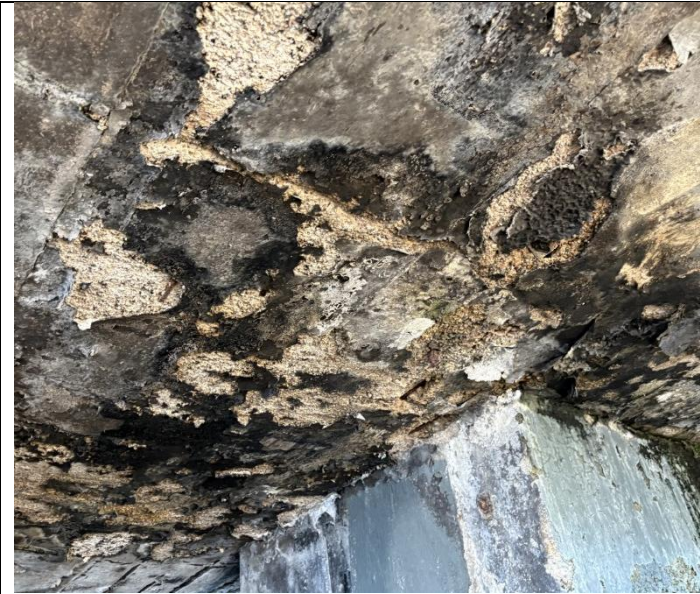
Figure 81. Example of delamination and spalling at underside of slab

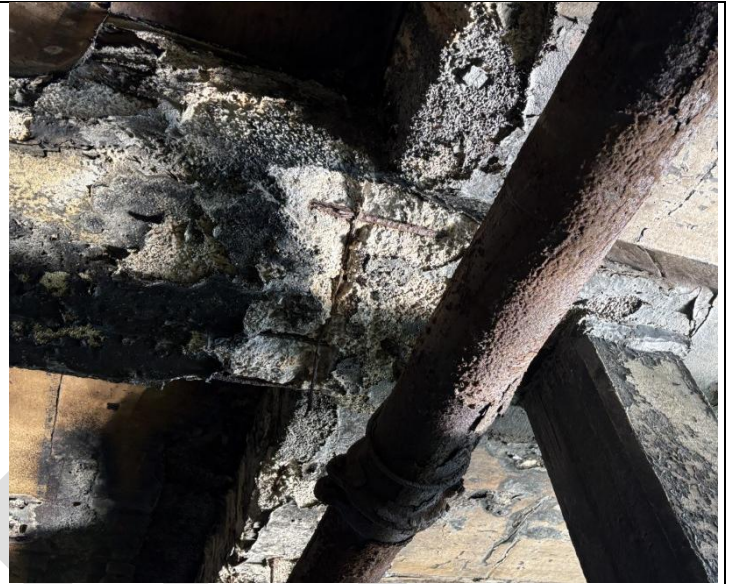
Figure 82. Spalling and sectional loss at underside of slab and beam, including corrosion of reinforcing steel

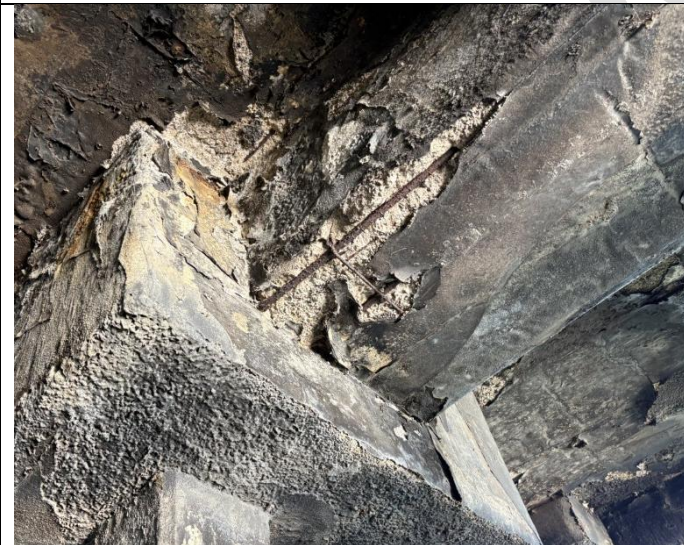
Figure 83. Spalling and sectional loss at underside of slab and beam, including corrosion of reinforcing steel

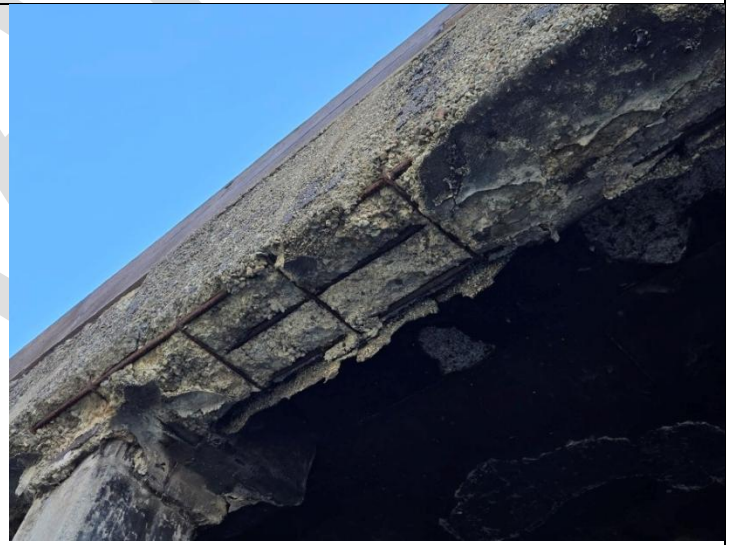
Figure 84. Spalling and sectional loss at perimeter beam, including corrosion of reinforcing steel

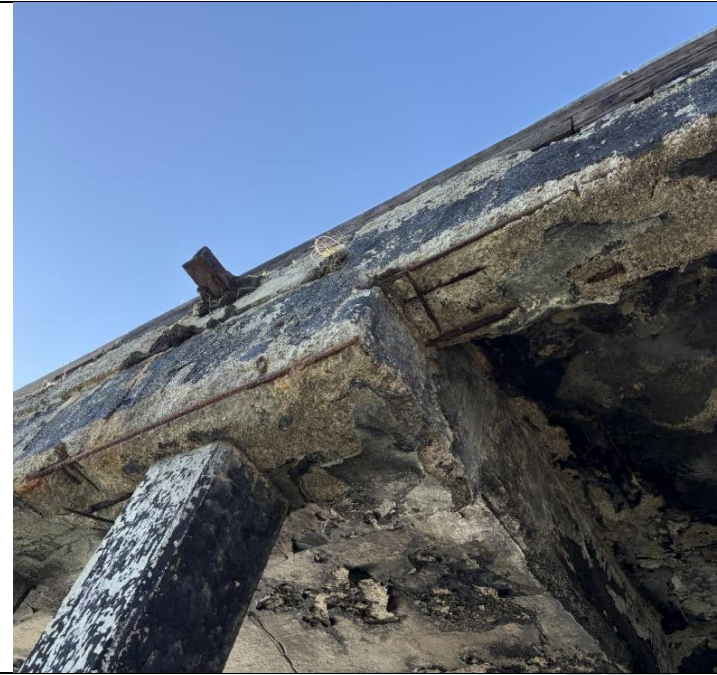
Figure 85. Spalling and sectional loss at perimeter beam, including corrosion of reinforcing steel

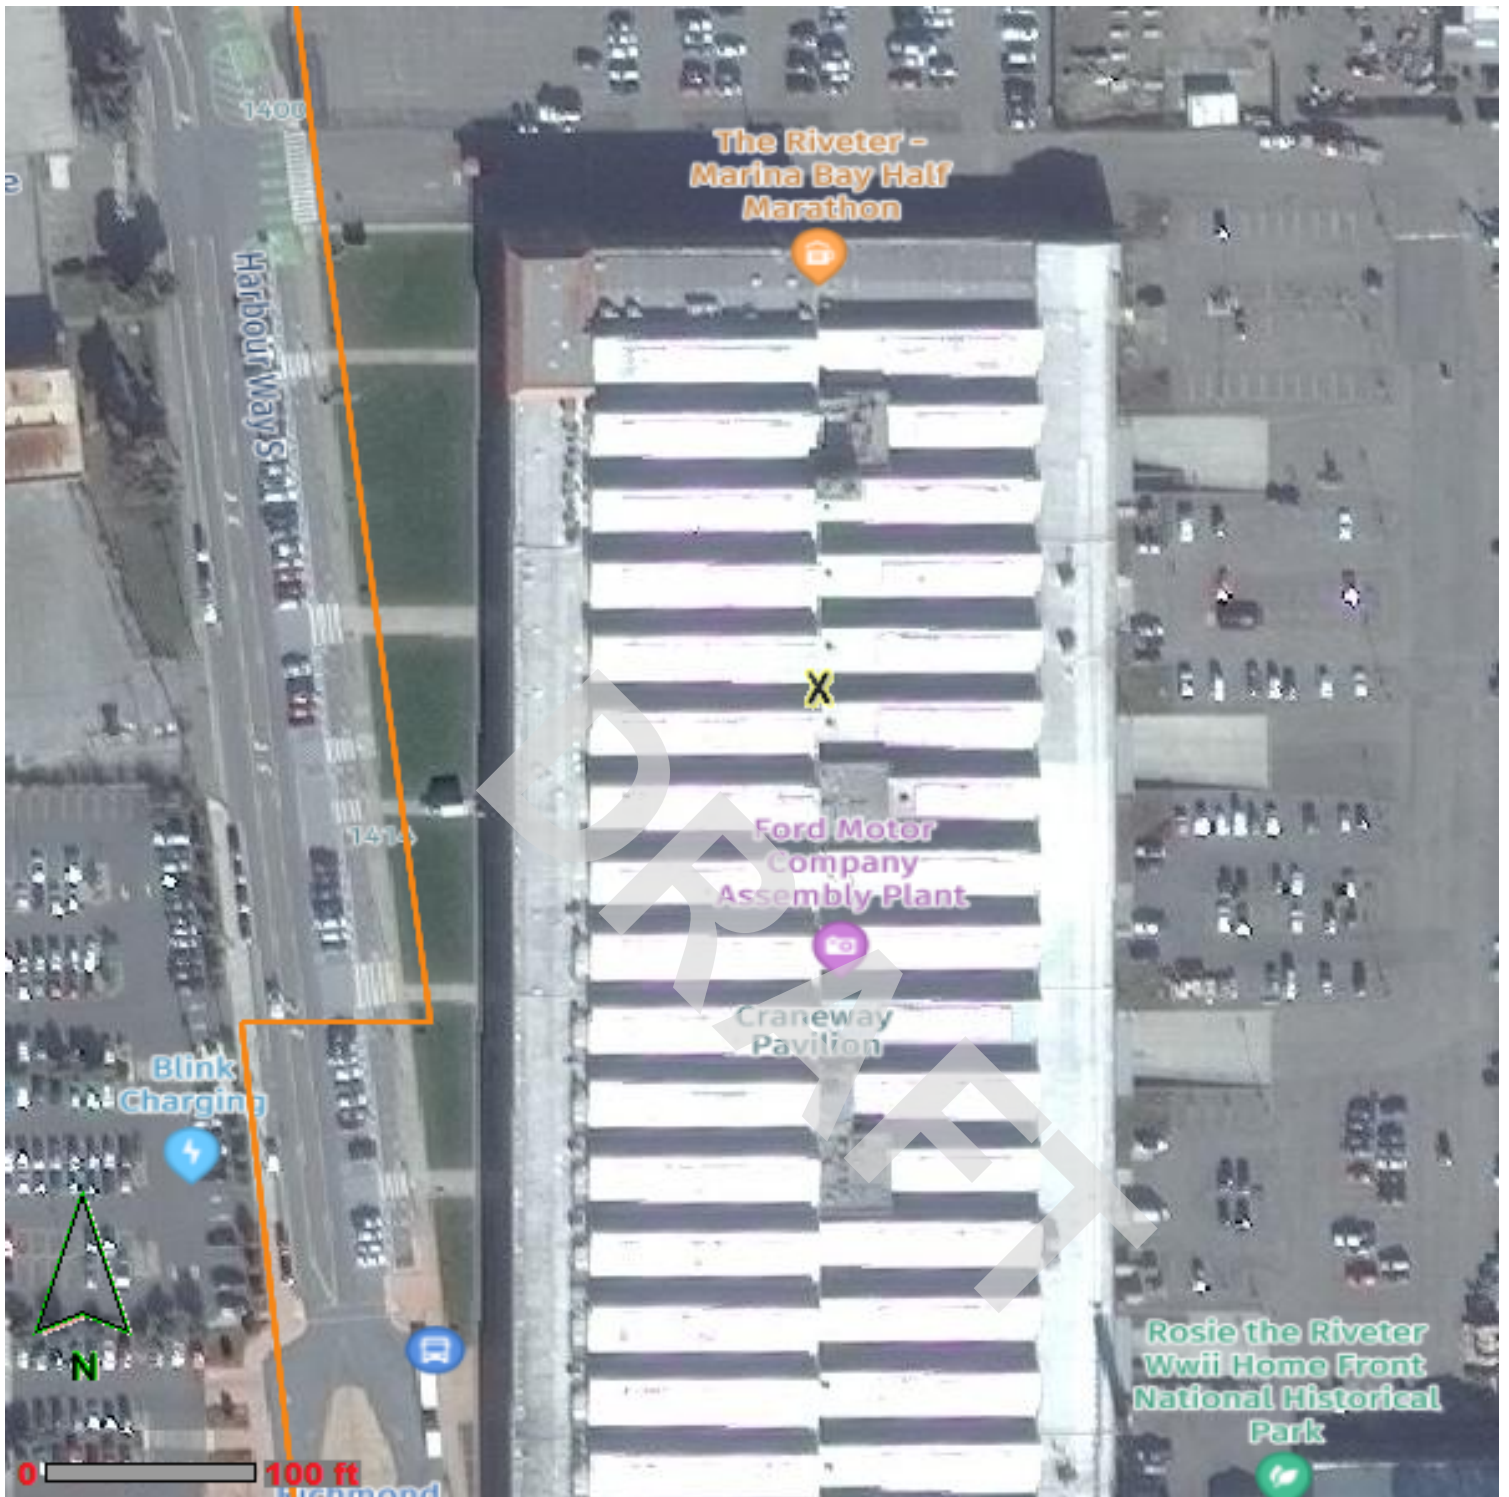
**Flood Zones
Legend**

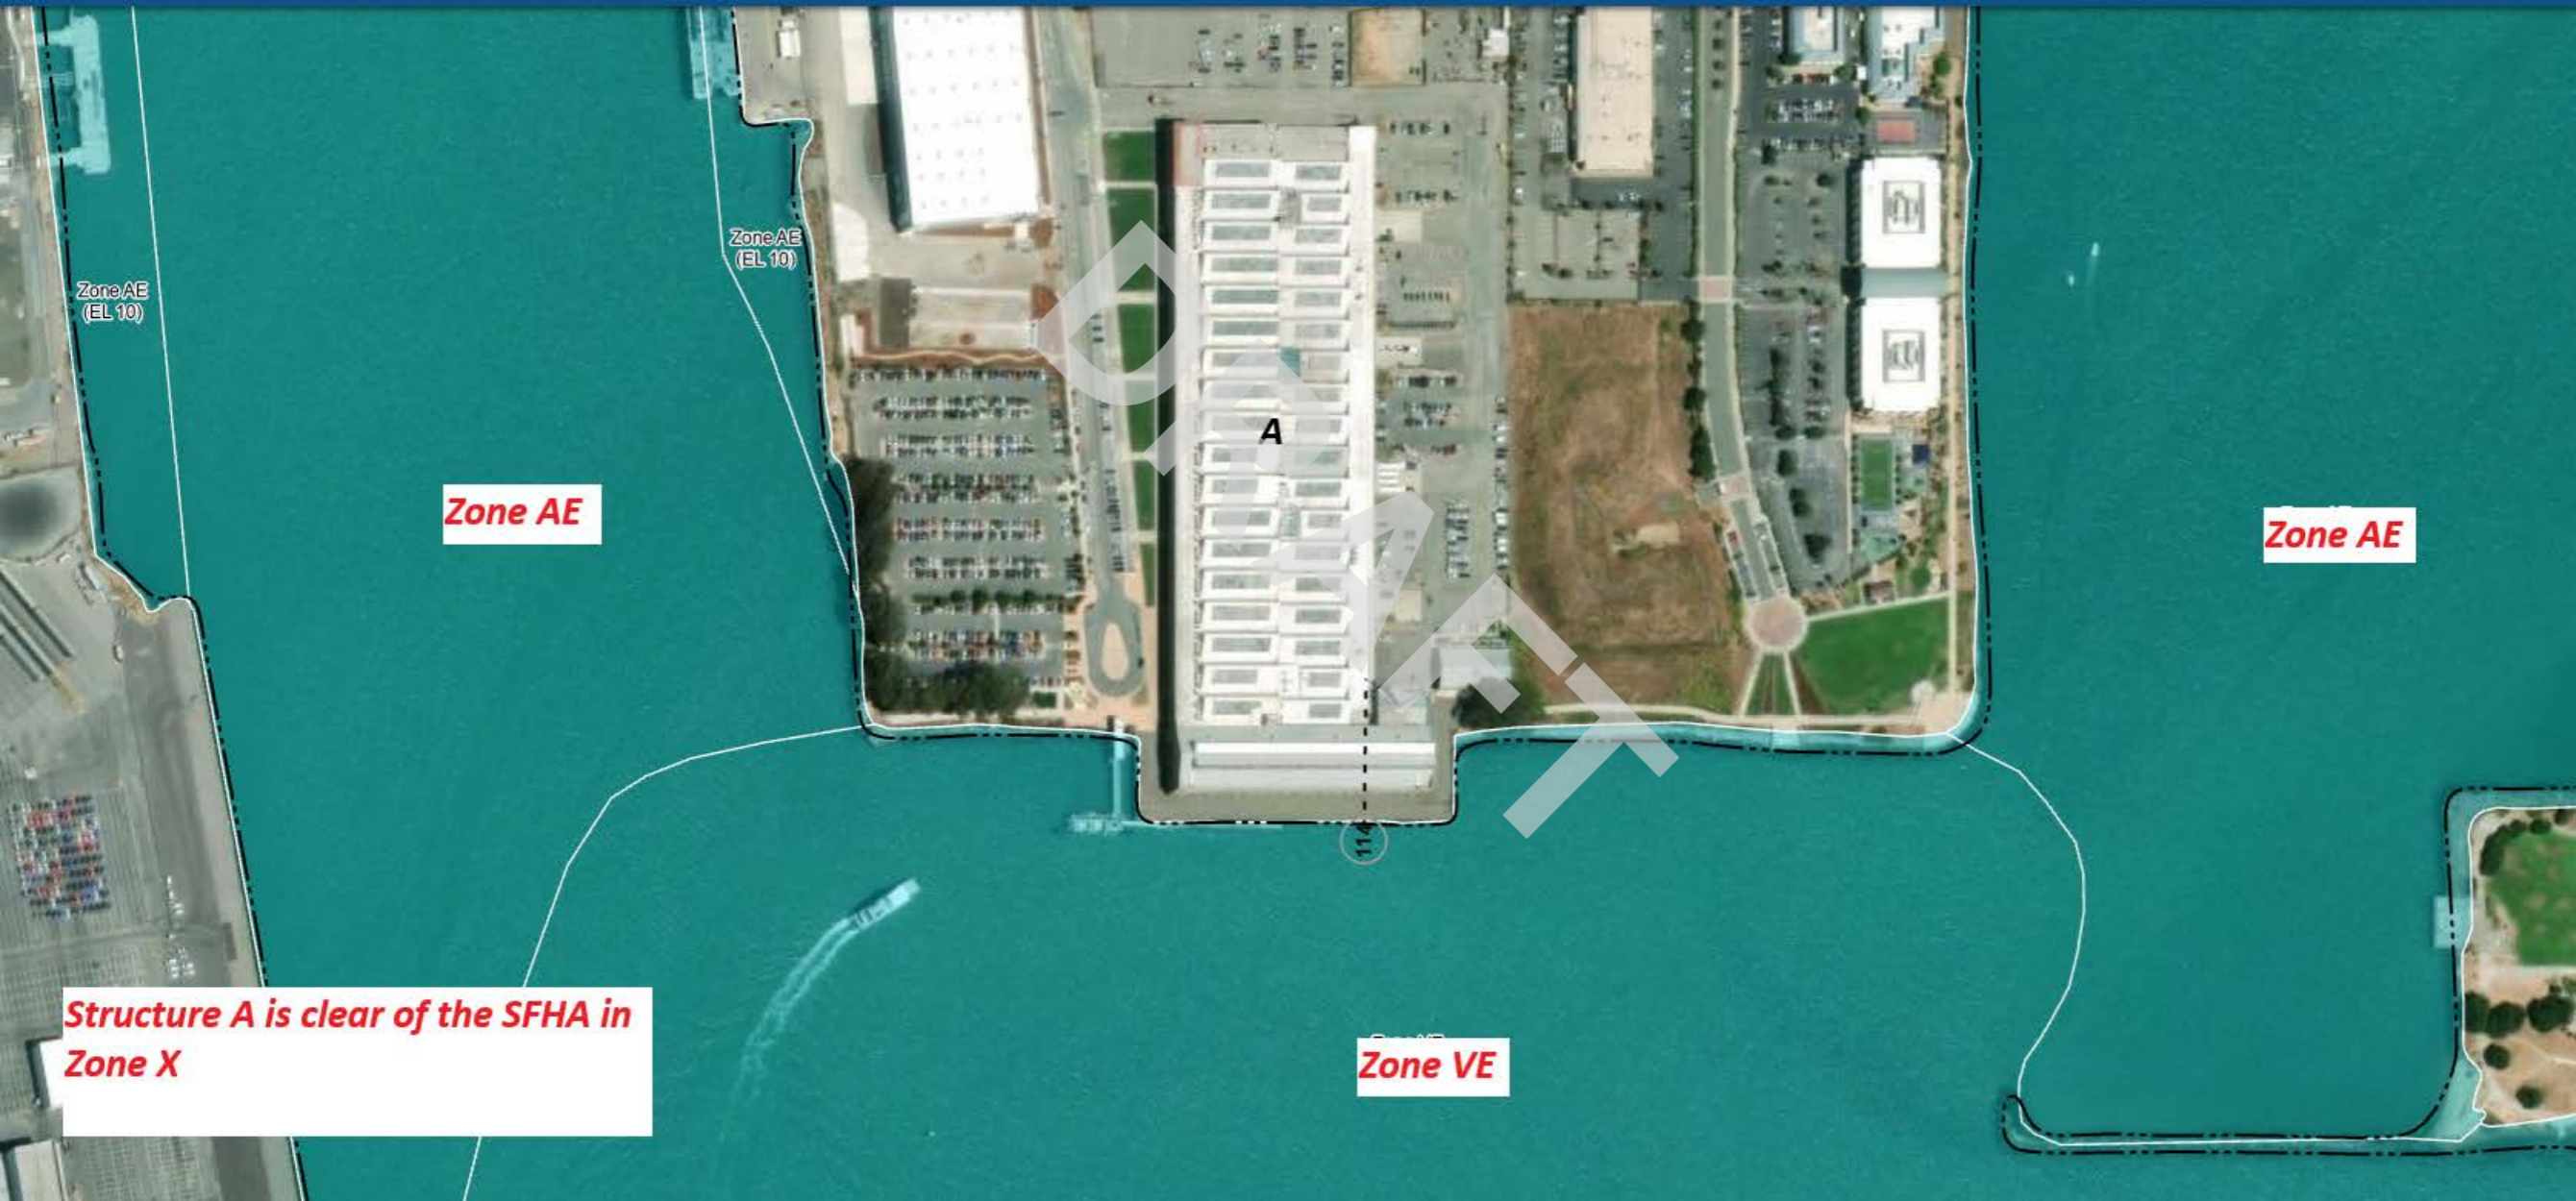
DISCLAIMER: THIS MAP IMAGE IS PROVIDED AS A VISUAL AID WITHOUT ANY WARRANTIES OR GUARANTEES; IT DOES NOT CREATE ANY PRIVATE CAUSE OF ACTION ON BEHALF OF THE BORROWERS OR INSURED PROPERTY OWNERS AGAINST THE FLOOD DETERMINATION PROVIDER. DISTANCE TO 100/500 YEAR FLOOD AREA IS AN APPROXIMATION CALCULATED FROM GEOCODING TECHNOLOGY AND IS NON-GUARANTEED.

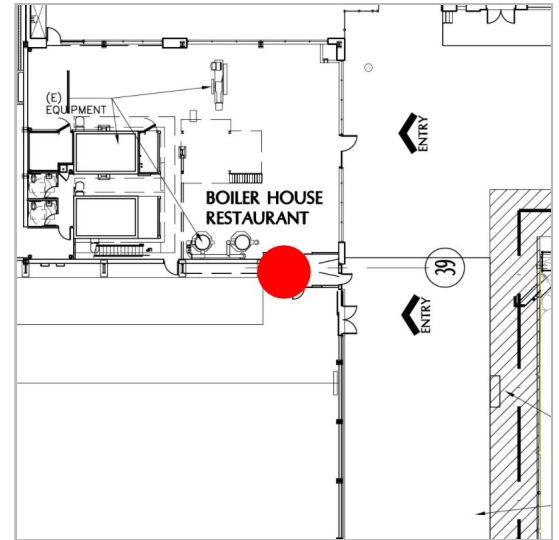
References and Attachments

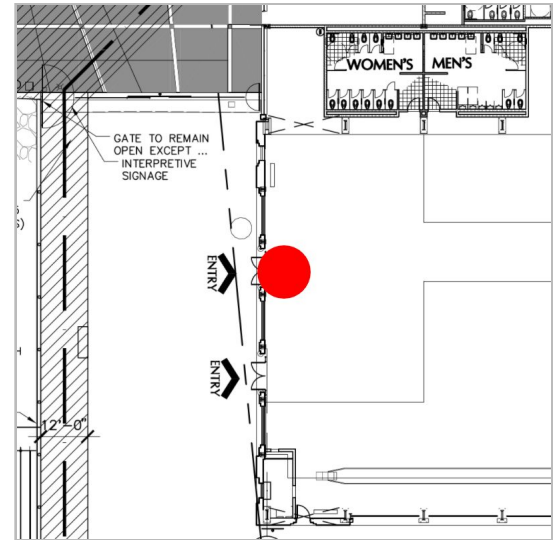
References and Attachments

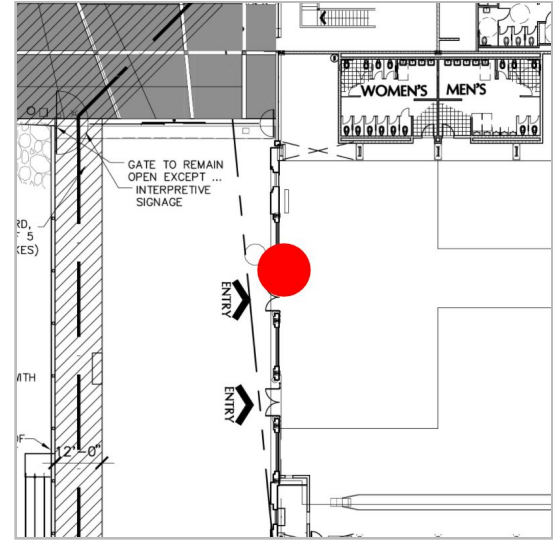
References and Attachments

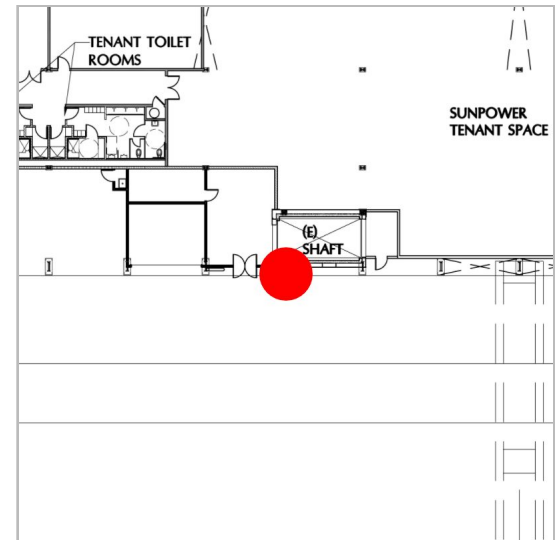
References and Attachments

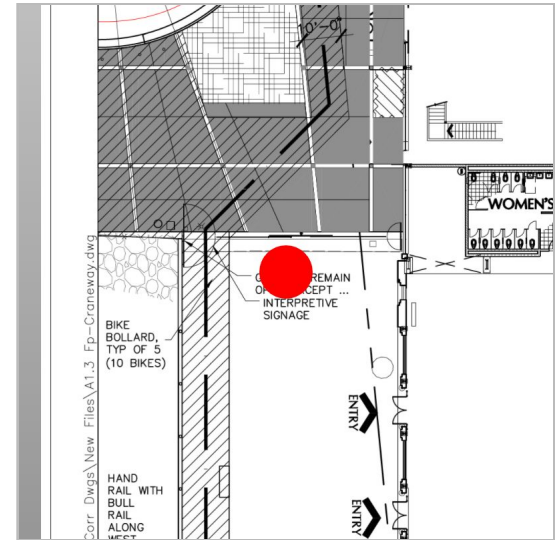
References and Attachments

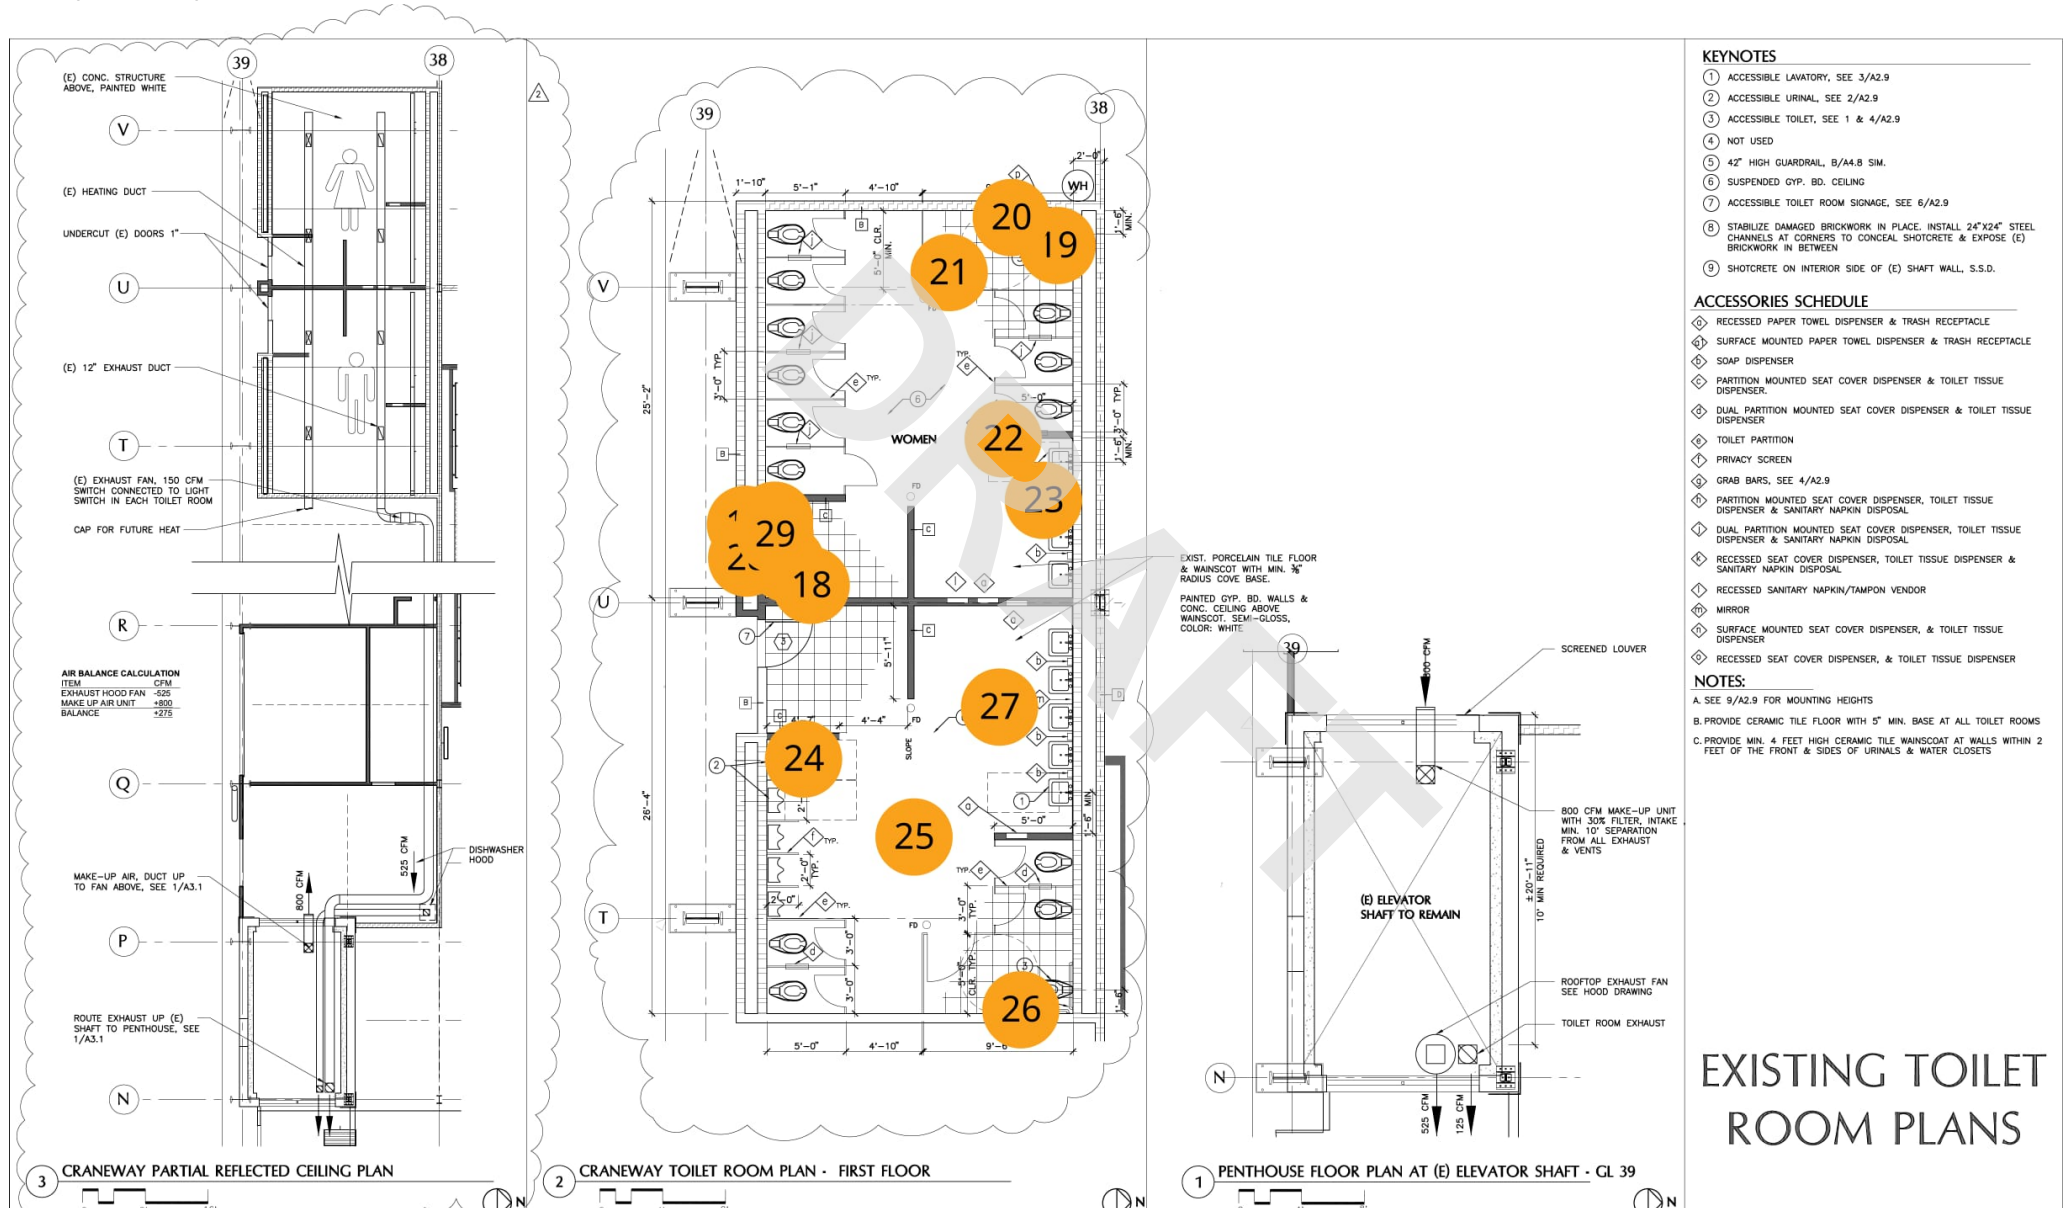
- KEYNOTES**
- ① ACCESSIBLE LAVATORY, SEE 3/A2.9
 - ② ACCESSIBLE URINAL, SEE 2/A2.9
 - ③ ACCESSIBLE TOILET, SEE 1 & 4/A2.9
 - ④ NOT USED
 - ⑤ 42" HIGH GUARDRAIL, B/A4.8 SIM.
 - ⑥ SUSPENDED GYP. BD. CEILING
 - ⑦ ACCESSIBLE TOILET ROOM SIGNAGE, SEE 6/A2.9
 - ⑧ STABILIZE DAMAGED BRICKWORK IN PLACE, INSTALL 24"x24" STEEL CHANNELS AT CORNERS TO CONCEAL SHOTCRETE & EXPOSE (E) BRICKWORK IN BETWEEN
 - ⑨ SHOTCRETE ON INTERIOR SIDE OF (E) SHAFT WALL, S.S.D.

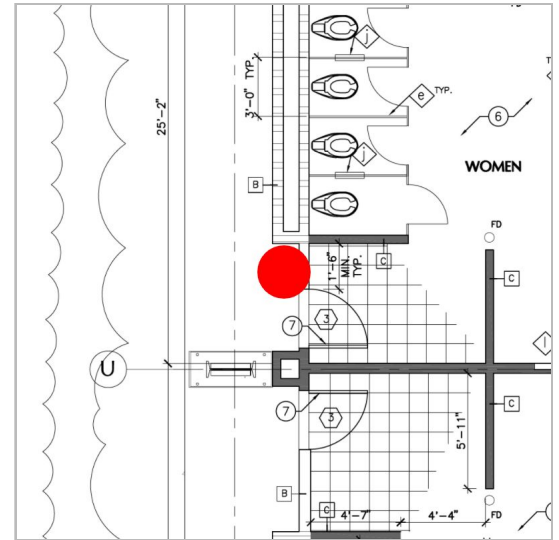
References and Attachments

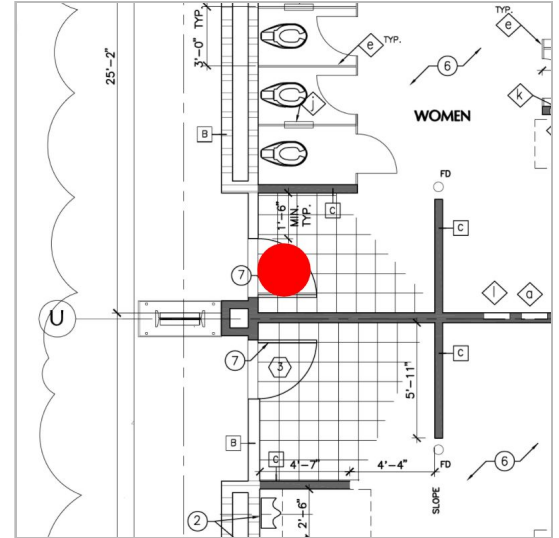
References and Attachments

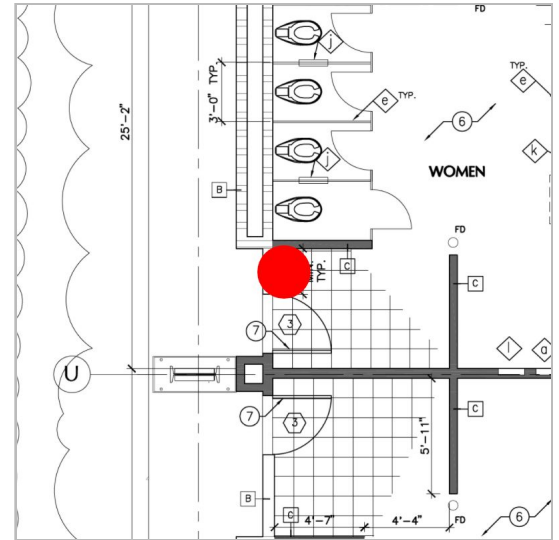
References and Attachments

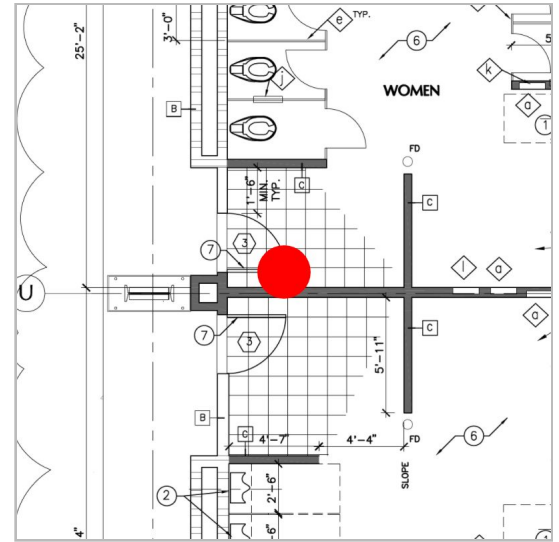
References and Attachments

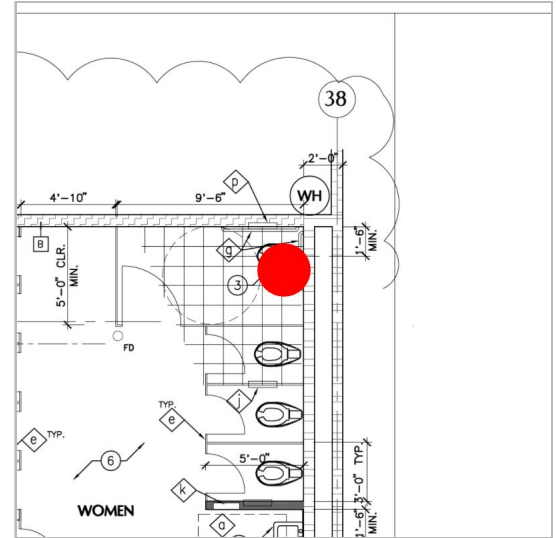
References and Attachments

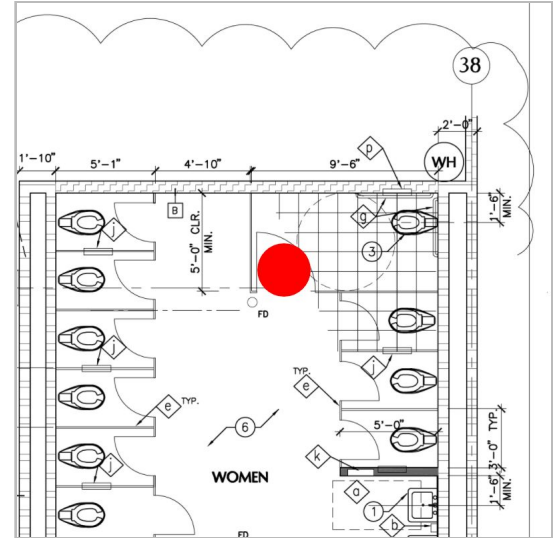
References and Attachments

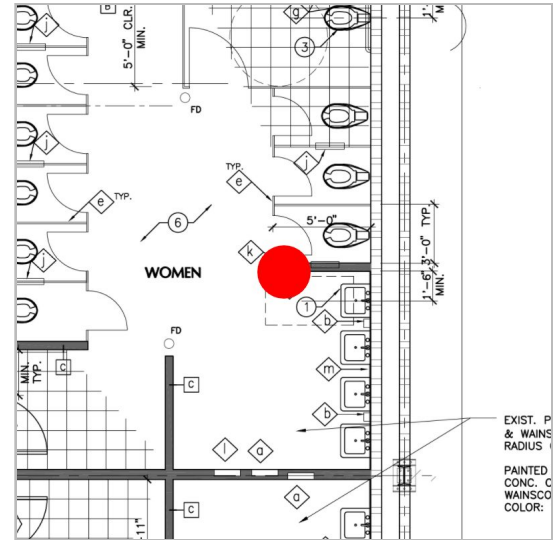
References and Attachments

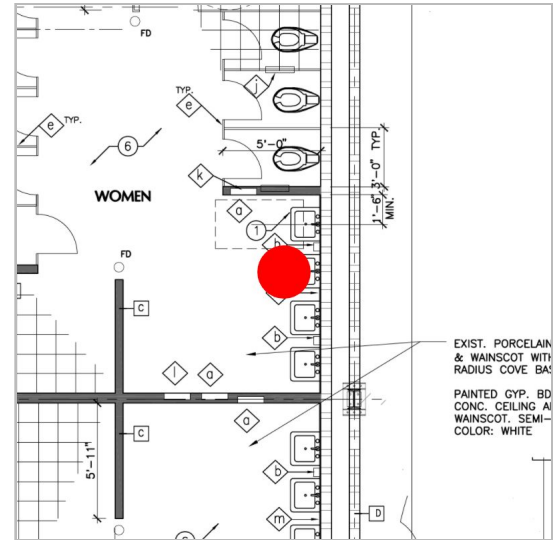
References and Attachments

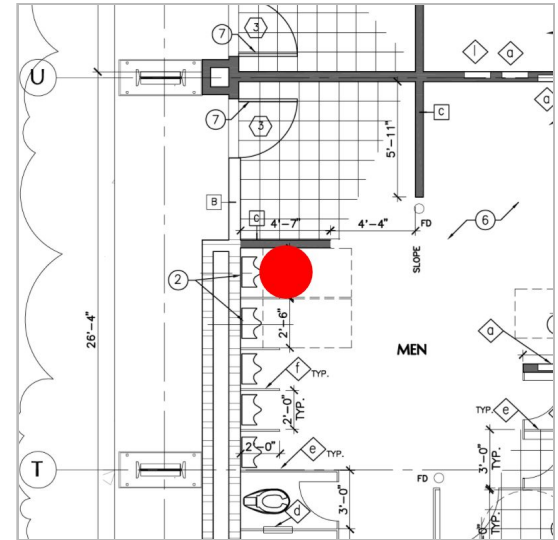
References and Attachments

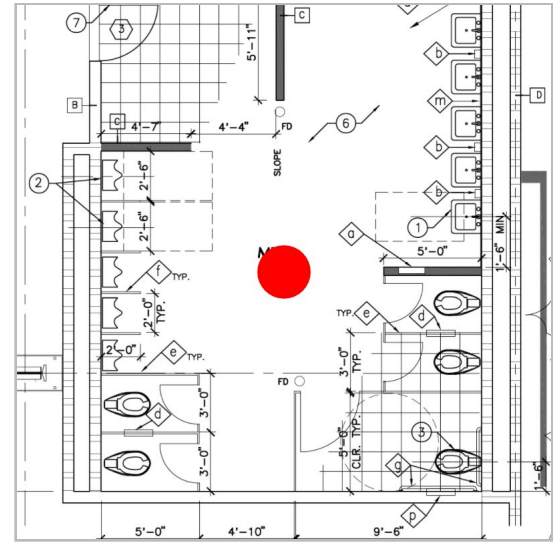
References and Attachments

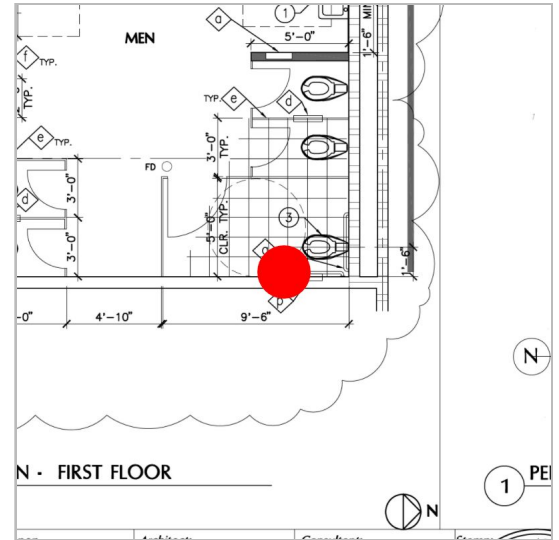
References and Attachments

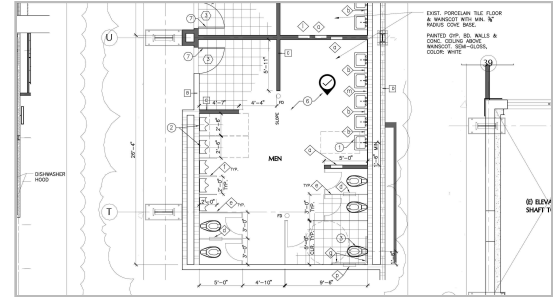
References and Attachments

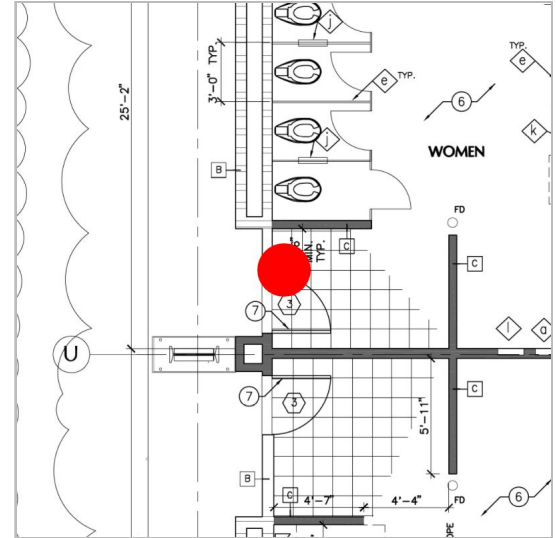
References and Attachments

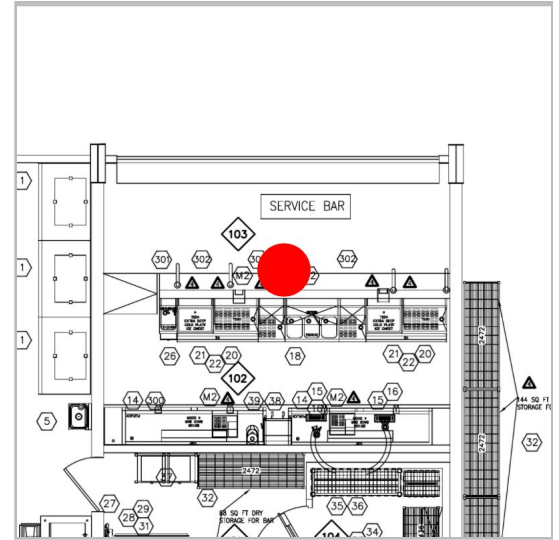
References and Attachments

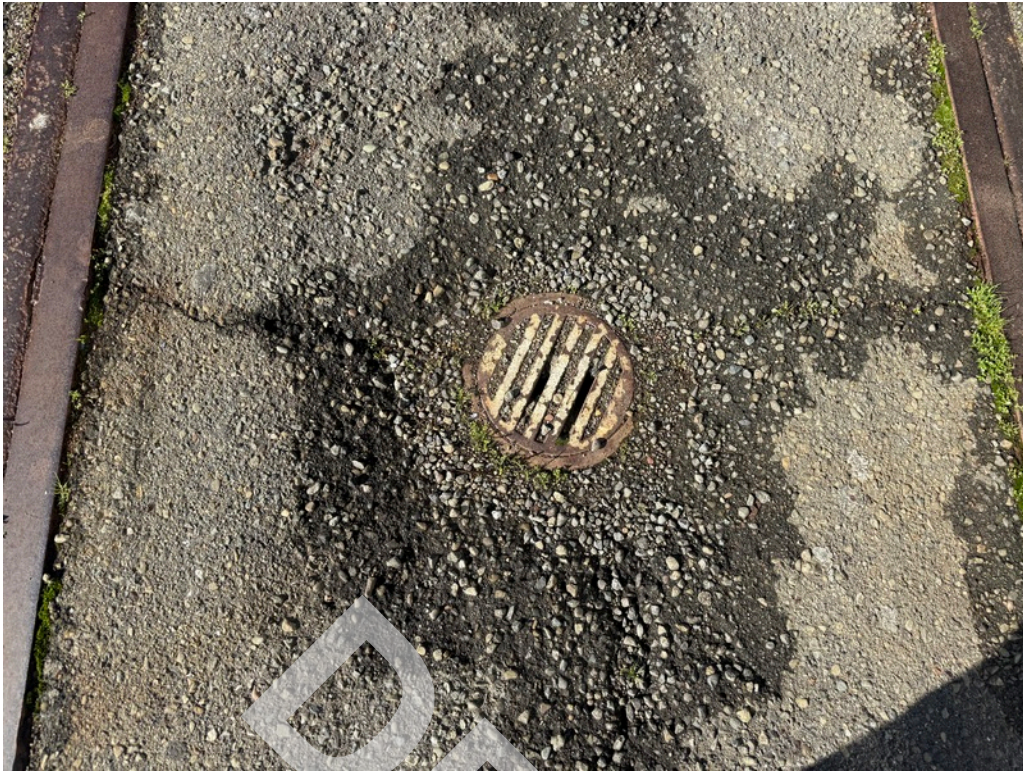
5 - Rusted area drain located along the south perimeter of the site.

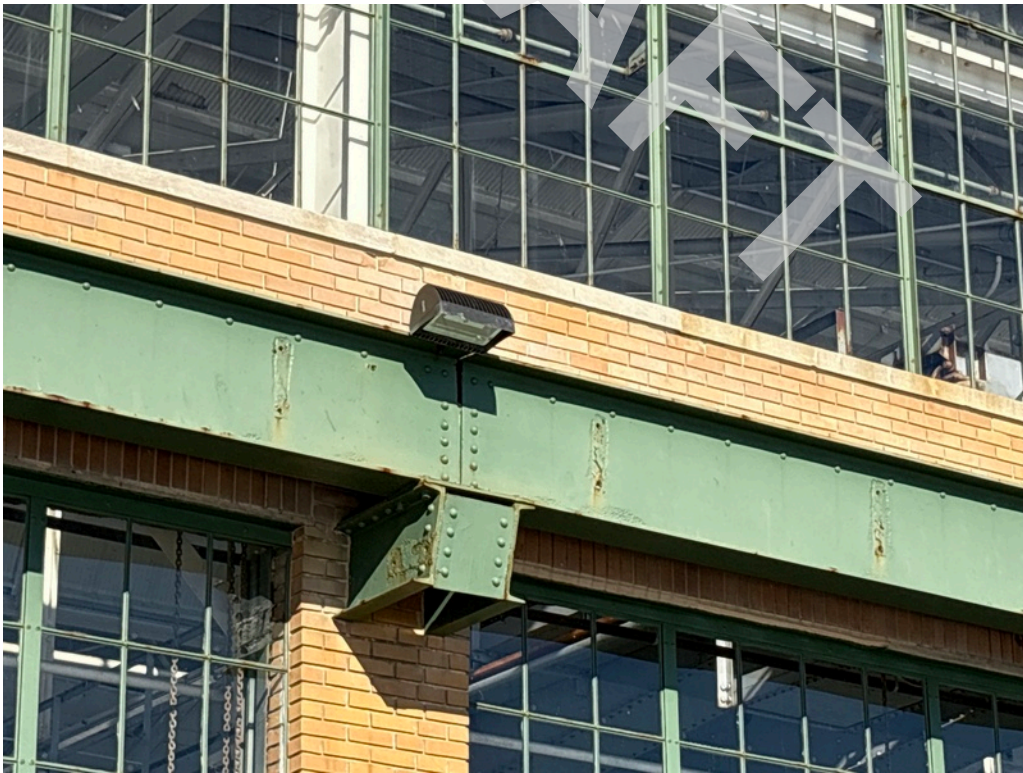
6 - Typical wall-mounted, exterior light fixture on the south elevation of the Craneway Pavilion.

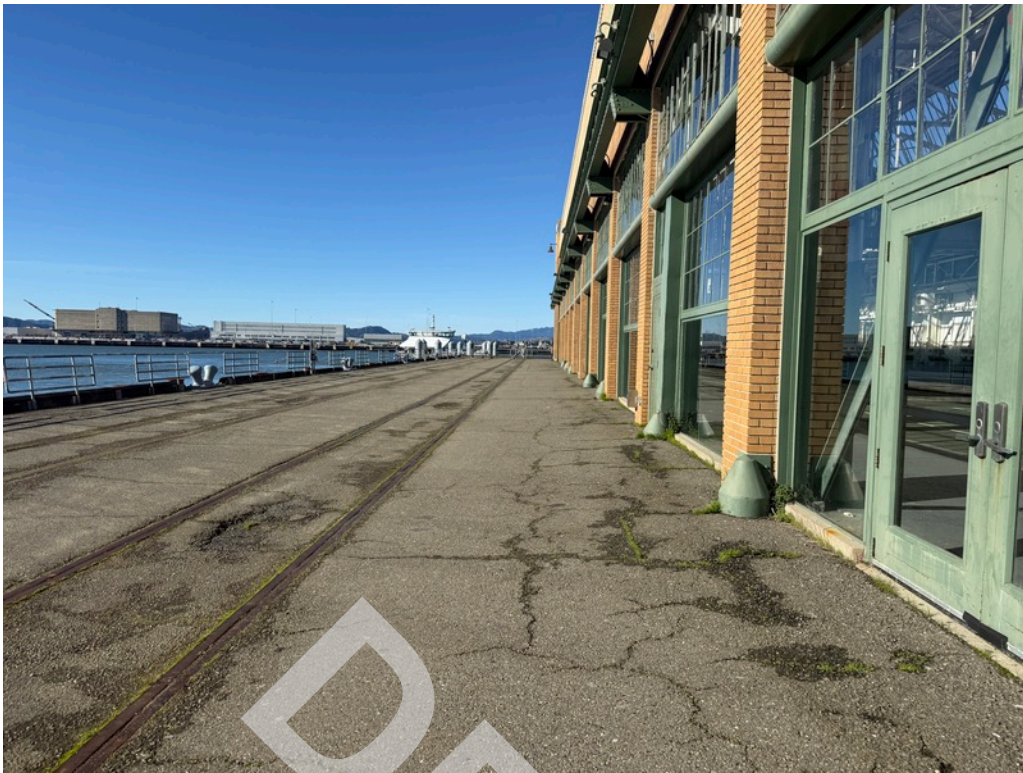
7 - Significant cracking and damage on the asphalt pavement along the south perimeter of the site.

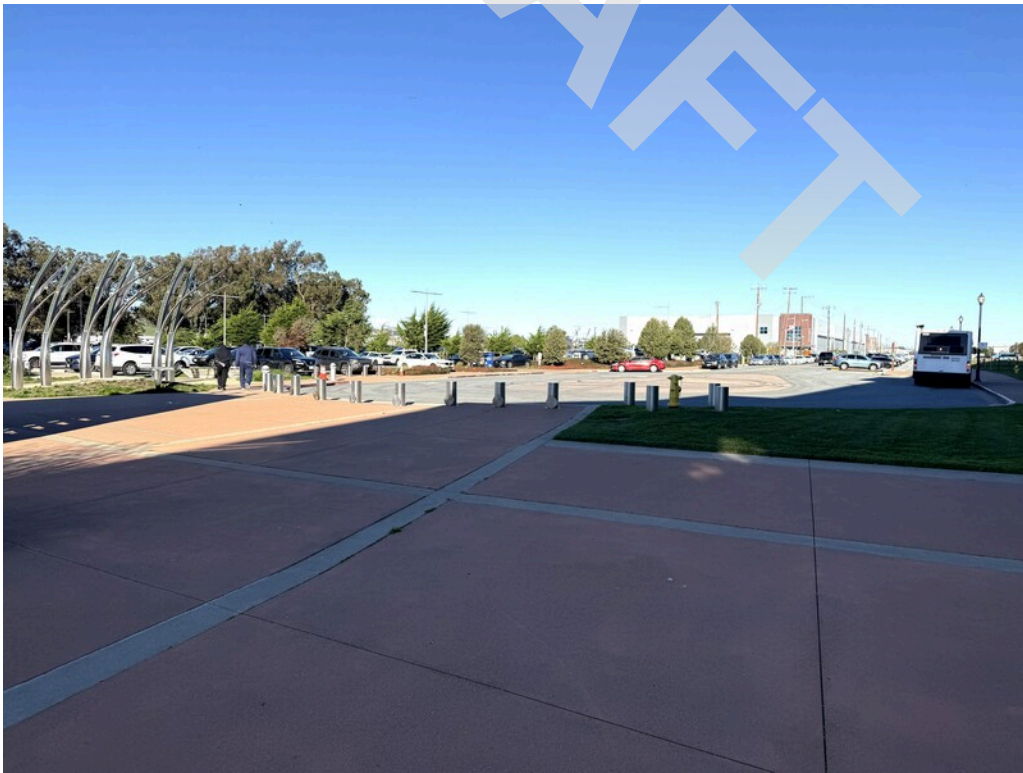
8 - Precast concrete paving is provided at the northwest corner of the site.

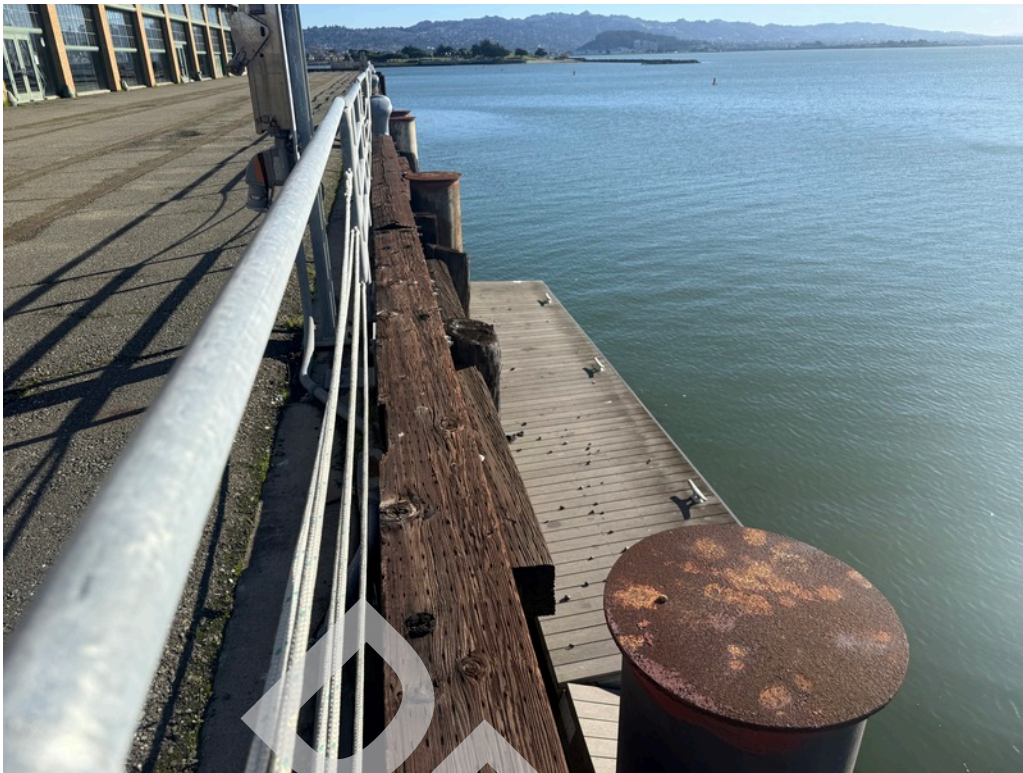
9 - Corroded steel piles at the main pier along the south perimeter of the site.

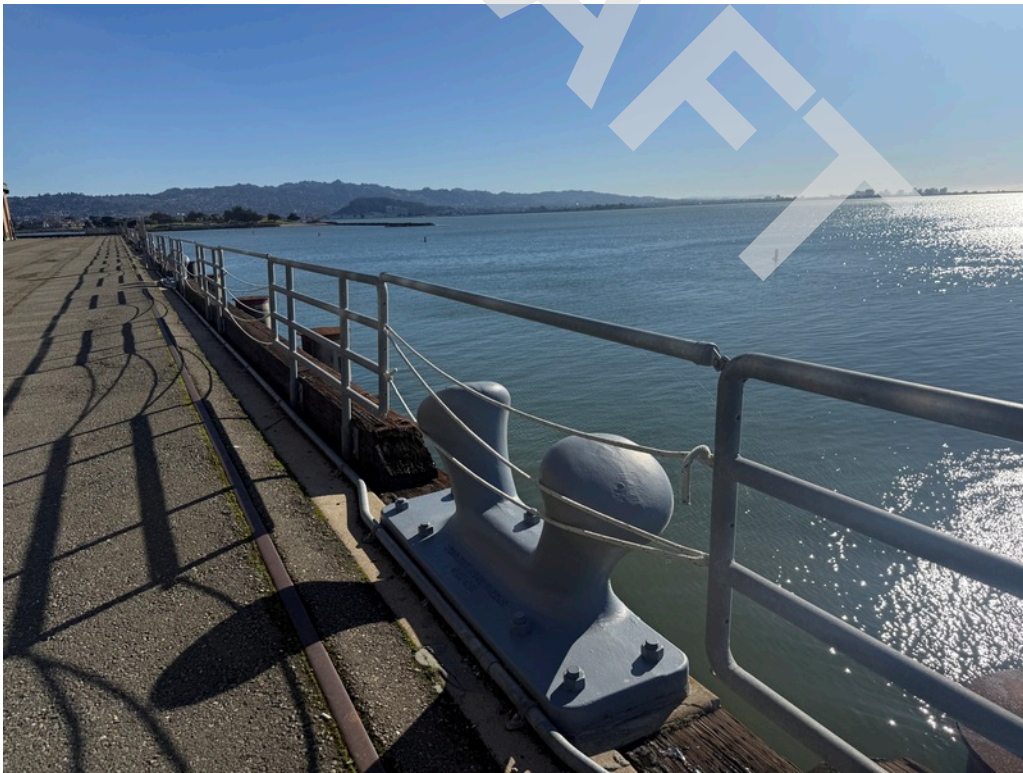
10 - Metal guardrails provided along the south boarder of the site.
