Building Enclosure Condition Assessment Report

Craneway Pavilion

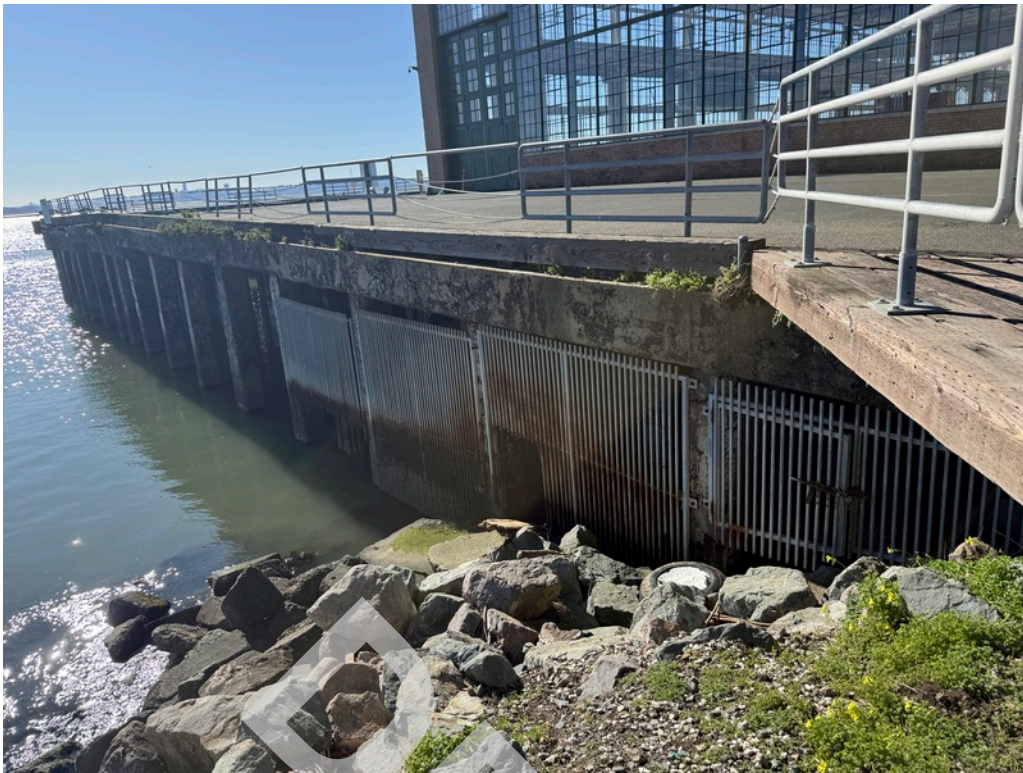
11 - Rusted and damaged metal picket fencing, located underneath the pier at the northeast corner of the site.

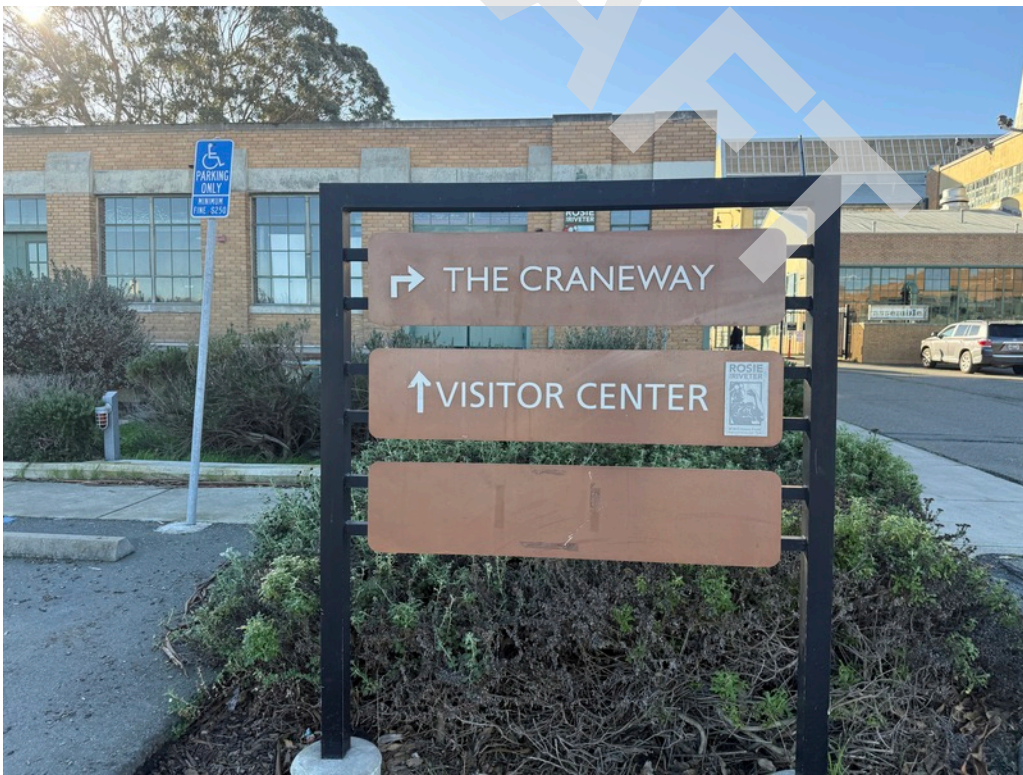
12 - Monument signage identifying the building name provided at the east parking area.

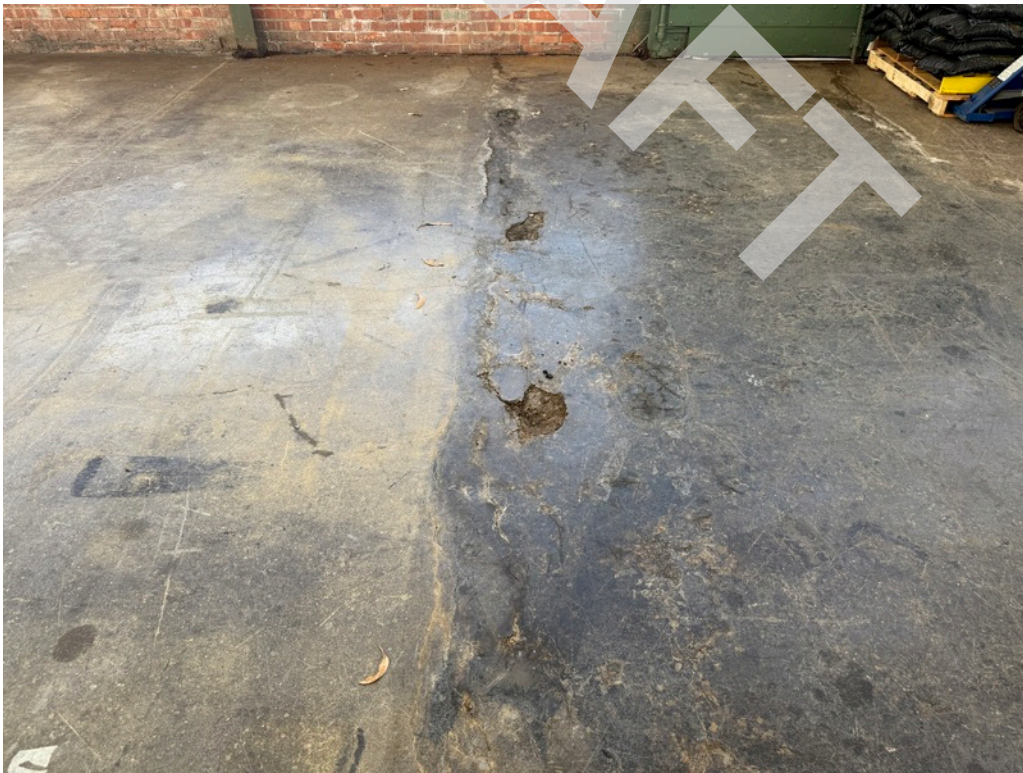
24 - Minor damage to the concrete flooring along the east elevation.

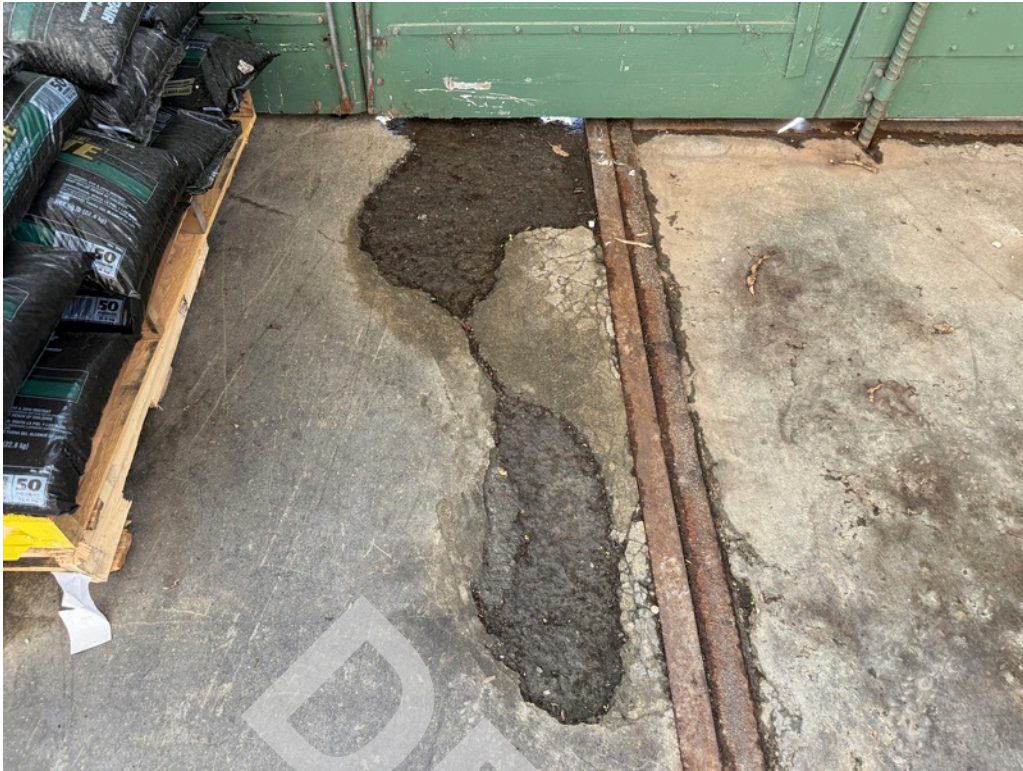
25 - Significant damage to the concrete flooring along the east elevation.

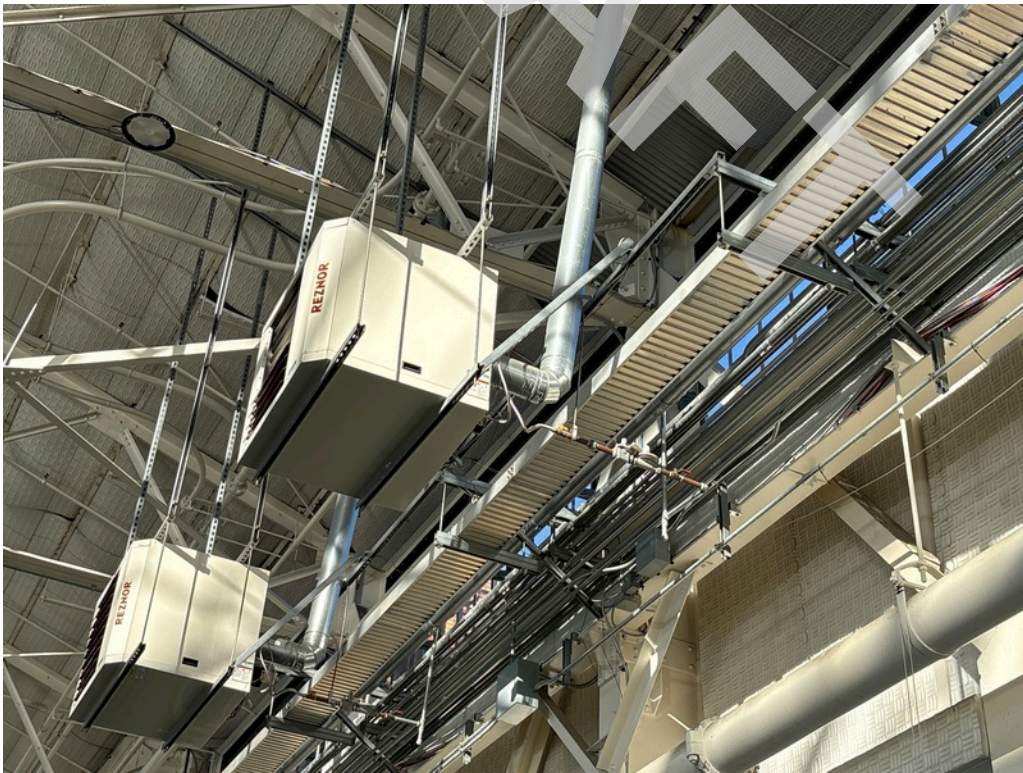
26 - Typical ceiling-hung unit heaters in the Craneway Pavilion.

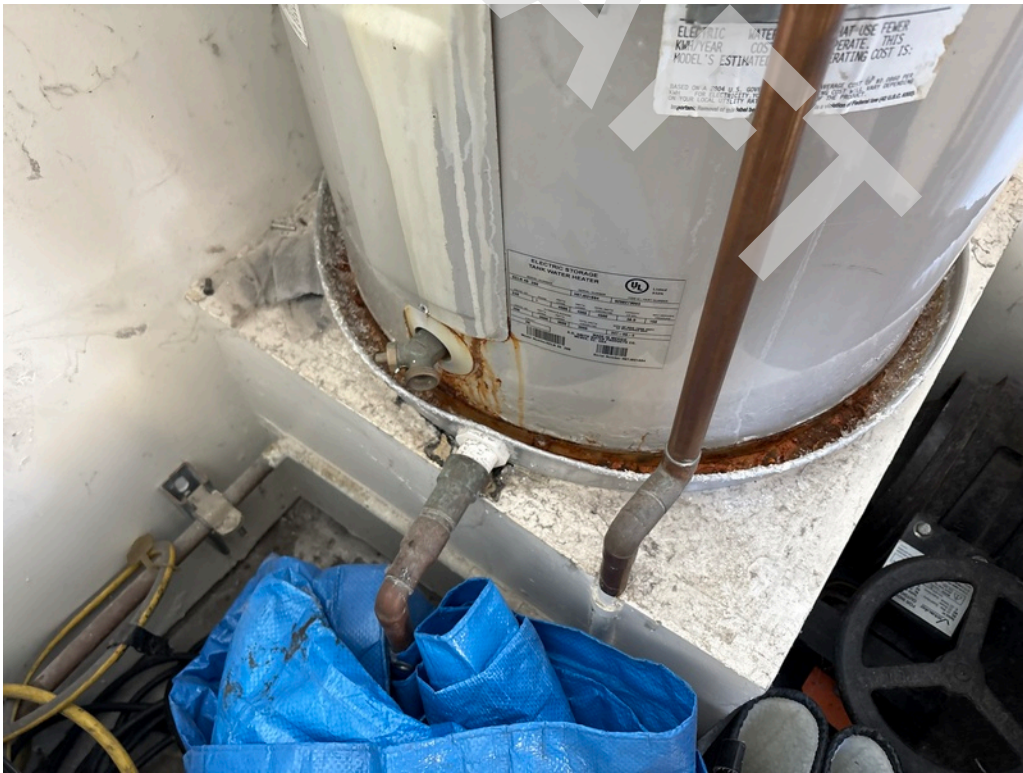
36 - Closeup view of the restroom DWH showing signs of leakage and corrosion in drain pan.

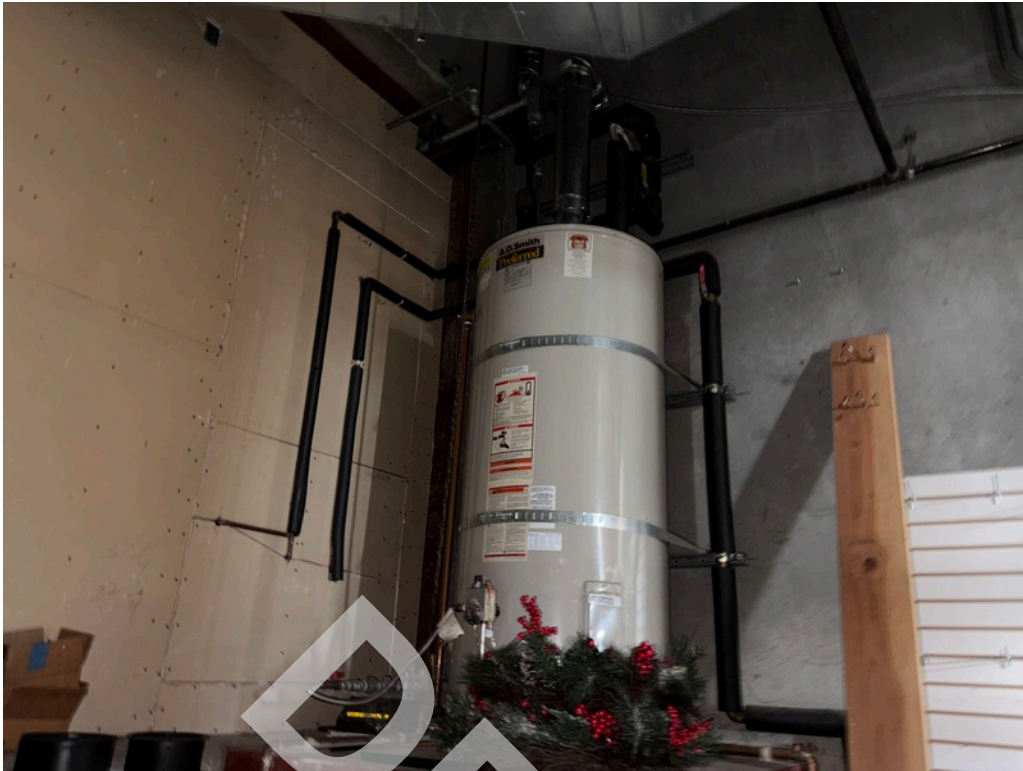
37 - Domestic water heater for the service kitchen in the adjacent utility room.

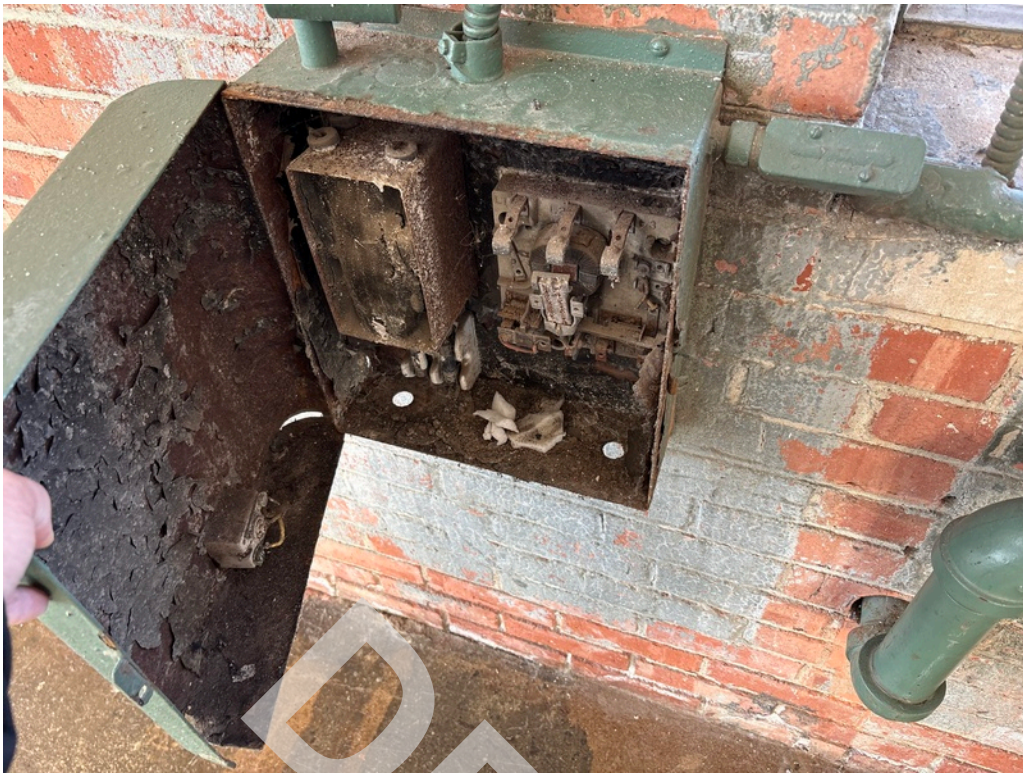
49 - Abandoned safety switch with damaged front cover on the west wall of the Craneway Pavilion.

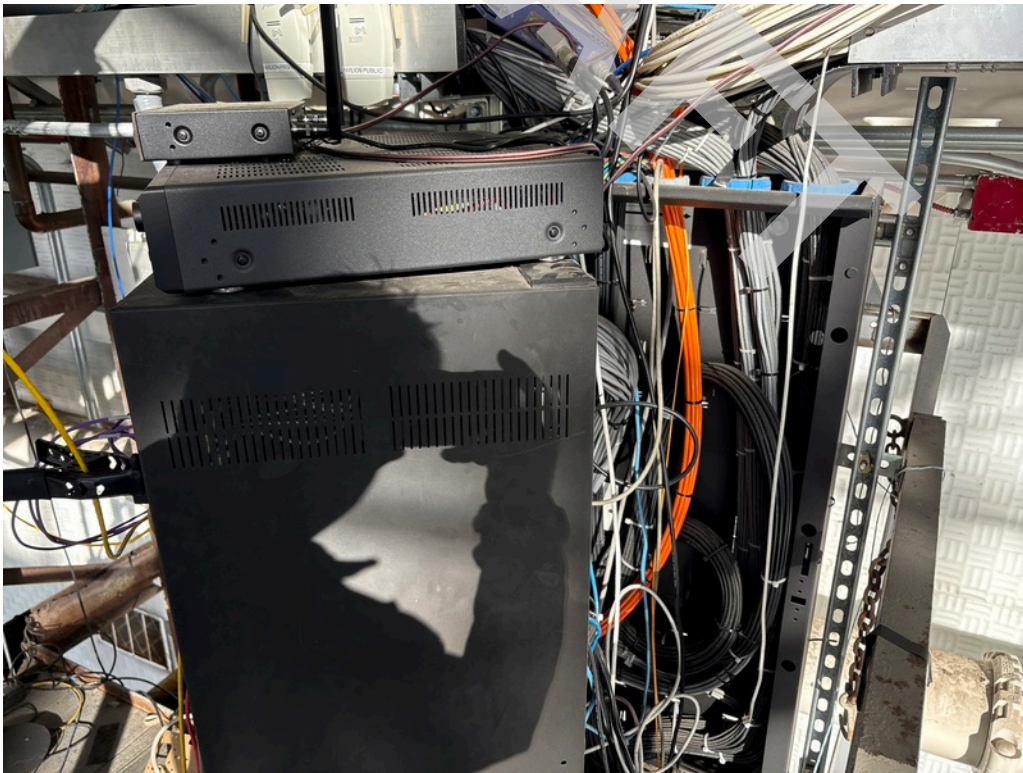
50 - A/V system equipment rack in the crane operator's station on the west beam crane.

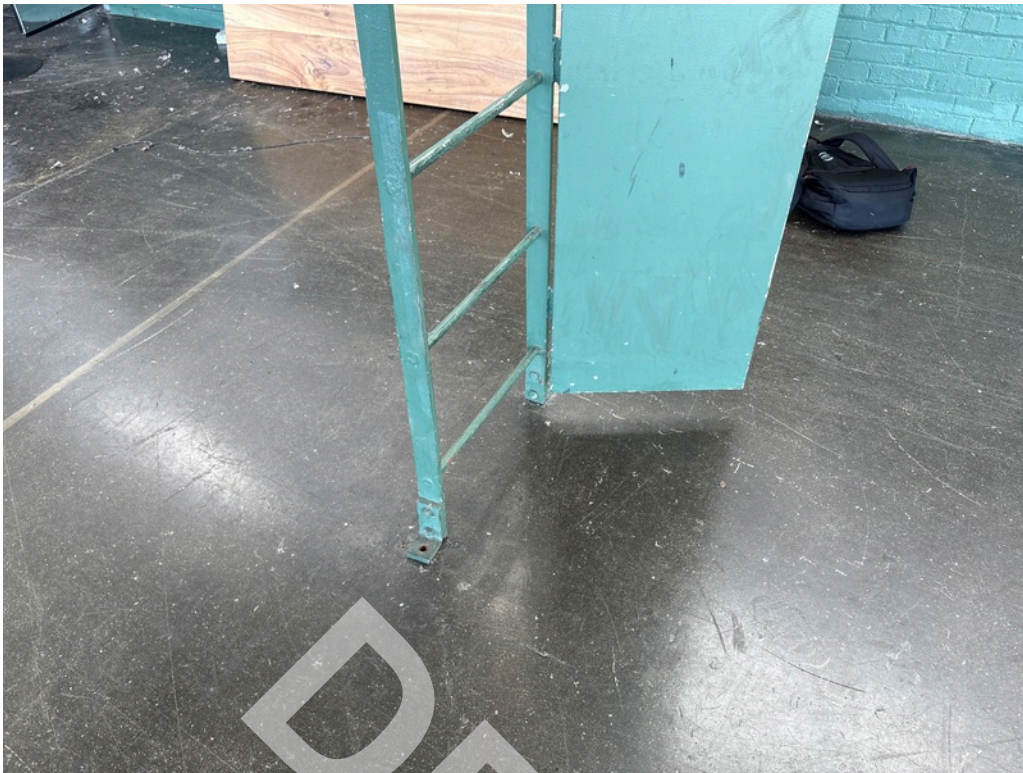
63 - Beam crane operator's station access ladder with missing bolt.

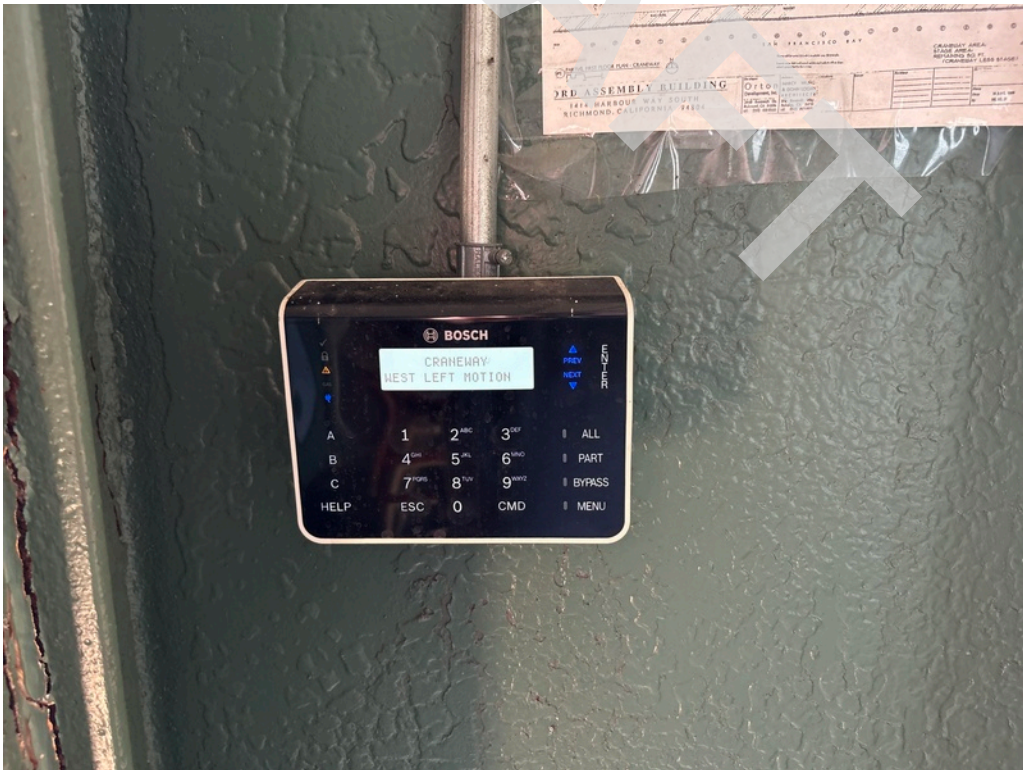
64 - Typical security alarm station in the Craneway Pavilion.

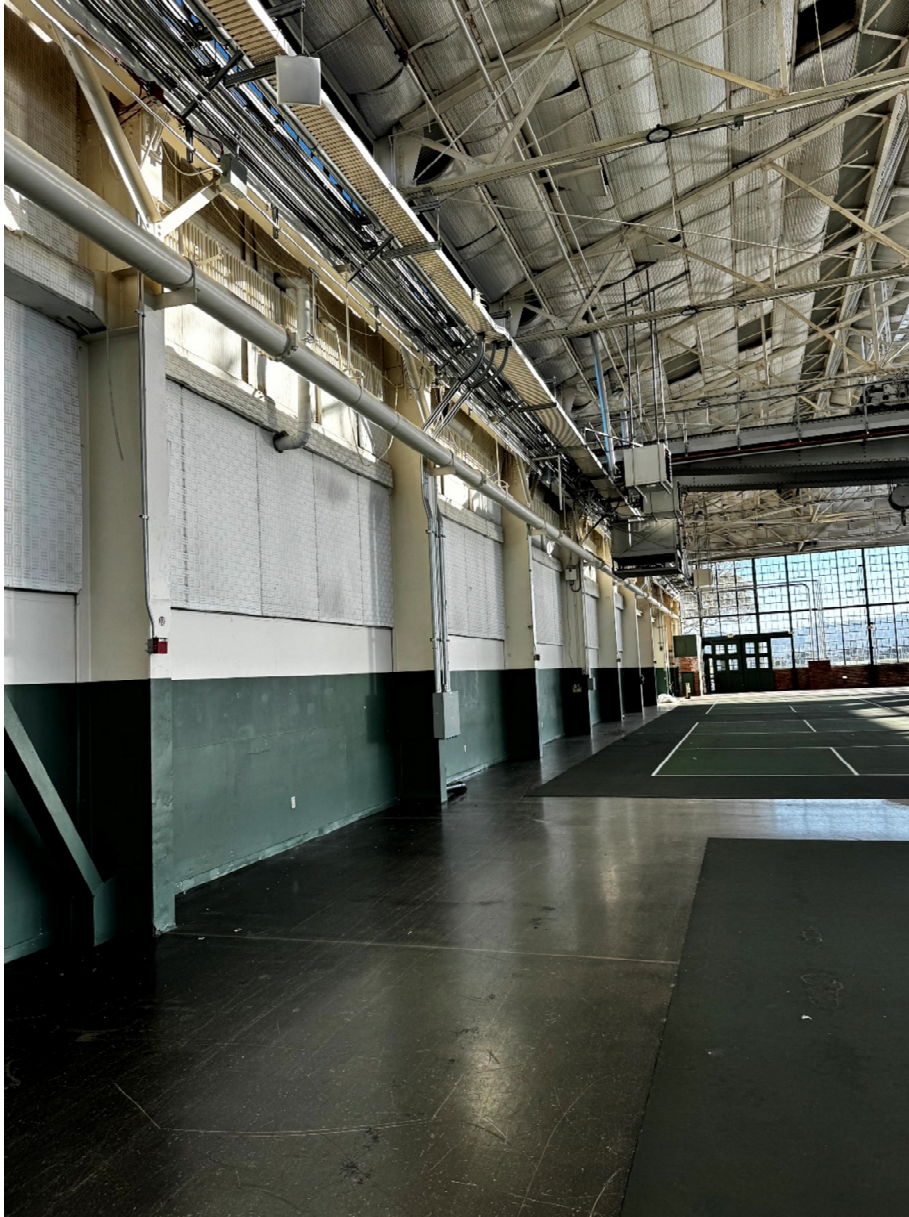
SLR SITE VISIT CHECKLIST AND DOCUMENTATION
