COASTLAND

Date: January 3, 2022

Subject: City of Richmond
Keller Beach Sanitary Sewer CCTV Review
and Assessment Report

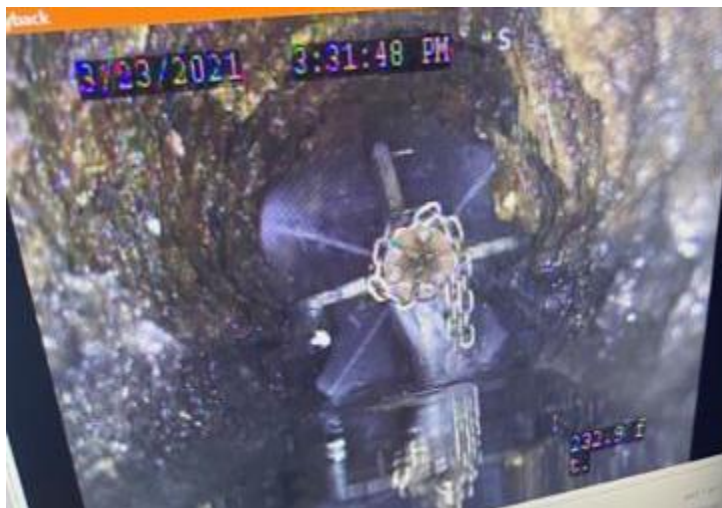
Figure 1. View of Keller Beach sewer pipe prior to cleaning. Hydro nozzle is in use. Chain flail is in view.

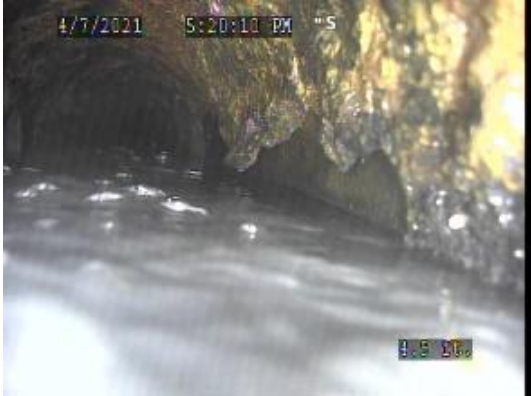
<p>CO Q-8 to MH Q-9</p>

According to Express Sewer, the entire reach of Keller Beach sanitary sewer was extremely corroded prior to cleaning. As shown in the post-cleaning images below, the upstream reach of pipe (MH Q-17 to MH Q-25) was generally descaled, while further downstream (MH Q-1 to MHQ-17) extensive turberculation and wall roughness remains.
