**A RESOLUTION OF THE COUNCIL OF THE CITY OF RICHMOND, CALIFORNIA,  
ACCEPTING THE KELLER BEACH SANITARY SEWER CCTV REVIEW AND  
ASSESSMENT REPORT FOR THE CITY OF RICHMOND PREPARED BY  
NCE-COASTLAND, DATED JANUARY 3, 2022**

## EXHIBIT A

**Date:** January 3, 2022  
**To:** Andre Jadcowski, P.E., NCE  
**From:** Jenny Melman, P.E.,  
NASSCO PACP Cert. U-0819-70306761  
**Subject:** City of Richmond  
Keller Beach Sanitary Sewer CCTV Review  
and Assessment Report

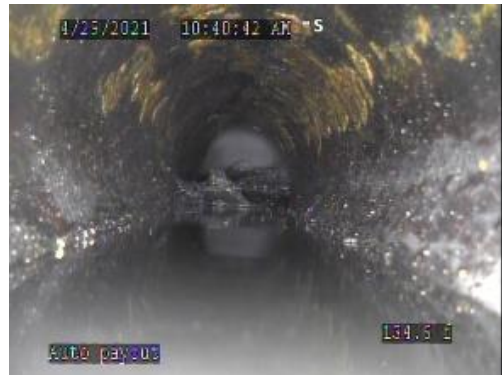
CO Q-18 to MH Q-19

According to Express Sewer, the entire reach of Keller Beach sanitary sewer was extremely corroded prior to cleaning. As shown in the post-cleaning images below, the upstream reach of pipe (MH Q-17 to MH Q-25) was generally descaled, while further downstream (MH Q-1 to MHQ-17) extensive turberculation and wall roughness remains.

No holes or cracks were observed in any segment (that was visible) of the Keller Beach sanitary sewer main, though the pipe walls show extensive evidence of pipe corrosion. Corrosion of the pipe walls (with a decrease of the pipe's structural integrity) has resulted over time due to the presence of corrosive hydrogen sulfide gas, a natural sewer gas, in the unlined pipe. The presence of extensive sags and pipe obstructions further exacerbate the problem by causing organic solids to settle and increases localized hydrogen sulfide gas production in the pipe. Corrosion will continue to deteriorate the pipe's structural integrity as long as the pipe remains exposed to sewage gases.
