City of Richmond

Sole Source Justification

Keller Beach Sanitary Sewer

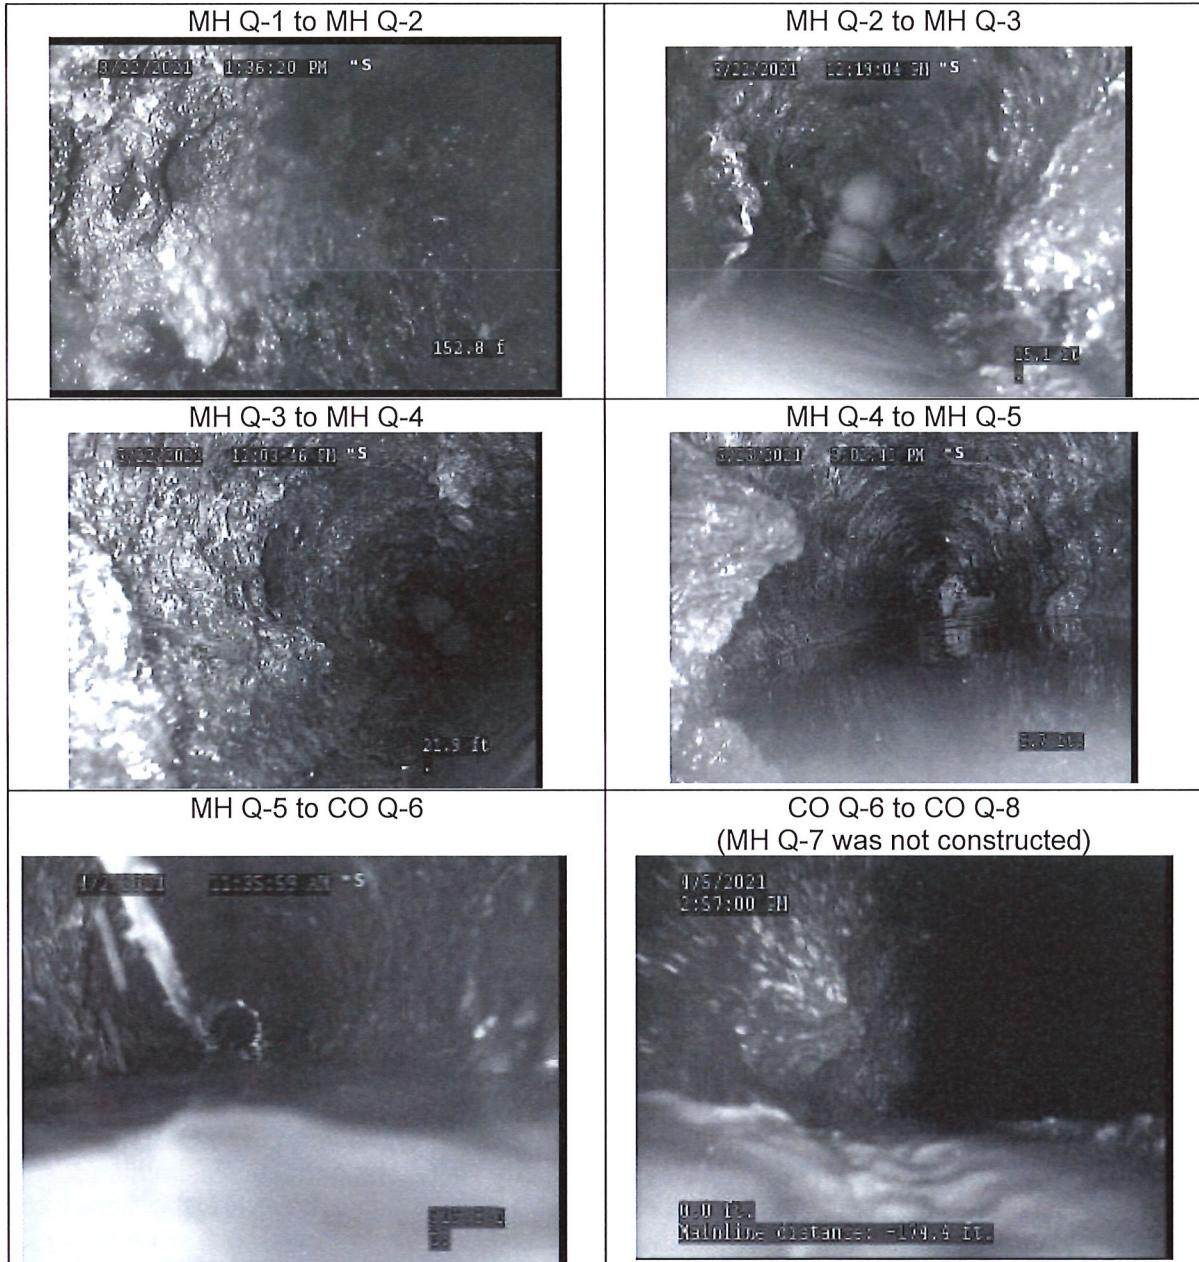
<p>CO Q-8 to MH Q-9</p>

According to Express Sewer, the entire reach of Keller Beach sanitary sewer was extremely corroded prior to cleaning. As shown in the post-cleaning images below, the upstream reach of pipe (MH Q-17 to MH Q-25) was generally descaled, while further downstream (MH Q-1 to MHQ-17) extensive turberculation and wall roughness remains.

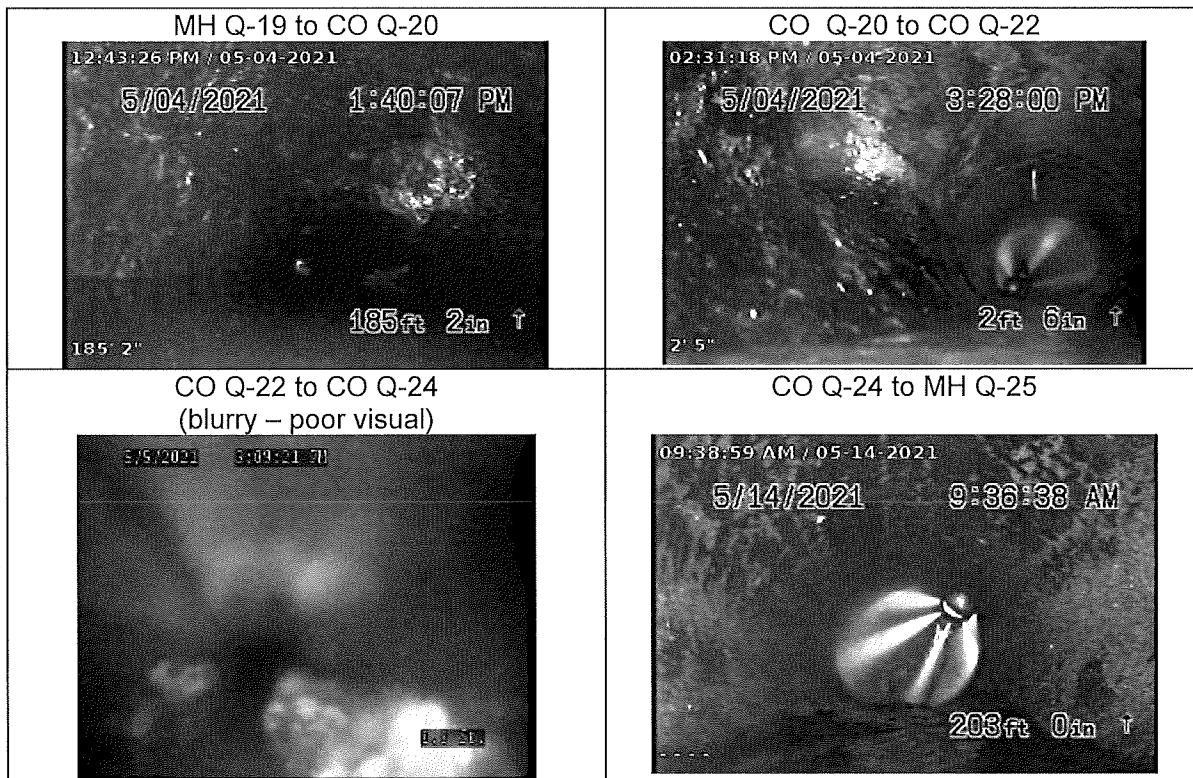
No holes or cracks were observed in any segment (that was visible) of the Keller Beach sanitary sewer main, though the pipe walls show extensive evidence of pipe corrosion. Corrosion of the pipe walls (with a decrease of the pipe's structural integrity) has resulted over time due to the presence of corrosive hydrogen sulfide gas, a natural sewer gas, in the unlined pipe. The presence of extensive sags and pipe obstructions further exacerbate the problem by causing organic solids to settle and increases localized hydrogen sulfide gas production in the pipe. Corrosion will continue to deteriorate the pipe's structural integrity as long as the pipe remains exposed to sewage gases.
