COASTLAND

Date: January 3, 2022

Subject: City of Richmond
Keller Beach Sanitary Sewer CCTV Review
and Assessment Report

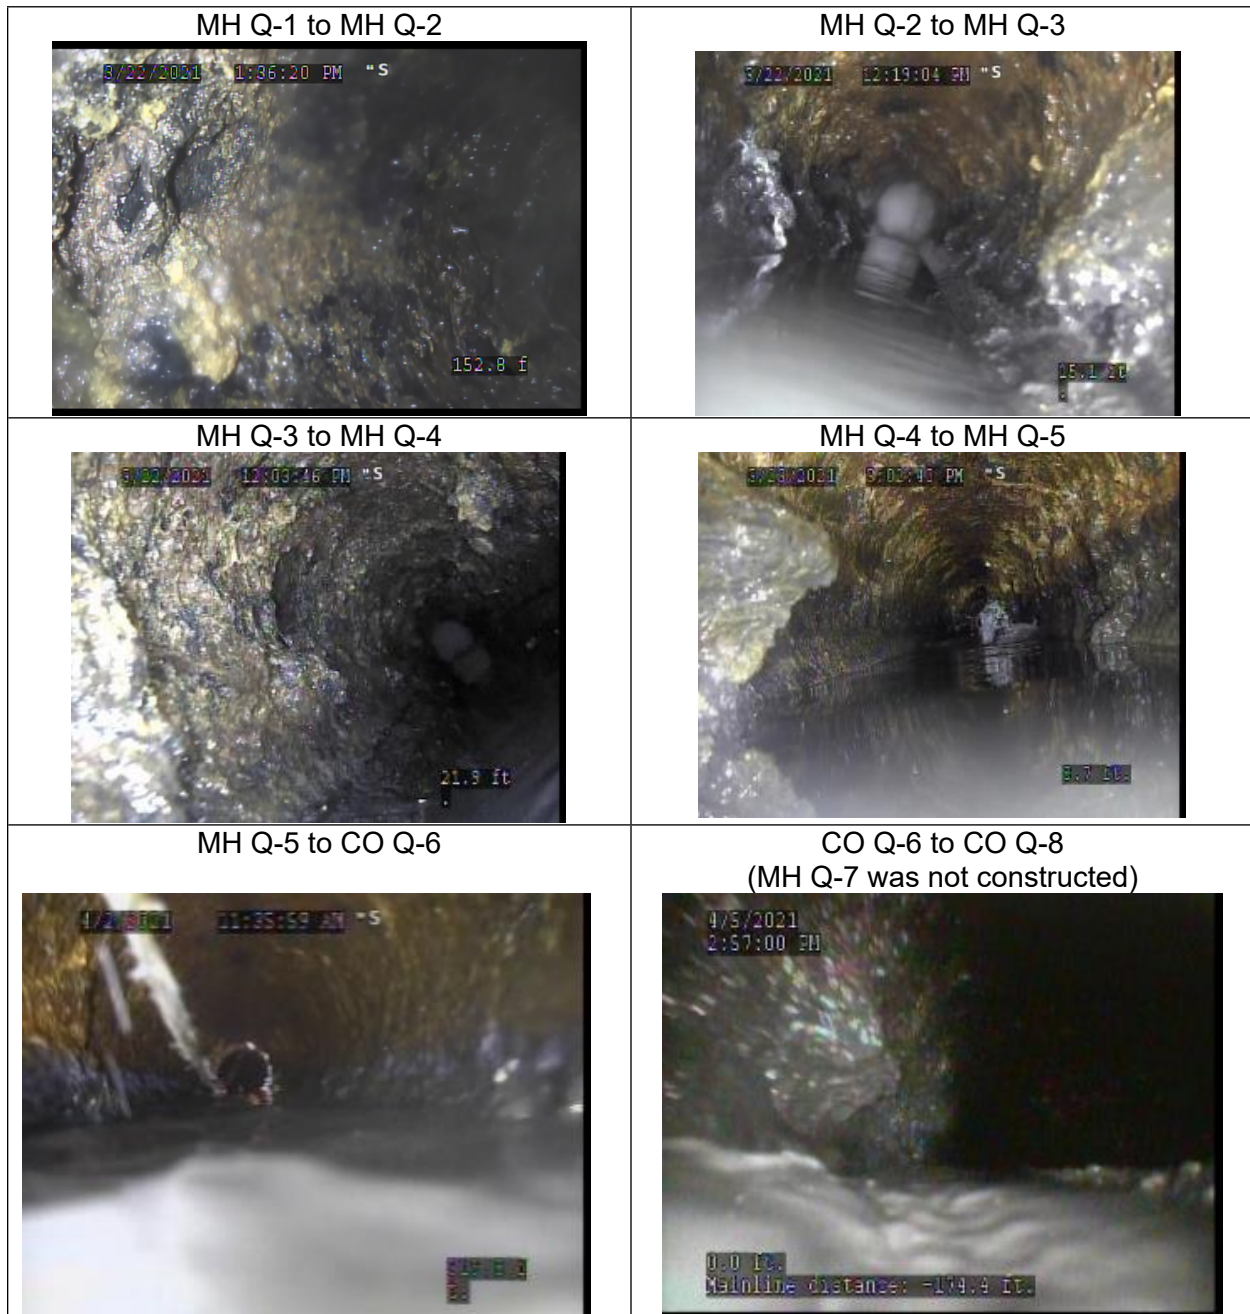
<p>CO Q-8 to MH Q-9</p>

According to Express Sewer, the entire reach of Keller Beach sanitary sewer was extremely corroded prior to cleaning. As shown in the post-cleaning images below, the upstream reach of pipe (MH Q-17 to MH Q-25) was generally descaled, while further downstream (MH Q-1 to MHQ-17) extensive turberculation and wall roughness remains.

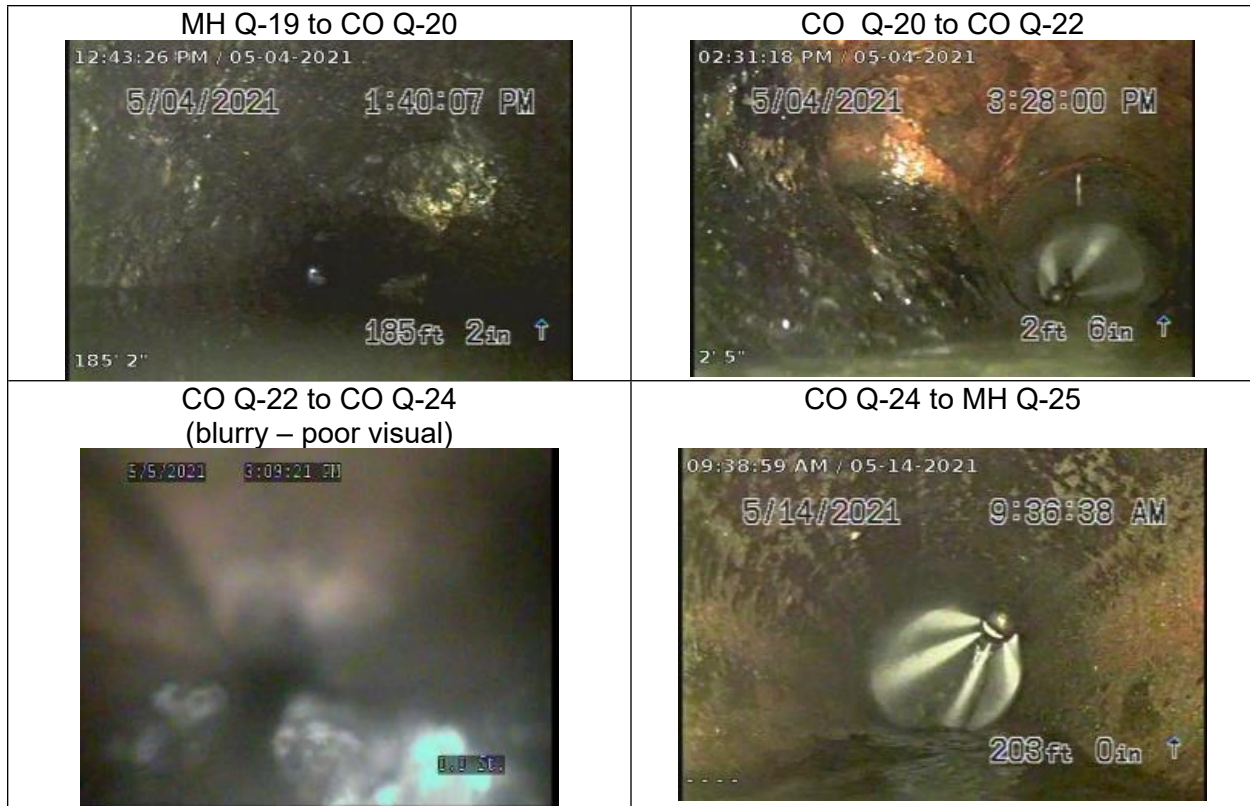
No holes or cracks were observed in any segment (that was visible) of the Keller Beach sanitary sewer main, though the pipe walls show extensive evidence of pipe corrosion. Corrosion of the pipe walls (with a decrease of the pipe's structural integrity) has resulted over time due to the presence of corrosive hydrogen sulfide gas, a natural sewer gas, in the unlined pipe. The presence of extensive sags and pipe obstructions further exacerbate the problem by causing organic solids to settle and increases localized hydrogen sulfide gas production in the pipe. Corrosion will continue to deteriorate the pipe's structural integrity as long as the pipe remains exposed to sewage gases.
